**AVIATION INVESTIGATION REPORT
A06C0131**

COLLISION WITH WATER

**HELICOPTER TRANSPORT SERVICES (CANADA) INC.
McDONNELL DOUGLAS HUGHES 369E (HELICOPTER) C-FHMF
DAVY LAKE, SASKATCHEWAN, 20 nm E
13 AUGUST 2006**

Report Number A06C0131

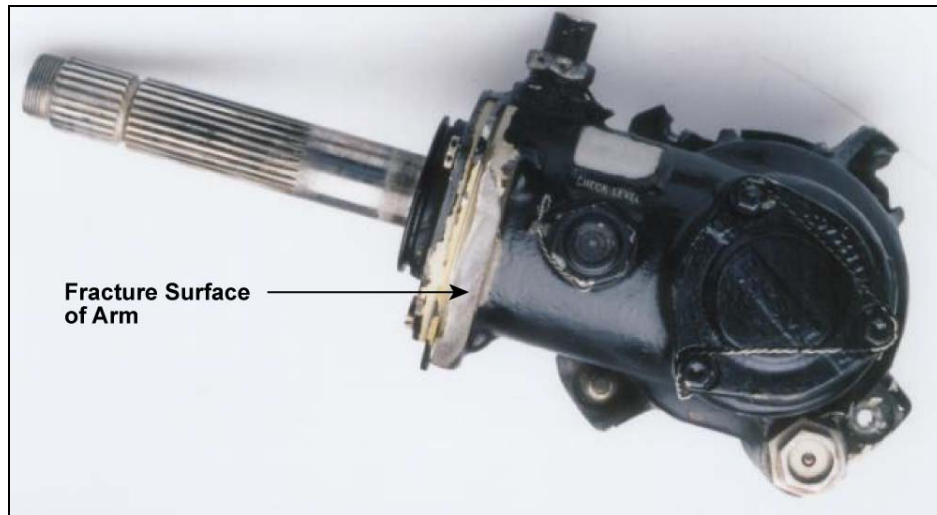
Examination of the instrument panel indicated that the generator-out warning light was illuminated before the filament was stretched by impact forces. No other warnings were illuminated. The examination of the instruments did not provide any reliable information for analysis. The fracture in the bell crank support arm was found to be a fatigue fracture that had developed through 75 per cent of the support arm. A photograph taken of the wreckage immediately after it was recovered to shore, and before the second impact, revealed that the bell crank support arm was still intact. The photograph also showed that paint was missing along the fracture line. The photographs in Appendix A were taken after the second impact. The remaining section of the bell crank support arm failed in overload due to the secondary impact. The entire fracture surface can be observed.

Since photographs revealed that the tail rotor bell crank support arm was still intact and had not broken apart before the crash, the developing fracture in the bell crank support arm likely did not contribute to the accident. Operation of the helicopter resulted in some movement of the bell crank support arm and caused paint to flake along the fractured area. The flaking of the paint was probably missed during the inspection because the tail rotor area was examined in darkness with the aid of a flashlight.

1. Serviceability inspections of the helicopter did not detect the fatigue crack developing in the support arm.

Photo 1. Tail rotor gearbox showing fracture of bell crank support arm

On 20 February 2007, the TSB issued Safety Information Letter A06C0131-D1-L1 – Pre-Crack/Fatigue Crack of the Tail Rotor Gearbox Bellcrank Support Horn, to the Director General, Civil Aviation. The Safety Information Letter stated that, in this occurrence, an inspection of the wreckage revealed a suspicious fracture surface of the tail rotor gearbox bell

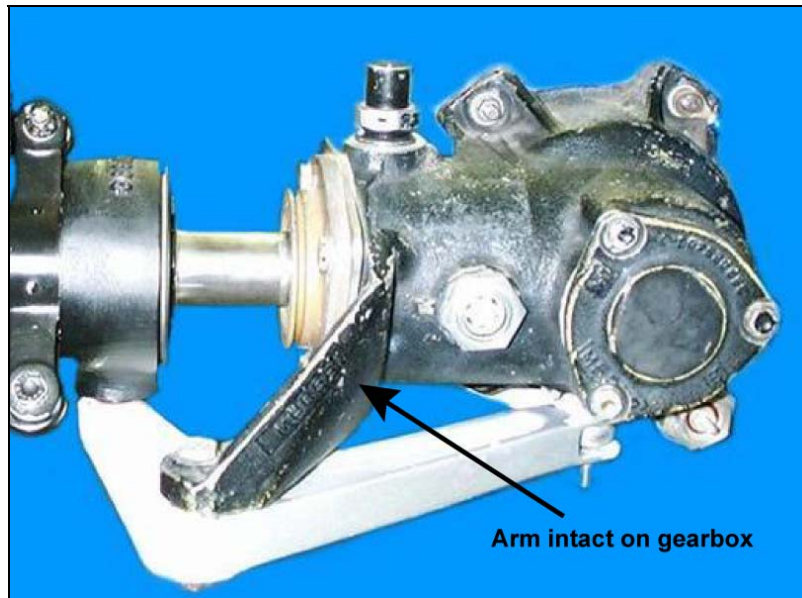
Photo 2. Exemplar gearbox

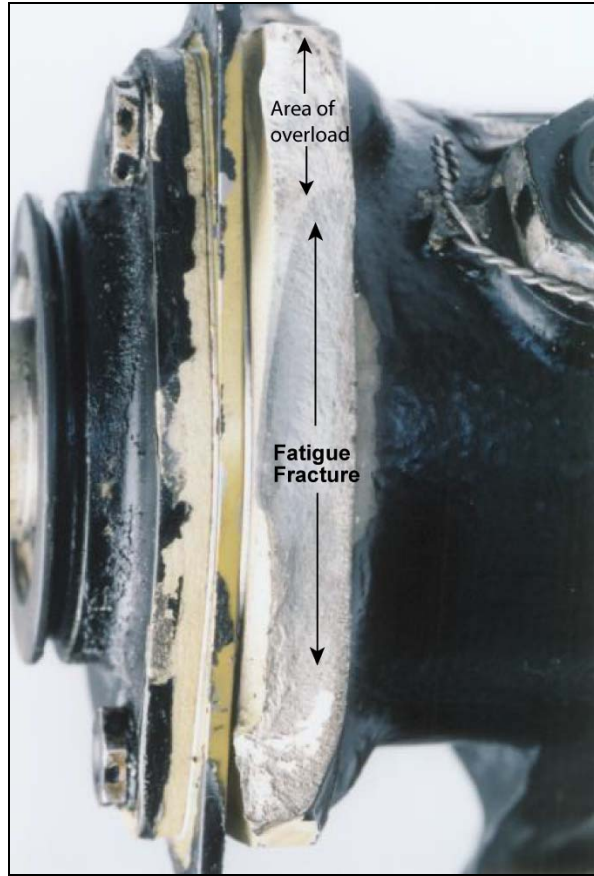
crank support horn. Analysis of the fracture revealed a pre-crack/fatigue crack extending across approximately 75 per cent of the entire cross section of the bell crank support horn. The fractured horn did not contribute to the accident.

Photo 3. Close-up of fracture area
