AVIATION INVESTIGATION REPORT

A06Q0180

LOSS OF ELECTRICAL POWER

BEEHCRAFT KING AIR 100 C-GJLP

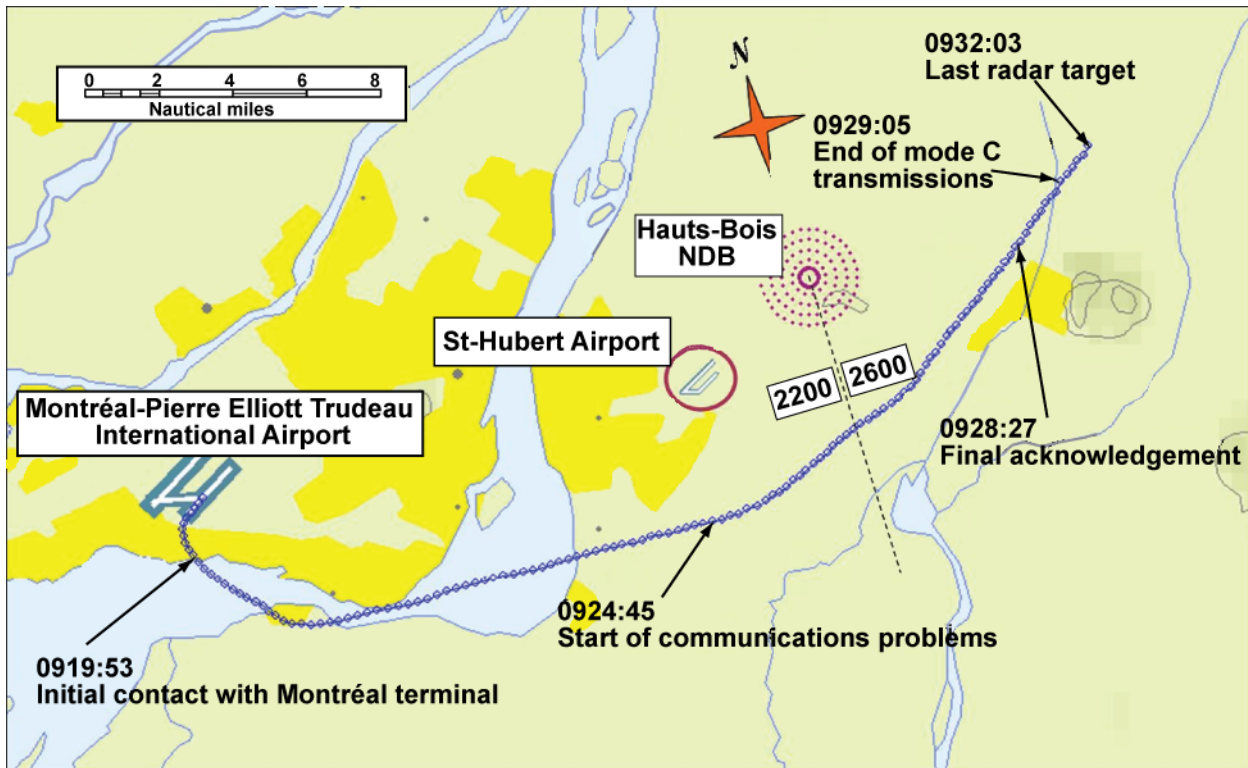
Figure 1. Radar track

During radar vectoring, the crew was able to estimate its position in relation to the St-Hubert Airport (see Figure 1). The pilot-in-command remembered that, during the initial climb in Montréal, he could see the ground through a thin scattered layer of cloud, to an altitude of about 2000 feet. The crew then decided to leave the last assigned altitude of 3000 feet for the minimum sector altitude (MSA),² which he believed to be 2200 feet. The MSA to the west of the Hauts-Bois non-directional beacon (NDB) (see Appendix A), the final approach fix (FAF) for Runway 24R, is 2200 feet while the MSA to the east of the Hauts-Bois NDB is 2600 feet.

At 2200 feet, the pilot-in-command saw the ground and made a steep turn to the left while maintaining visual reference. Once the aircraft was levelled, the crew estimated the ceiling to be approximately 200 feet above ground level (agl) and the visibility to be ½ mile. The radar track shows that, during the descent, the aircraft was 9 nautical miles (nm) east-northeast of the NDB; the MSA for this area would have been 2600 feet.

1. The crew descended to an altitude below the sector altitude applicable to its position, without knowing its exact position. This situation increased the risk of collision with the terrain or with obstacles.

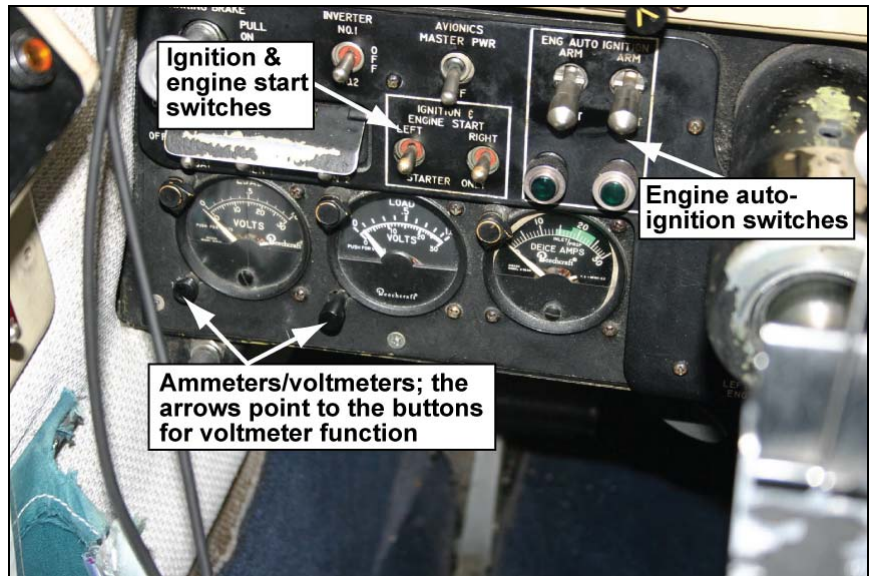
Photo 1. The switches

Engine auto-ignition switches and ignition and engine start switches on the King Air 100 aircraft are located on the lower left of the instrument panel (see Photo 1). They are accessible to the pilot-in-command only, and are not visible to the copilot. The view of the switches is obstructed by the left control wheel and any documents affixed to it. A movement of the head is required to observe the switches.

The auto-ignition switches have two positions: up and down. When the switches are in the down position, the system is deactivated. When the switches are in the up position, the auto-ignition is in the armed mode. The position is confirmed by two green warning lights located below the switches. In addition, two white warning lights, “L IGNITION” and “R IGNITION,” on the annunciator panel illuminate when the engine torque falls below 425 pound-feet. The switches are protected against inadvertent activation by a detent that requires the switch lever to be pulled to make a selection. The King Air A100 checklist requires that the switches be placed in the armed mode during the line-up checks, which is the final item to be completed before take-off. They must be placed in the OFF position during the post-landing check.

The ignition and engine start switches have three positions. The down position is used to turn the engines without ignition. The centre position disables the switches, and the up position is for ignition and engine start. There is no protective detent on these switches; therefore, they can be activated inadvertently. In the down position, a return spring moves the switch toward the centre. However, when the switch is placed in the up position for engine start-up, there is no return spring. The switch thus remains in the ignition and engine start position until it is deactivated. In this position, the appropriate white warning light, “L IGNITION” or “R IGNITION,” on the annunciator panel illuminates and remains on, regardless of the engine power produced.

On King Air 100 engines, the same unit alternates the functions of starter and generator. Selecting the ignition and engine start position activates the starter function and deactivates the generator function. In such a case, the battery provides all of the aircraft’s electrical needs. On C-GJLP, if the switches are inadvertently left in the ignition and engine start position, the crew is not provided with the red light warnings “L GENERATOR” and “R GENERATOR” that would indicate that the two generators are off line.

The line-up checklist does not require a verification of the load indicators when the auto-ignition switches are placed in the ON position. The load indicators located under the ignition and engine start switches are not easy to read by the pilot in the left seat and are not visible to the pilot in the right seat.

All indications suggest that, shortly before take-off, the pilot-in-command selected the ignition and engine start switches instead of the auto-ignition switches. Although the two sets of switches have distinct operating mechanisms, the differences were not sufficient to prevent the error. This type of error is common for routine tasks where the object to be activated is located close to another. The line-up checklist does not require a load indicator reading when the auto-ignition switches are selected, which would confirm that the generators are on line.

1. Shortly before take-off, the pilot-in-command inadvertently selected the ignition and engine start switches instead of the auto-ignition switches. As a result, all of the aircraft electrical needs were powered by the battery, which was unable to maintain the load needed for the normal use of the electrical system and its related instruments.

2. The line-up checklist does not require a load indicator reading when the auto-ignition switches are selected, which would confirm that the generators are on line.

Since this incident, during initial and recurrent ground training, Propair Inc. instructors emphasize the risk associated with the starter/generator system and its consequences on some of the company's Beechcraft King Air 100.
