**AVIATION INVESTIGATION REPORT
A06W0104**

LOSS OF CONTROL AND COLLISION WITH TERRAIN

**PRECISION HELICOPTERS INC.
BELL 206B C-GPGX (HELICOPTER)
NOSE MOUNTAIN TOWER, ALBERTA
03 JULY 2006**

Report Number A06W0104

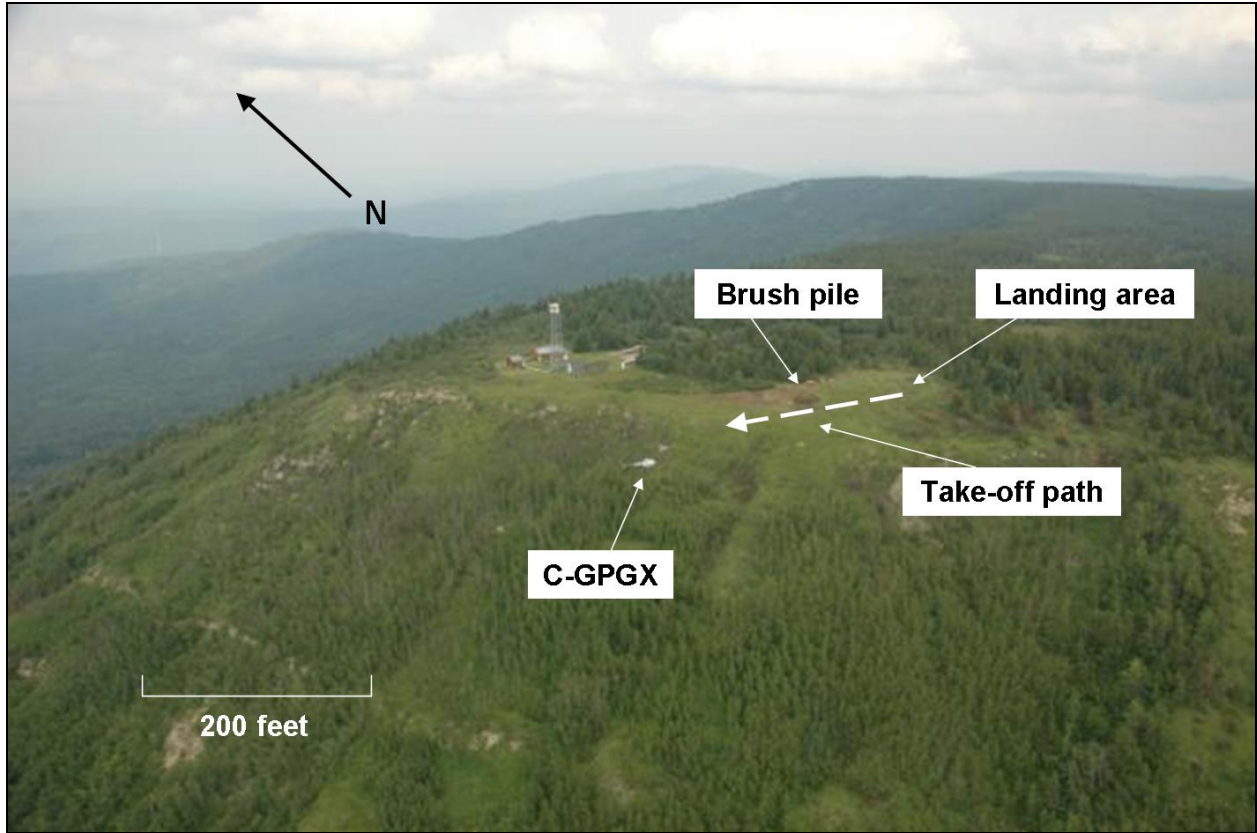
Appendix A – Landing Area and Accident Site

The landing area measured about 200 by 150 feet and was on the northeast side of a clearing, surrounded on three sides by trees up to 25 feet tall. Second growth brush had recently been removed from the clearing to improve aircraft operations and facilitate multiple helicopter landings and departures. A mound of brush about 6 feet high and 20 feet in diameter had been piled in the clearing, to the west of the landing area. The distance from the landing area to the escarpment was about 200 feet, and the distance from the take-off position to the rim of the escarpment was about 125 feet (see Appendix A). The elevation of the landing area is 4879 feet above sea level (asl).

The prevailing winds were normally from the west, and pilots usually departed from the landing area to the west and over the escarpment. A departure directly to the east would have required an initial climb of 25 to 30 feet to clear the tree-line. The pilot had departed directly from the landing area toward the escarpment many times in the past, often at high gross weight.

To depart toward the escarpment on the accident flight, it was necessary to manoeuvre the helicopter to avoid the brush pile. The pilot performed a clearing hover turn to the right, then hover-taxed southward, while maintaining a westerly heading, along the southeast edge of the clearing. This positioned the helicopter for an unobstructed take-off run to the west, across flat ground and toward the escarpment. The helicopter did not attain sufficient speed for translation lift² before reaching the rim of the escarpment. The accident site is at latitude 54°34' N, longitude 119°38' W.

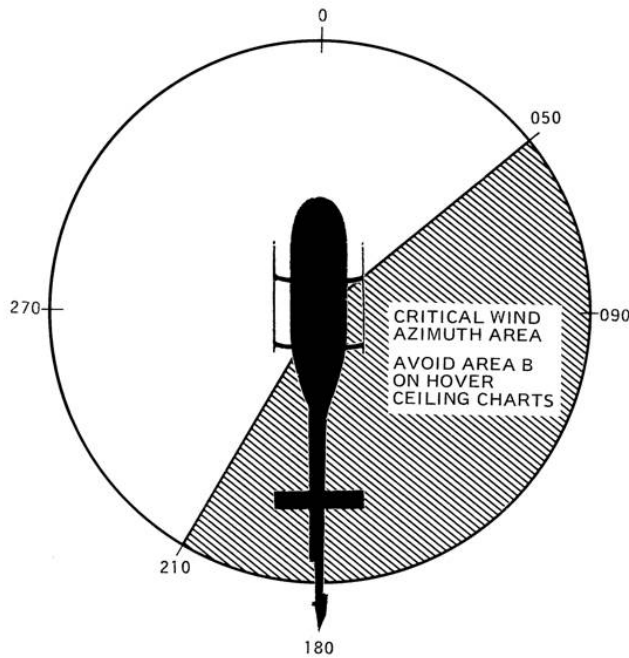
Appendix B – Critical Relative Wind Azimuth Area for Bell 206B

The hover out-of-ground effect (HOGE) charts in the Bell 206B Flight Manual provide hover performance (that is, maximum allowable gross weight) for conditions of pressure altitude and temperature. The charts are divided into Area A and Area B. Area A indicates hover performance for which satisfactory stability and control has been demonstrated in relative winds of 17 knots sideward and rearward for all loading conditions. Area B indicates hover performance that can be realized in calm winds or in winds outside the critical relative wind azimuth area. Tail rotor control may not be possible for operations in Area B of the hover ceiling charts when the relative wind is in the critical wind azimuth area. For the Bell 206B, the critical relative wind azimuth area extends clockwise 50° from the nose of the helicopter to 210° from the nose of the helicopter (see Appendix B).

The wind direction was particularly significant, in that a departure to the west placed the tail of the helicopter within the critical relative wind azimuth area. This increased the risk of URY. As well, departing in a tailwind required significantly more distance to accelerate through transitional lift. Departing in the tailwind also increased the likelihood of the helicopter encountering down-flowing air over the rim of the escarpment.

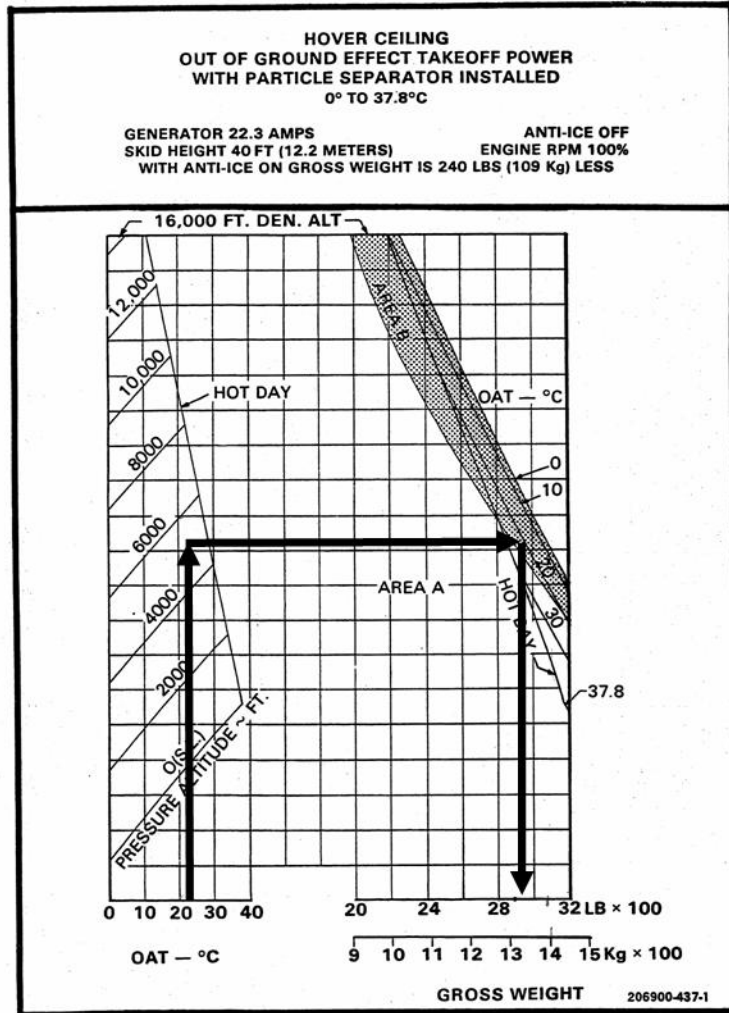
Appendix C – Hover Out-of-Ground Effect Chart for Bell 206B

The Bell 206B HOGE chart indicates that, for the conditions at the occurrence site, 2925 pounds would be the maximum weight to HOGE and remain in Area A (see Appendix C). At 3245 pounds, the helicopter was about 320 pounds above that maximum weight, and now in Area B of the HOGE chart.

6. The weight of the helicopter at take-off was incorrect because of inaccurate estimates of the weights of the firefighters, their gear, and the equipment. For the existing conditions, the take-off weight exceeded both the maximum gross weight limit and the hover out-of-ground effect (HOGE) ceiling limit.
