AVIATION INVESTIGATION REPORT
A07C0225

DOUBLE ENGINE POWER LOSS

HICKS & LAWRENCE LIMITED
AERO COMMANDER 500B C-GETK
ARMSTRONG, ONTARIO, 20 nm SW
30 NOVEMBER 2007

Report Number A07C0225

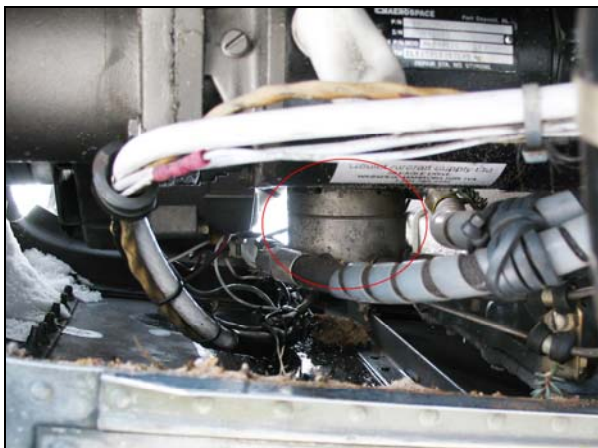
During examination of the aircraft at the accident site, a restriction or blockage was found in the fuel supply to both Lycoming IO-540-B1A5 engines. The left engine had a partial blockage with no fuel supply to the forward cylinder nozzles; the right engine had a complete blockage with no fuel supply to any of the cylinder nozzles. The blockage was determined to be within the fuel distributor valve(s) because fuel pressure was present upstream of the valves (see Photo 1). The location of the fuel distributor valve on the IO-540-B1A5 Lycoming engine, in conjunction with the Aero Commander 500B engine cowling configuration, exposes the valve directly to the cooling blast of the outside air.

Photo 1. Fuel distributor valve installation in the lower front engine area

The location of the fuel distributor valve on the IO-540-B1A5 Lycoming engine, in conjunction with the Aero Commander 500B engine cowling configuration, exposes the valve directly to the cooling blast of the outside air. Generally, cooling of the fuel distributor valve is desired in warm ambient operations. However, in extremely cold conditions, the exposure of the valve directly to the cold airstream can lead to the freezing of super-cooled water droplets present in the fuel stream. The high altitude testing of piston engines conducted in the early 1970s identified the risk of ice accumulations in the fuel distributor valve associated with cold weather operations. The use of a fuel additive icing inhibitor mitigated the risk by bonding with and reducing the freezing point of the water.

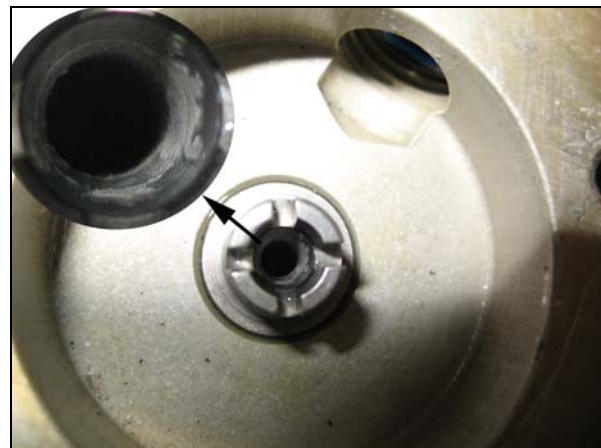
The right engine fuel distributor valve was removed and examined. Ice was found adhering to the internal main metering well surface (see Photo 2). Ice formed from super-cooled water droplets was also found adhering to the servo bleed screen and fully covering and blocking the return-to-tank bleed orifice (see Photos 3 and 4).

Photo 2. Ice on main metering well

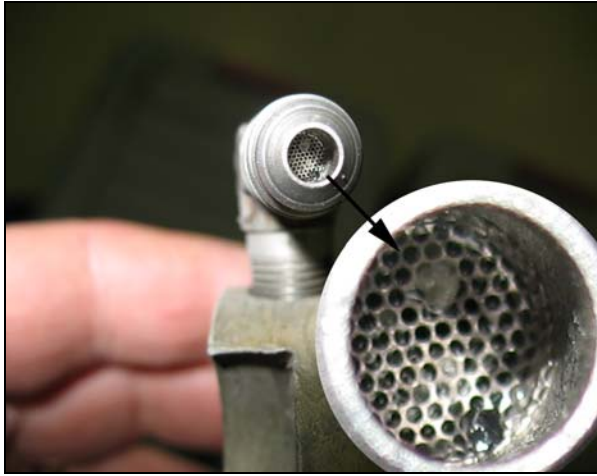
Photo 3. Super-cooled droplet ice formation on the servo bleed screen

The precipitated moisture, in the form of super-cooled water droplets, emerged from the pump and was carried through the fuel injection metering unit to the fuel distributor valve. At the bottom of the distributor valve plunger well, a significant reduction in flow velocity occurred that combined with a reduced fuel distributor valve surface temperature (due to the cooling air blast against the forward face of the valve) to promote the formation of ice crystals. These ice crystals continued to capture the super-cooled water droplets until the ice build-up blocked the fuel flow to the forward fuel injection lines, causing a reduction in engine power.

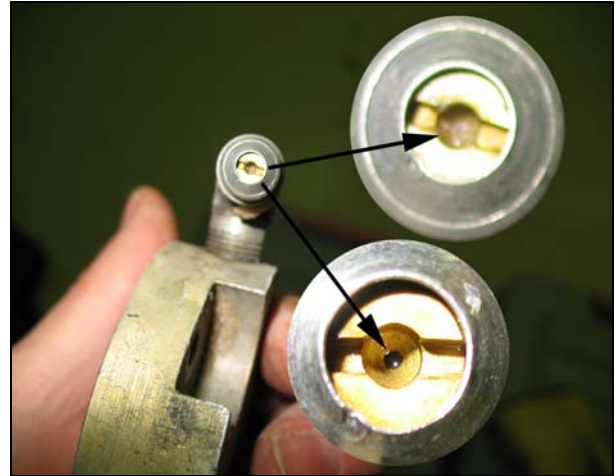
Photo 4. Return-to-tank bleed orifice (shown frozen and thawed for comparison)
