## AVIATION INVESTIGATION REPORT

A07W0186

### ENGINE FAILURE AND COLLISION WITH TERRAIN

**PIPER MALIBU PA-46-310P, C-GTCS**  
**INVERMERE, BRITISH COLUMBIA, 11 nm E**  
**26 OCTOBER 2007**

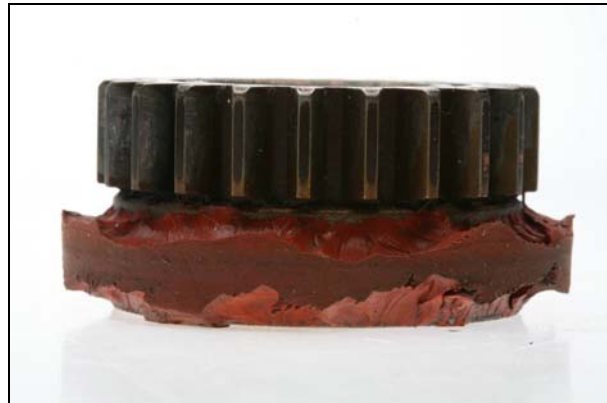
This washer was found to have forced the rubber ring further out of the cup and engage the gear teeth of the crankshaft alternator drive gear. This resulted in the destruction of the rubber portion of the coupling. Rubber particles of various sizes found their way into the engine sump (see Photo 1).

The rubber particles found in the engine sump matched those of the old coupling. In addition, several of the lifters contained rubber debris, indicating that the oil filter had been in a bypass state, allowing debris to flow into the system. The oil filter was also found to contain a large amount of rubber and metal debris. When the coupling was changed, the engine oil and filter were not changed, nor was the engine oil system flushed. The engine maintenance manual recommends checking the oil filter for metal debris during oil changes, but does not specify checking for other types of debris during other forms of maintenance. The engine manufacturer issued Service Bulletin M84-5 in 1984 that addressed gear-driven alternator malfunctions on all of its 520 series engines. It specifies that if any contamination is found upon removal of the alternator, the oil sump must be removed, the pick up cleaned or replaced, and, if anything further is found, a Teledyne Continental service representative should be contacted. This service bulletin does not apply to the 550 series engines even though they are equipped with gear-driven alternators. Standard industry practice is to check oil systems when contamination of any kind is found or known about, to flush the system, and to ascertain the source before releasing the aircraft for flight.

**Photo 1.** Gear damage to rubber material

An unapproved, shop-made washer that had been installed in the alternator drive coupling contributed to a quantity of rubber debris entering the engine. The presence of the washer in the coupling also caused the rubber disc to contact the alternator spur gear on the crankshaft, causing more debris to enter the sump. This debris then restricted oil flow in the failed area of the engine. The industry standard check of oil systems when contamination is found or known to exist was not carried out. The company performing the maintenance did not benefit from guidance developed in Service Bulletin M84-5 as the bulletin did not include this series of engine even though it had a gear-driven alternator.

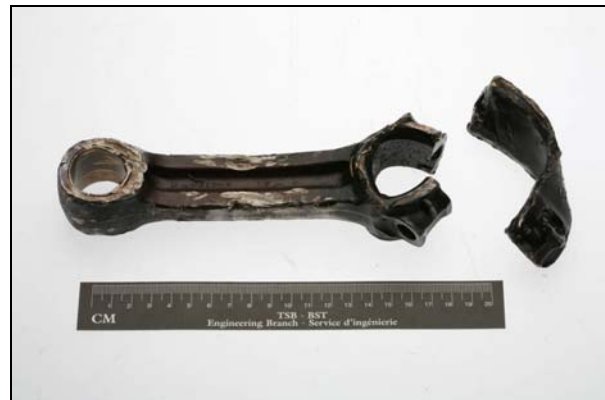
The top of the engine at centreline had a large hole over the number two connecting rod. The crankshaft and the number two connecting rod had indications of extreme heat, which was localized to this area (see Photos 2 and 3). The number two main bearing on one side was broken due to low-cycle pounding stresses. The number two piston had been making contact over time with its cylinder head and valves.

**Photo 2.** Heat and contact damage to connecting rod 2

It is highly probable that the engine failure was initiated by a partial blockage of oil flow, caused by debris in the oil, to the number two connecting rod journal and bearing. This resulted in a progressive loosening of the clearances at that location, which allowed a gradual increase in piston stroke and increasing contact between the piston and the cylinder/valves. This looseness caused repeated reaction forces on the number two main bearing, pounding it until fatigue cracking broke up the left bearing shell. The connecting rod journal continued to overheat and elongate the bearing area until the lower connecting rod end cap nut came apart. Total engine failure and seizure then occurred.

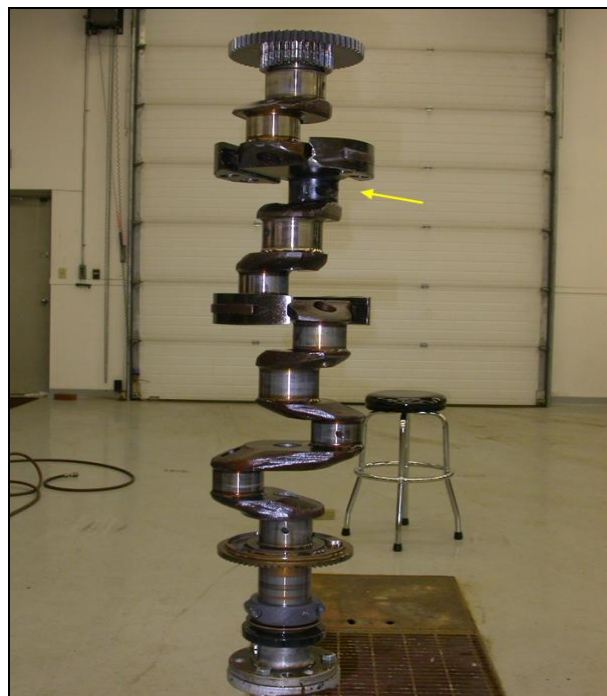
**Photo 3.** Crankshaft showing heated area
