**AVIATION INVESTIGATION REPORT
A08O0215**

LOSS OF SEPARATION / RISK OF COLLISION

**NAV CANADA
TORONTO / LESTER B. PEARSON INTERNATIONAL AIRPORT
MISSISSAUGA, ONTARIO
09 AUGUST 2008**

Report Number A08O0215

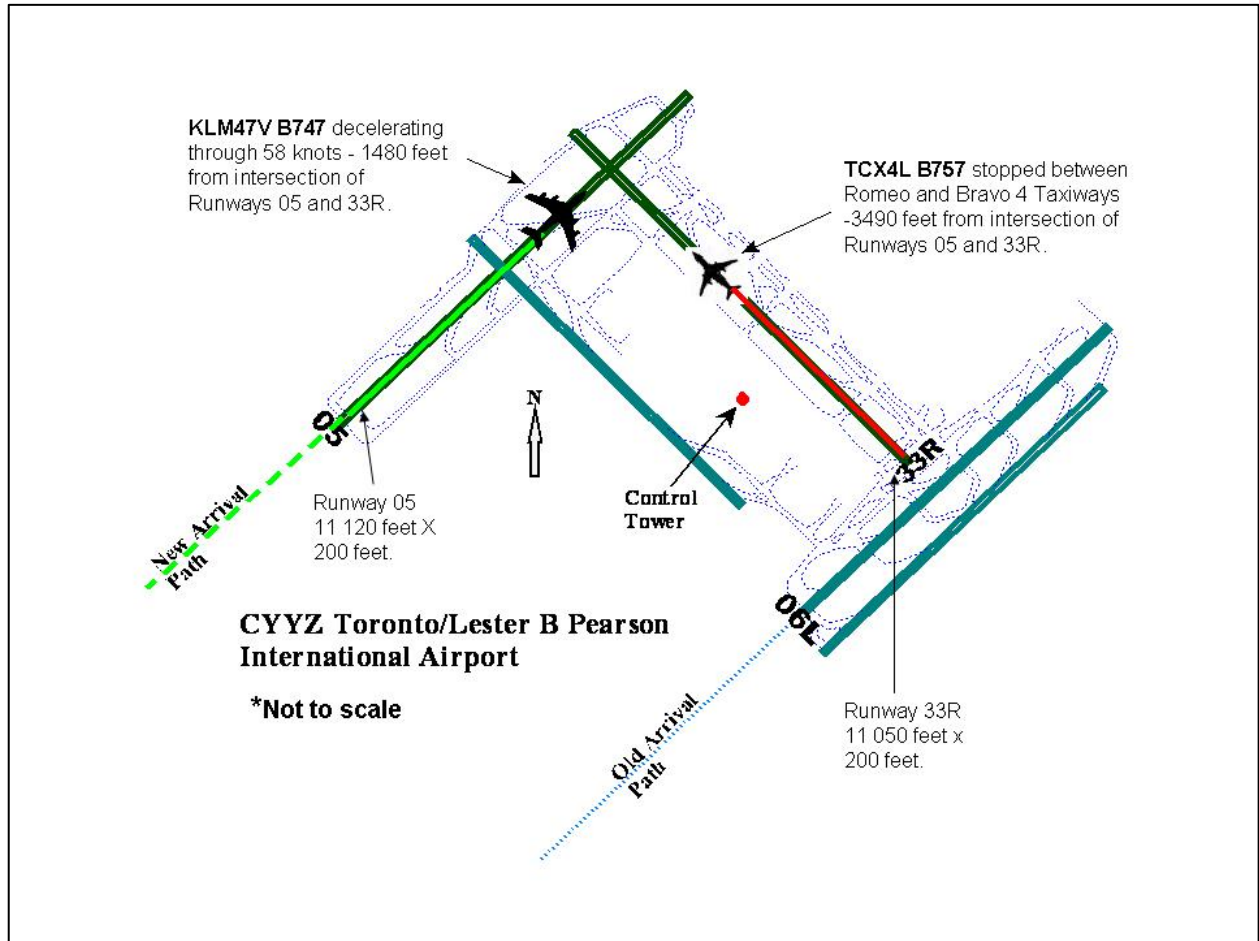
Appendix A – Aircraft Positions at 1610:18

TCX4L reached a maximum of 126 knots. The aircraft came to a stop on Runway 33R between Romeo and Bravo 4 Taxiways at 1610:18, approximately 6260 feet from the threshold of Runway 33R (approximately 3490 feet from the intersection with Runway 05). By the time TCX4L stopped, KLM47V had passed the Hotel 3 high-speed exit on Runway 05 (approximately 1480 feet before the intersection with Runway 33R) travelling at 53 knots (see Appendix A - Aircraft Positions at 1610:18).
