AVIATION INVESTIGATION REPORT

A08P0125

LOSS OF ENGINE POWER AND COLLISION WITH TERRAIN

**BIGHORN HELICOPTERS INC.
BELL 206B JET RANGER (HELICOPTER) C-GCHE
CRANBROOK, BRITISH COLUMBIA
13 MAY 2008**

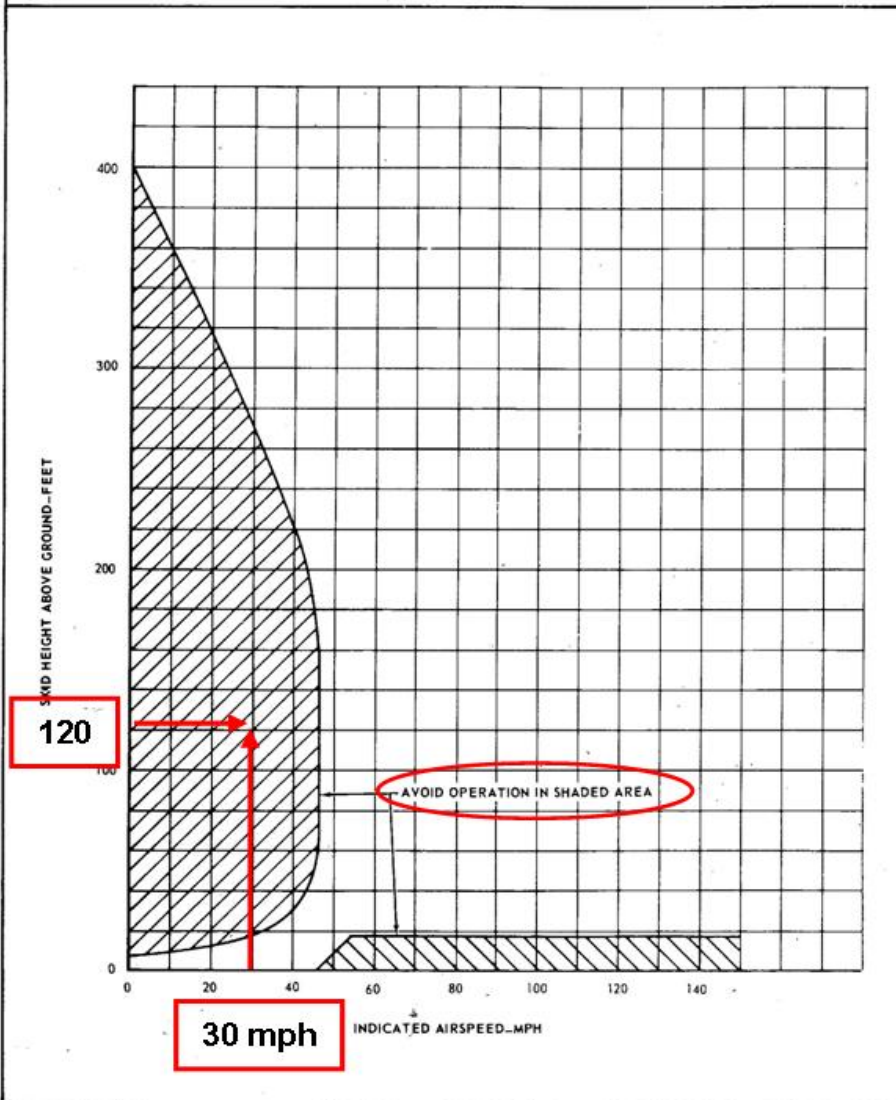
Appendix D – Height Velocity Diagram

The two-part HVD for the Bell 206B is contained in Section 3 – Performance of the RFM and is shown in Appendices D and E of this report. Note that the airspeed is referenced in miles per hour (mph). The HVD shows that a pilot should not expect to establish full autorotation from heights between 40 and 200 feet above the ground, unless the airspeed is above 45 mph. In the case of C-GCHE, the helicopter was at about 120 feet agl and travelling at about 30 mph; with such height and speed, the helicopter could not have achieved full autorotation before it struck the ground.

In reviewing the accident flight path, it can be seen that the helicopter was frequently exposed to the higher-risk avoid zones of the HVD during its passage over the built-up areas of Cranbrook. Under these conditions, the helicopter would not have had sufficient altitude or time to develop autorotative flight following a sudden loss of engine power. As a result, the pilot would have had no opportunity to conserve rotor rpm and a high rate of descent would have developed rapidly. Any manoeuvring by the pilot to avoid obstacles would have exacerbated this deteriorating condition.
