AVIATION INVESTIGATION REPORT

A09C0087

IN-FLIGHT FIRE

ULTRA HELICOPTERS LIMITED
BELL 204B (HELICOPTER), C-GAPJ
EASTERVILLE, MANITOBA

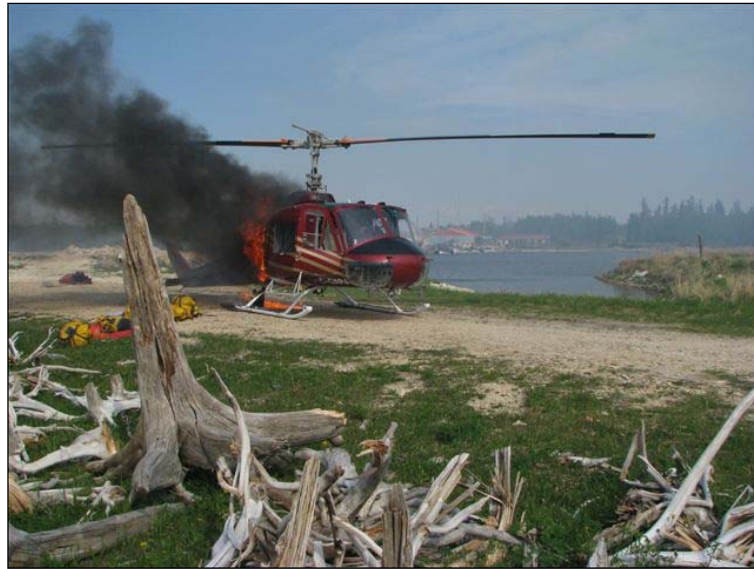
Photo 1. Helicopter showing fire emanating from the engine area.

caution lights illuminated. The pilot aborted the water pickup and proceeded to the ground staging area situated approximately 100 metres away. Black smoke billowed from the right rear belly area. Prior to reaching the ground staging area, a SPARE caution light illuminated and smoke in the cockpit emanated from the anti-torque pedal area. Once over land, the pilot jettisoned the water bucket and set the helicopter down. The pilot rapidly shut down the engine, turned off the fuel and electrics, and exited the helicopter with the helitac officer. At no time did the ENGINE FIRE warning light illuminate. The flames in the right engine cowling area prevented the pilot from returning to the helicopter to activate the engine fire extinguisher. The fire progressed rapidly until the helicopter was completely engulfed in flames and destroyed (see Photo 1).

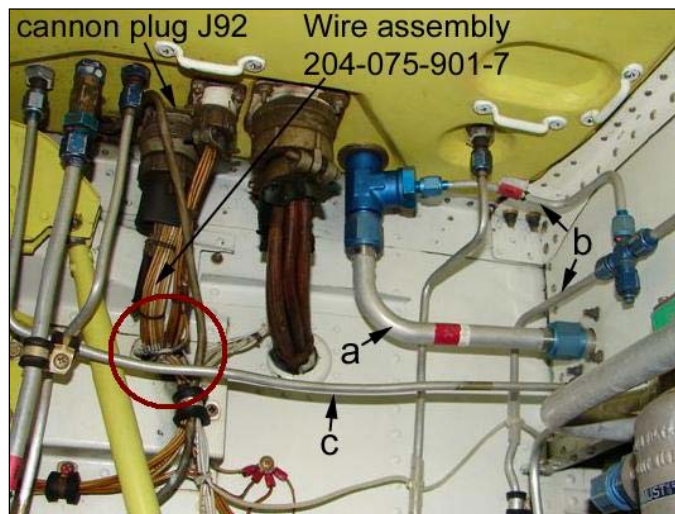
The engine power turbine governor vent return line (see Photo 2, item c) is mounted in close proximity to the steel fuel delivery line. In the event of a fuel leakage inside the power turbine governor chamber, the vent line returns the fuel to the main fuel tanks. The oil cooler blower is mounted below the steel fuel delivery line and blows cooling air past the oil cooler and into the cockpit area around the anti-torque pedals. An ENG FUEL PUMP caution light is mounted on the caution panel adjacent to the RIGHT FUEL BOOST caution light. The light is set to illuminate should a pressure drop occur across the dual-element engine-driven fuel pump.

Photo 2. Typical oil cooler blower compartment (shown for illustration purposes)

Two of the four identified wires controlled caution lights in the cockpit, the ENG FUEL PUMP caution light and the ICE DETECTOR caution light (marked SPARE due to the disarming of the ice detector system). The location of the arc was in an area where the wire assembly passed through the bulkhead from the oil cooler blower compartment into the aft electrical compartment (see circled areas on Photos 2 and 3).

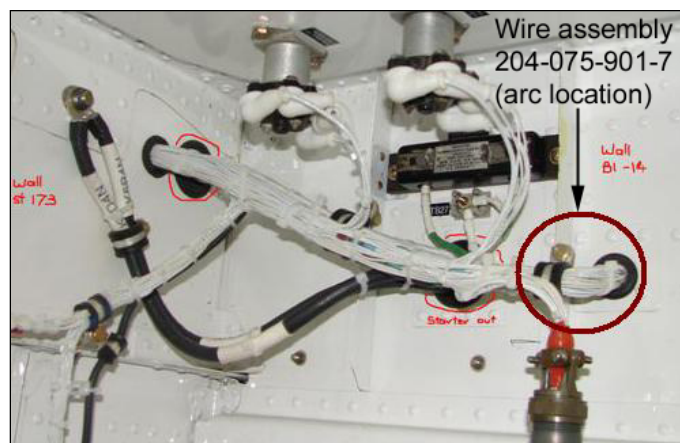
Photo 3. Typical aft electric compartment (shown for illustration purposes)

Upon entering the aft electrical compartment, the wiring bundle makes a sharp 90-degree bend before continuing on into the forward electrical compartment. Just past the 90-degree bend, the wire bundle is secured to a stiffener that is riveted to the compartment wall.

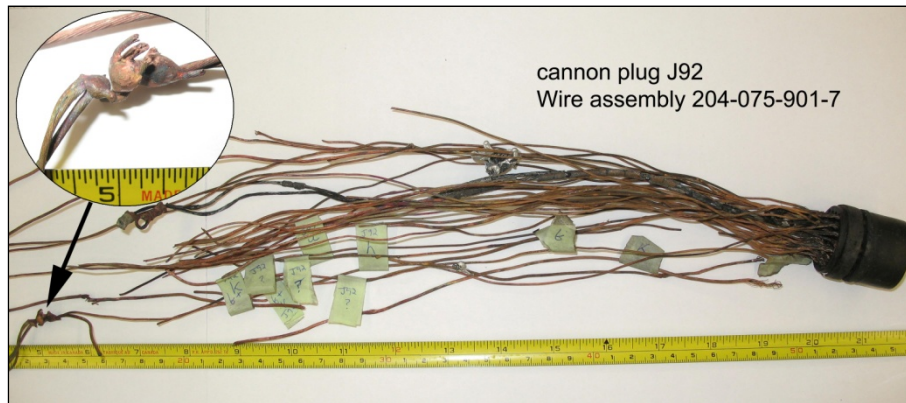
Examination of the engine electrical harness, at the juncture of the oil cooler blower compartment and the aft electrical compartment wall, revealed electrical arcing on 19 individual wires. Eleven of the 19 arced wires were located in wire assembly 204-075-901-7 running to the engine deck cannon plug J92 (see Photos 2, 3, and 4). Four of the 11 arced wires in wire assembly 204-075-901-7 were identified as to their function.

Photo 4. Close-up of wire assembly 204-075-901-7 with arc damage

The first indication for the crew of a problem in flight was an electrical burning odour, which was eventually followed by the illumination of two caution lights in the cockpit. The initial electrical burning odour was likely due to the arcing of wires in wire assembly 204-075-901-7 at the juncture of the oil cooler blower compartment and the aft electrical compartment wall. The exact cause of the wire arcing could not be determined. The smell and smoke would have been noticeable in the cockpit due to the normal flow pattern of the cooling air provided by the oil cooler blower.

1. Electrical arcing occurred in an engine electrical harness in the area of the oil cooler blower compartment and the aft electrical compartment wall. The exact cause of the wire arcing could not be determined.
2. The initial electrical arcing likely breached a nearby fuel line, which led to the rapid propagation of the fire and the total destruction of the helicopter.
