AVIATION INVESTIGATION REPORT

A09O0159

TREE STRIKE DURING CLIMB-OUT

CESSNA TU206G (AMPHIBIOUS), C-GGMG

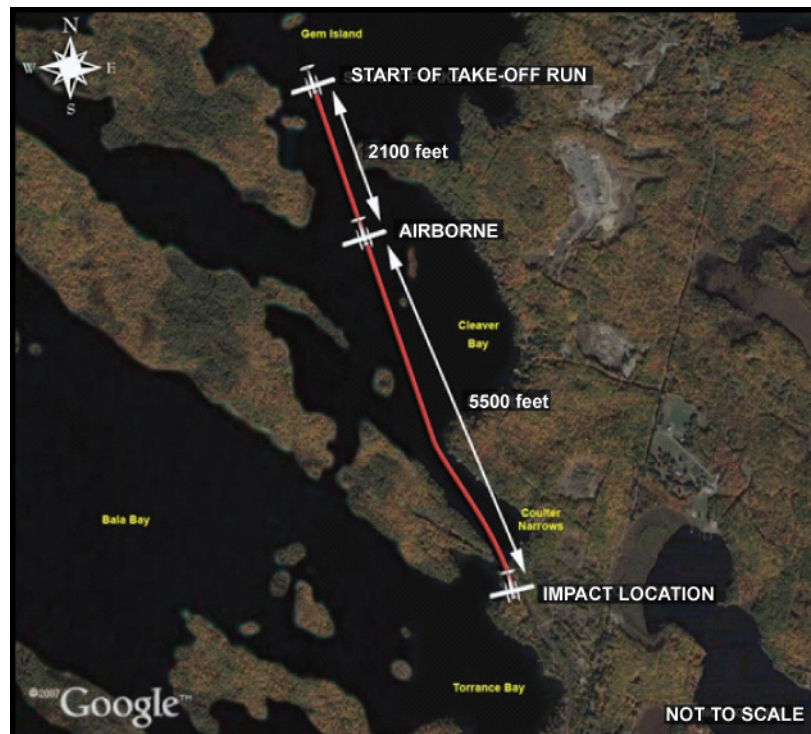
Figure 1. Estimated Flight Path

The aircraft was photographed close to a level attitude when it reached approximately 40 feet above the lake surface. This was the last observation until it struck the trees on the south shore of Coulter Narrows, an approximate distance of 5500 feet from where it became airborne and an estimated height of 90 feet above the lake surface (See Figure 1).
