AVIATION INVESTIGATION REPORT

A09P0210

IN-FLIGHT BREAKUP

**KOOTENAY VALLEY HELICOPTERS LTD.
ROBINSON R44 ASTRO (HELICOPTER) C-FKAJ
CRESTON, BRITISH COLUMBIA, 8.5 nm NW
22 JULY 2009**

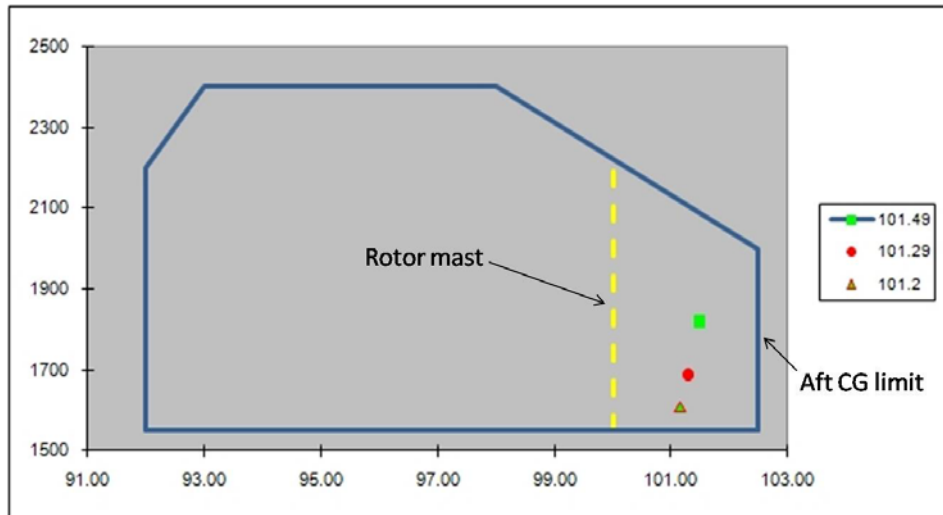
Figure 1. CG Envelope C-FKAJ

The helicopter had an empty weight of 1461.9 pounds, with a centre of gravity (CG) of 106.4 inches.² Before take-off on the accident flight, the student pilot had filled both external fuel tanks to 35 US gallons, for a total of 210 pounds. TSB calculations show that the helicopter likely weighed in the order of 1820 pounds at take-off from KVH with a CG of 101.49 inches (square in Figure 1). As the flight progressed and fuel was consumed, the CG would have moved forward toward the zero-fuel weight position of 101.2 inches (triangle in Figure 1). At the time of the accident, the weight and balance (circle in Figure 1) was likely within the prescribed limits and near the aft region of the CG envelope. The main rotor mast is 100 inches from the datum.

Flight with an aft CG condition within the certificated flight envelope is permissible. An aft CG condition, in flight, requires the pilot to maintain a more forward cyclic stick input, thus reducing the available forward cyclic stick travel. Under normal circumstances, this condition is an operational characteristic of helicopter flight, and requires cautious cyclic movement to avoid reaching the forward limit of longitudinal cyclic travel. However, the amount of available cyclic movement may be insufficient for the pilot to control the helicopter under some unusual conditions.

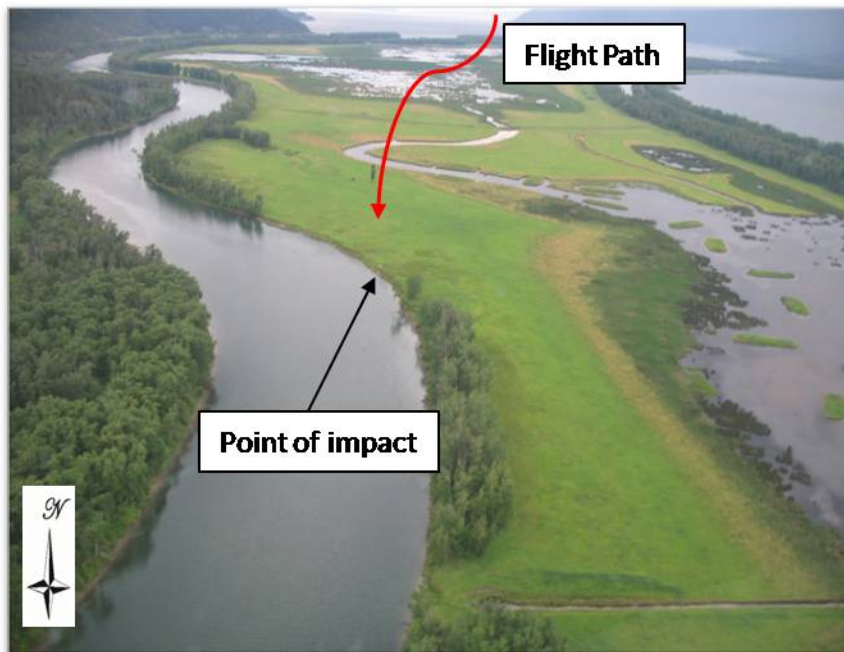
Photo 1. Accident flight path

The trail of wreckage shows that the helicopter broke up in flight near the southern end of Duck Lake, and fell in a southerly direction towards the river, a trajectory path of about 100 metres. The damage to the helicopter indicates that the helicopter fuselage struck the river left side low, almost in a level attitude.

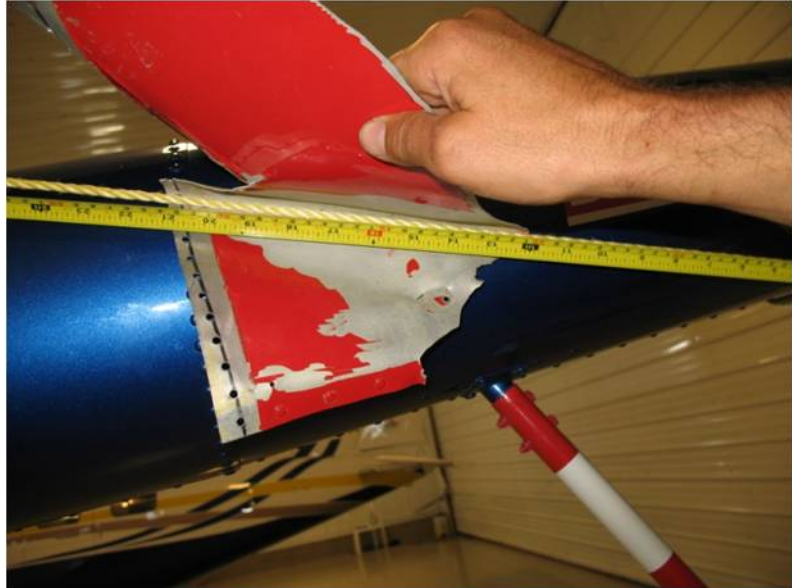
Photo 2. Tailboom rotor blade strike

All the rotor system components were found within the wreckage, with the exception of a section of one main rotor blade. Of the two main rotor blades (herein called red and blue for ease of identification), the whole red blade was still attached to the blade hub but the main spar was bent and fractured 60 inches from the root; the trailing edge remained intact. The red blade showed evidence of impact with the tailboom precisely matching the damage on the tailboom (see Photo 2).

Barring in-flight failure of one of the primary flight controls for helicopter attitude, there are few likely reasons for main rotor blade-to-tailboom contact (see Photo 2), namely:

The damage patterns to the main rotor and the fuselage suggest moderate rotor energy and rpm, although no definitive rpm could be ascertained.

The airframe damage indicates that the tail rotor assembly was intact at main rotor blade impact, and there was no sign of contact with any other component.

Wreckage damage and distribution also indicate that the lead event was the main rotor flapping down into the tailboom severing the tail rotor driveshaft, tailboom, and tail rotor assembly in one unit. This damage and loss of airframe structure was catastrophic and immediately rendered the helicopter uncontrollable.

Main rotor blade impact marks on the tailboom are indications of extreme in-flight rotor flapping. Frequently, such rotor strikes signify low-to-moderate rotor rpm, and in this accident, the tailboom contact marks, the proximity of the separated components, and the rotor blade damage are all characteristic of a rotor strike being the initiating event of the in-flight breakup and resulting loss of control.
