AVIATION INVESTIGATION REPORT

A09Q0071

IN-FLIGHT BREAKUP OF THE RIGHT WING

AVENTURIER C-GZIR
LAC AU MIRAGE, QUEBEC
13 MAY 2009

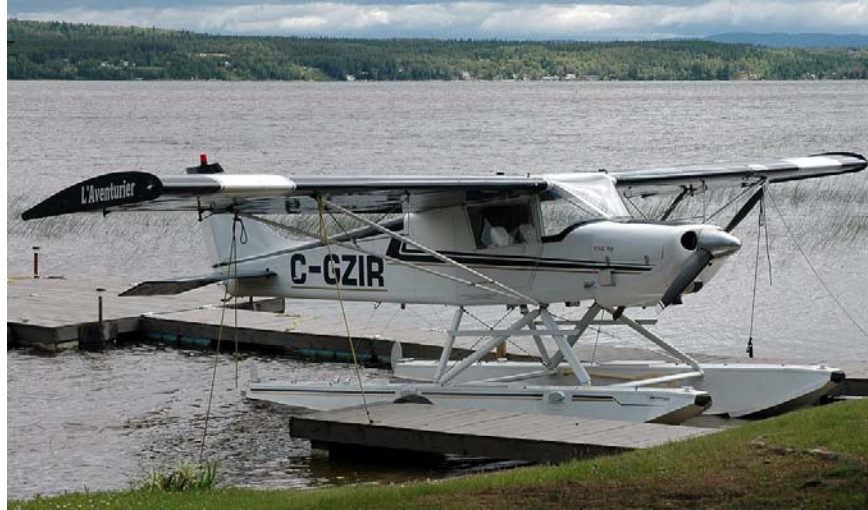
The Aventurier C-GZIR was built in 2003 from parts of an advanced ultralight Club Aéronautique Delisle Inc. (C.A.D.I.) model that had been involved in an accident in July 2002 (see Photo 1). The fuselage and tail were re-used after they were modified and repaired, as were certain parts of the flight controls. The flaps were 82 inches long and the ailerons were 72 inches in length. The wings were each 178 inches long and had been built with new ribs and coverings.

Photo 1. C-GZIR before extension of the wings.
