**AVIATION INVESTIGATION REPORT
A10P0388**

ENGINE FAILURE - HARD LANDING

**VIH HELICOPTERS LTD.
BELL 407 (HELICOPTER) C-GNVI
BLUE RIVER, BRITISH COLUMBIA, 8NM SE
15 DECEMBER 2010**

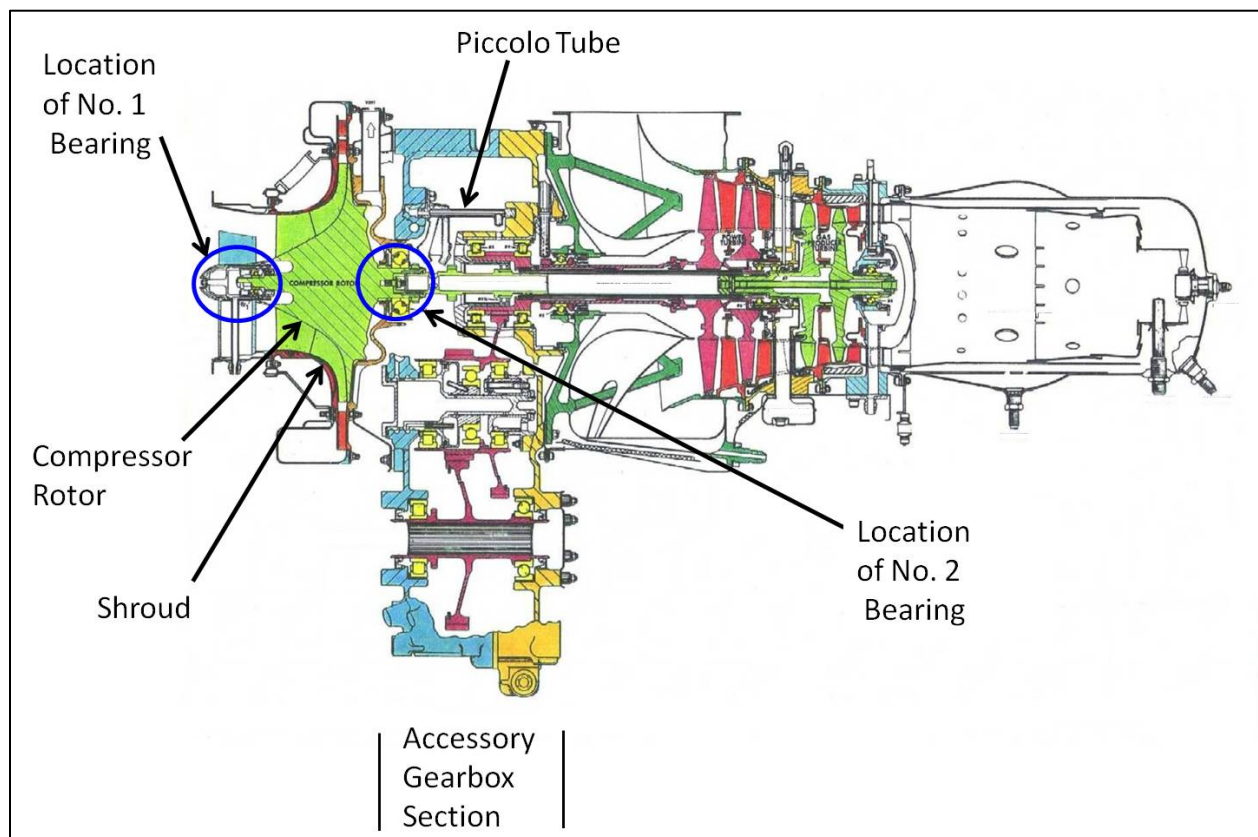
Figure 1. Engine Architecture

An examination of the engine (serial number CAE-848126) determined that the No. 2 bearing, (part number 23009670, serial number MP001190), which supports the aft end of the compressor, had failed (see Figure 1).

The compressor impeller vanes and the compressor shroud exhibited severe rubbing damage. The oil slinger, located between the No. 2 bearing and the compressor rear support, was cut circumferentially into 2 pieces. The No. 2 bearing support bore in the compressor rear support was not damaged, and the fit of the bearing in the bore was within limits. A substantial number

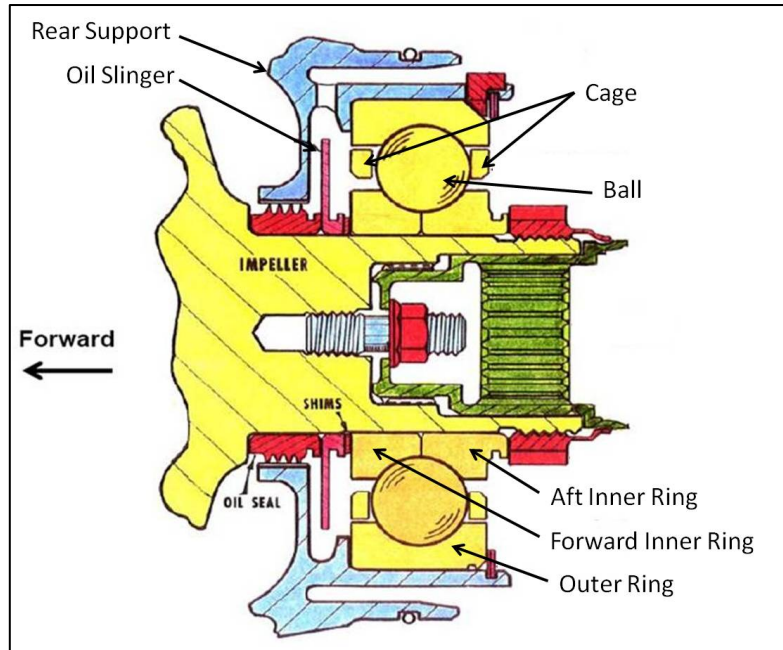
Figure 2. Number 2 Bearing Detail

The No. 2 bearing in the accident engine was manufactured for Rolls-Royce by Timken and is an on-condition ² item. It consists of a circumferentially split inner ring (also referred to as a race), 10 balls, a ball separator (cage) and an outer ring (see Figure 2). Each component of the bearing is manufactured to a nominal dimension which incorporates a specified allowance above or below that dimension.

On 11 April 2011 Rolls-Royce issued a Commercial Engine Bulletin (CEB) which included CEBs 72-3285, 72-5058 and 72-6067. The bulletins require that No. 2 bearings with part number 23009670, 6898606 or 6893002 be replaced with bearing part number M250-10354, which incorporates several design changes that address the various items identified as part of the investigation, resulting in an improved design capable of meeting manoeuvre requirements across its allowable manufacturing and installation variation. The CEB requires that the No. 2 bearing be replaced the next time the engine, module, or component is sent to an authorized repair/overhaul facility for any reason.

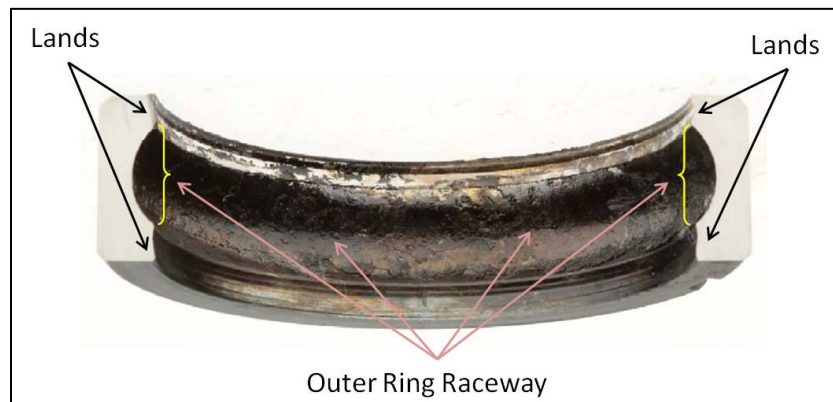
The outer ring raceway³ was damaged by the balls skidding. It remained largely intact but was burnt and covered with coked oil which precluded examination of surface wear damage. The lands of the outer ring were extensively worn and heat-affected (see Photo 1).

Photo 1. Outer ring raceway showing damaged lands

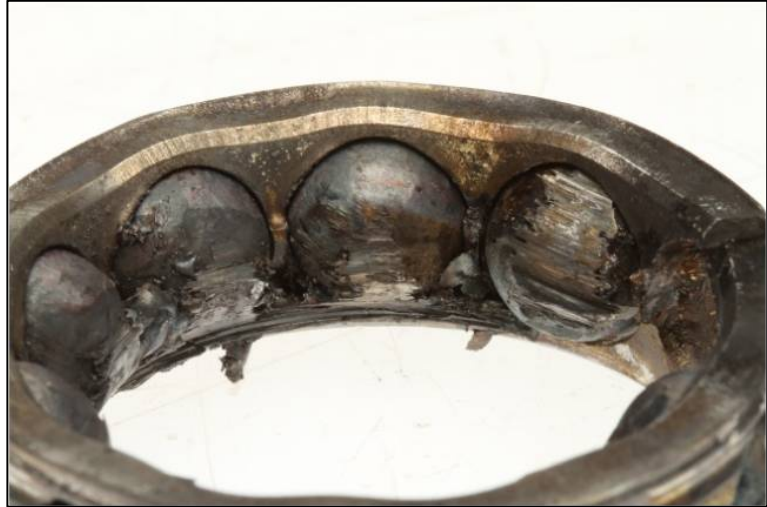
The ball cage (also referred to as the ball separator) was distorted and the ball pockets bulged forward. The rails to each side of one ball pocket were fractured with at least one of the fractures being primarily fatigue induced. The outside surface of the cage was worn along the rails from contact with the lands of the outer ring.

All 10 balls were similarly scored due to skidding (see Photo 2). Each ball had melted material (solidified metal droplets) at the edges of the skid area.

Photo 2. Ball and cage damage

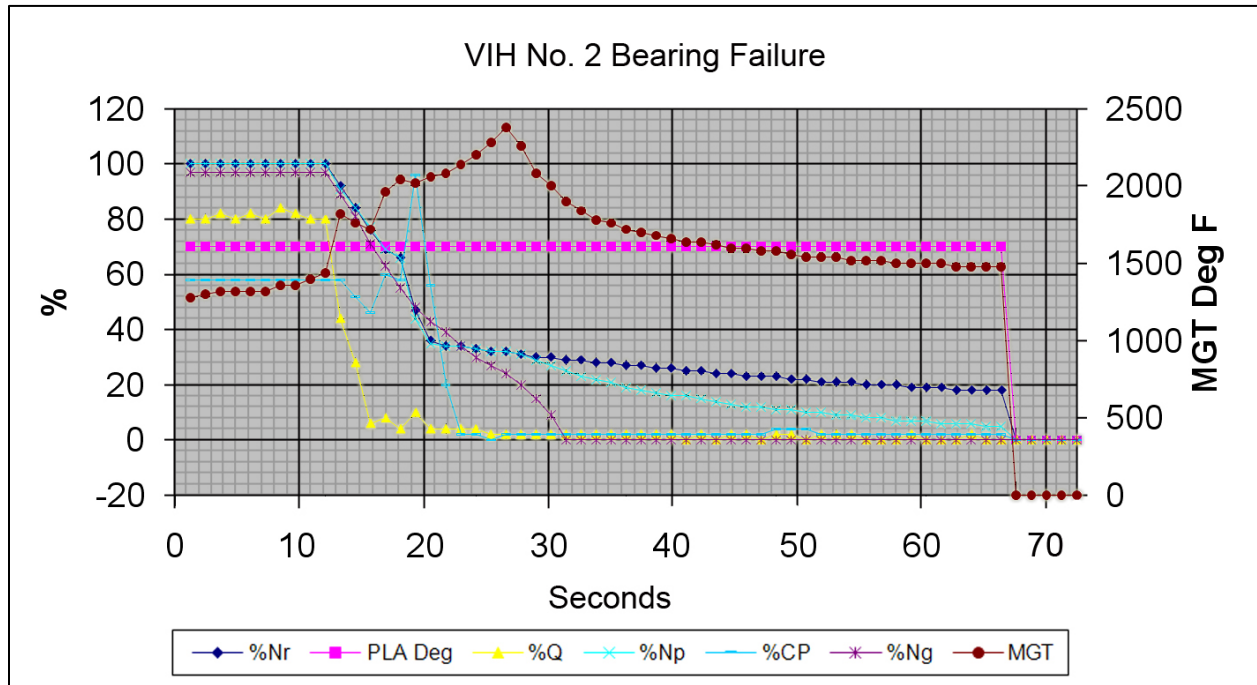
Appendix A – Electronic Control Unit (ECU) Graph

Immediately prior to the power loss the helicopter was climbing at about 65 knots, about 200 feet above ground level (agl) over rising terrain. The intended landing site was about 100 feet vertically above and 700 feet laterally from the helicopter when a bang and shudder (later identified as a compressor stall) occurred. The engine sound began to change about 5 seconds prior to the bang and shudder. The main rotor low rpm warning, which activates when the main rotor rpm falls below 95%, occurred 1 second after the bang and shudder. The engine-out warning that activates when the gas producer rpm falls below 55%, occurred 4 seconds later. The main rotor rpm decayed from 100% to 66% by the time the helicopter hit the snow-covered terrain.
