**AVIATION INVESTIGATION REPORT
A10W0038**

LOSS OF SEPARATION

**NAV CANADA
EDMONTON AREA CONTROL CENTRE / YELLOWKNIFE
TOWER
YELLOWKNIFE, NORTHWEST TERRITORIES
01 MARCH 2010**

Report Number A10W0038

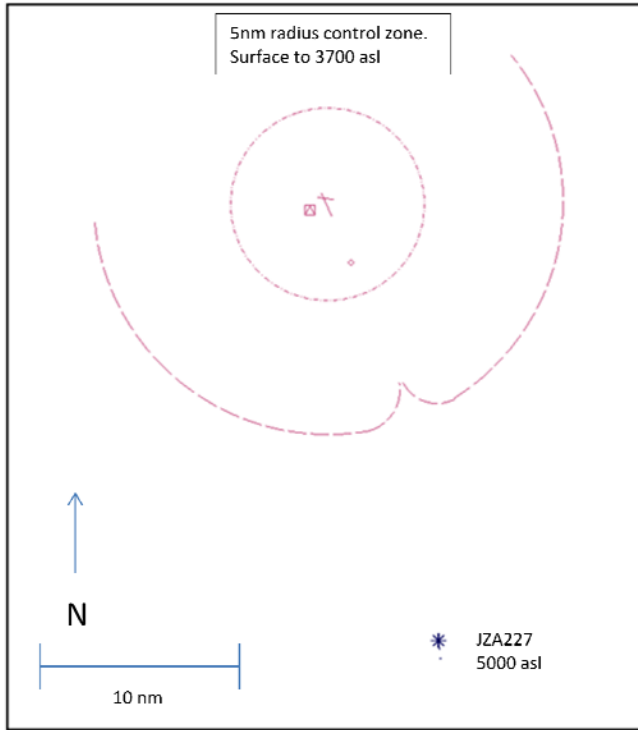
Figure 1. JZA227 cleared ILS Rwy 33 at 1755:46.

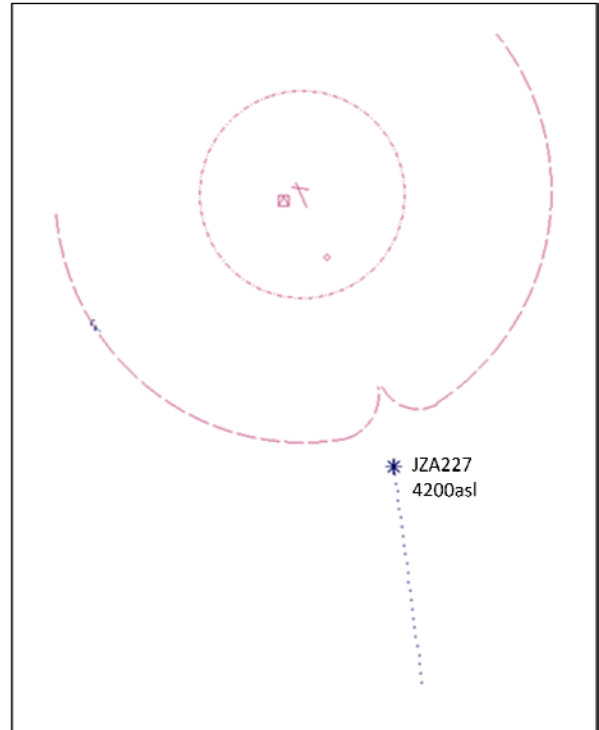
Figure 2. JZA227 position when PLR510 cleared takeoff Rwy 15 at 1757:39.

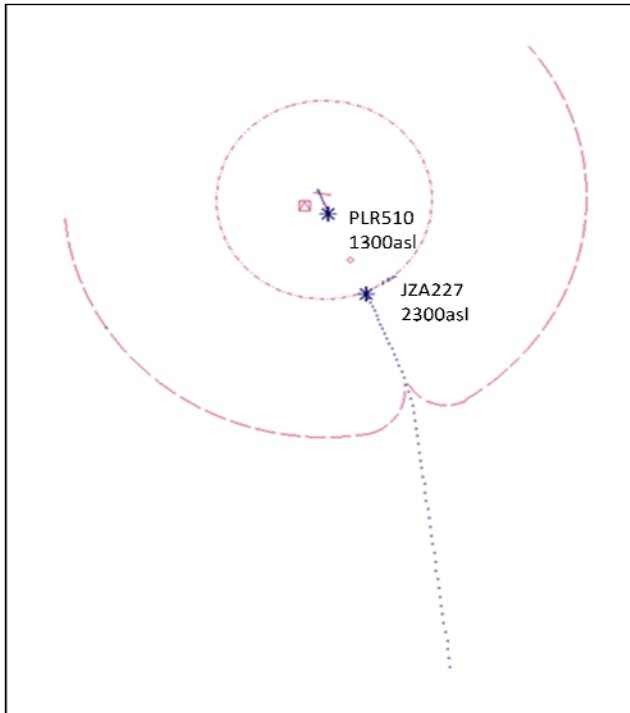
Figure 3. PLR510 calls Yellowknife tower in the turn at 1759:55. Aircraft are separated 4 nm horizontally and 1000 feet vertically.

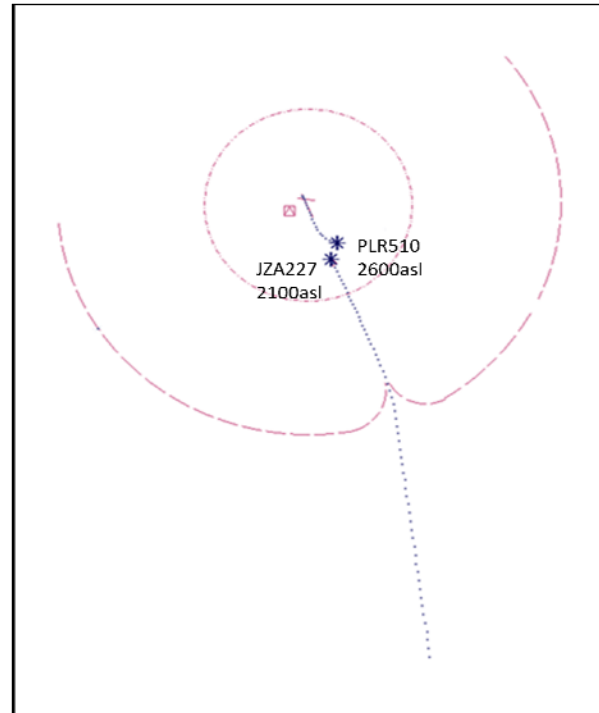
At 1759:13, the Yellowknife Airport controller contacted JZA227, instructing it to level off at 2500 feet asl, as it had already passed through 3000 feet asl. JZA227 responded that it was currently at 2300 feet asl and asked if it should climb to 2500 feet asl. At this time, separation was approximately 1400 feet vertically and 5.6 nm laterally, and decreasing. The Yellowknife Airport controller confirmed that, if able, JZA227 should return to 2500 feet asl. At 1759:55, PLR510 advised tower that it was in the turn and was told by the tower to level off at its current altitude of 1300 feet asl. JZA227 was at 2300 feet asl and the lateral separation was about 4.7 nm. At 1800:05, PLR510 contacted Yellowknife sector to report it was climbing through 2400 feet asl. At the time, JZA227 was at 2100 feet asl and the lateral spacing was 3.5 nm. At 1800:40, the aircraft were on diverging tracks when the two aircraft passed with 0.8 nm horizontal and 500 feet vertical spacing (see Appendix B – Plan View of Aircraft Convergence). As the conflict developed, no traffic information was passed to either flight.

Figure 4. PLR510 and JZA227 at lowest separation of 0.8 nm and 500 feet (1800:40).
