AVIATION INVESTIGATION REPORT A11Q0028

RISK OF COLLISION

**AIR INUIT LTD.
BETWEEN DHC-8-314 C-GUAI
AND DHC-8-102 C-FCJD
PUVIRNITUQ, QUEBEC, 117 NM SOUTH
07 FEBRUARY 2011**

Report Number A11Q0028

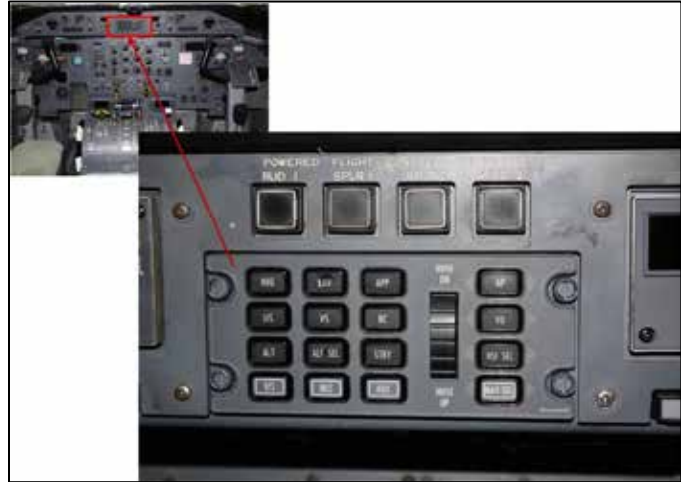
Photo 1. Flight guidance mode selector

In this occurrence, the aircraft used for flight AIE304 was oscillating in pitch when the autopilot was engaged in altitude-hold mode. For this reason, the crew chose to use VS mode to halt the oscillation, by displaying “0” as the vertical speed. The use of VS mode, in such a case, was customary and also used by other pilots in the company. Nothing prohibited it. Furthermore, the minimum equipment list (MEL) allows flight, with certain restrictions, despite an autopilot defect. Among other things, the MEL indicates that any mode that functions can be used. According to the Pilot’s Manual,⁸ vertical plane oscillation is a typical issue that can arise in various modes of use.⁹

Pitch oscillations when the autopilot was engaged had been observed in the past, not only by this crew or on this particular aircraft, but on other DHC-8s of the company. Nothing indicates that this situation had been formally pointed out to the company’s maintenance personnel, such as by means of an entry in the aircraft logbook.

In this occurrence, the cause(s) of the pitch oscillations could not be determined. In the autopilot manufacturer’s experience, there are 2 likely causes for the problem: poor tension of the flight control cables or a malfunction of the air data computer.

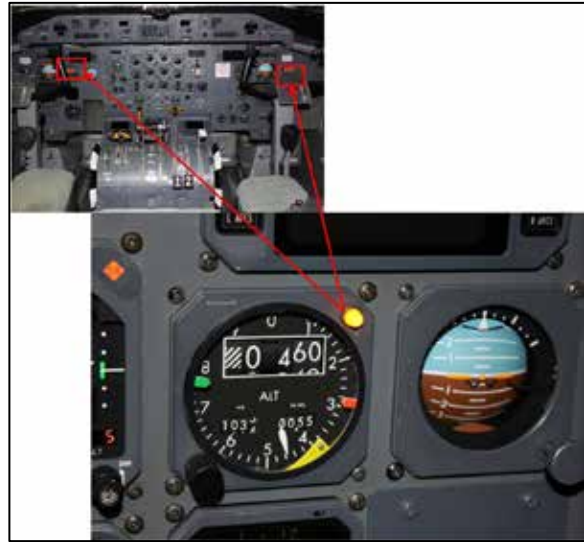
Photo 2. Altitude warning light

The altitude alerting system controller, located to the left of the engine instrument panel, consists of a set knob and a 5-figure digital display. As soon as the aircraft deviates more than 250 feet from the altitude selected, the altitude warning light located on each of the pressure altimeters lights up as a visual alarm¹⁰ (Photo 2). It does not flash.

In this occurrence, the light would have illuminated when AIE304 descended below 22 750 feet, and would have remained lit until the aircraft returned to the altitude selected. The PF, alone in the cockpit at that time, did not observe the warning light. Following the occurrence, no anomaly in the warning light was reported by the flight crew in question, or by subsequent flight crews. All indications are that it operated correctly.

Although the aircraft was equipped with an altitude warning light, this light attracts less attention than it might because it does not flash. In addition, under daylight conditions, the contrast between the light when extinguished and lit is reduced. Although it is possible that the sunny day may have reduced the light's visibility, special attention to the altimeter should have made it possible to detect the loss of altitude and the illumination of the indicator light. The captain did not see that once he had deviated more than 250 feet from the altitude displayed, the altitude warning light was lit for approximately 9 minutes. The installation of an audible alarm, such as that found on the other DHC-8 belonging to the company, would have provided an additional defence against unexpected loss of altitude.

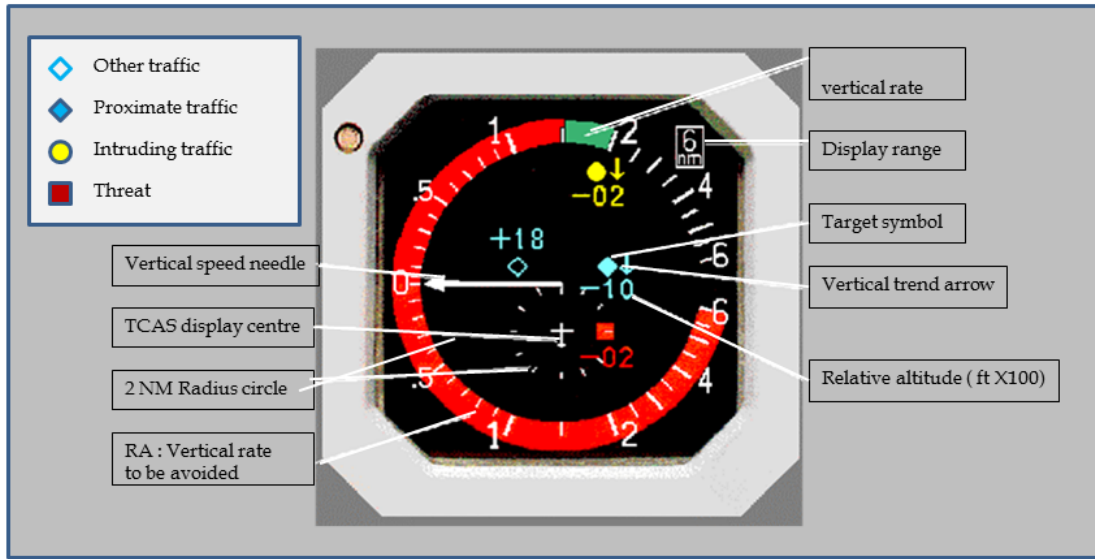
Appendix C—Example of RA Display

The TCAS display superimposes several symbols as representations, the interpretation of which can be ambiguous if training is absent, poorly adapted or incomplete. Following the RA, the PF of AIE880 had the reflex to turn left following a misinterpretation of the RA display. It is possible that the appearance of the target in the upper right-hand corner of the display may have caused the PF to turn left. In the case of the PF of AIE304, the right turn remains unexplained considering that the intruder was to his right. It is unlikely that the PF of AIE304 had, using the TCAS display, visually identified the other aircraft considering that he initiated a right turn when the aircraft was on his right on a converging trajectory.
