**AVIATION INVESTIGATION REPORT
A11Q0136**

ENGINE STOPPAGE AND FORCED LANDING ON WATER

**AIR TAMARAC INC.
CESSNA A185E C-FZNK
BOSTONNAIS RIVER, 10 NM
NORTHEAST OF LA TUQUE, QUEBEC,
18 JULY 2011**

Report Number A11Q0136

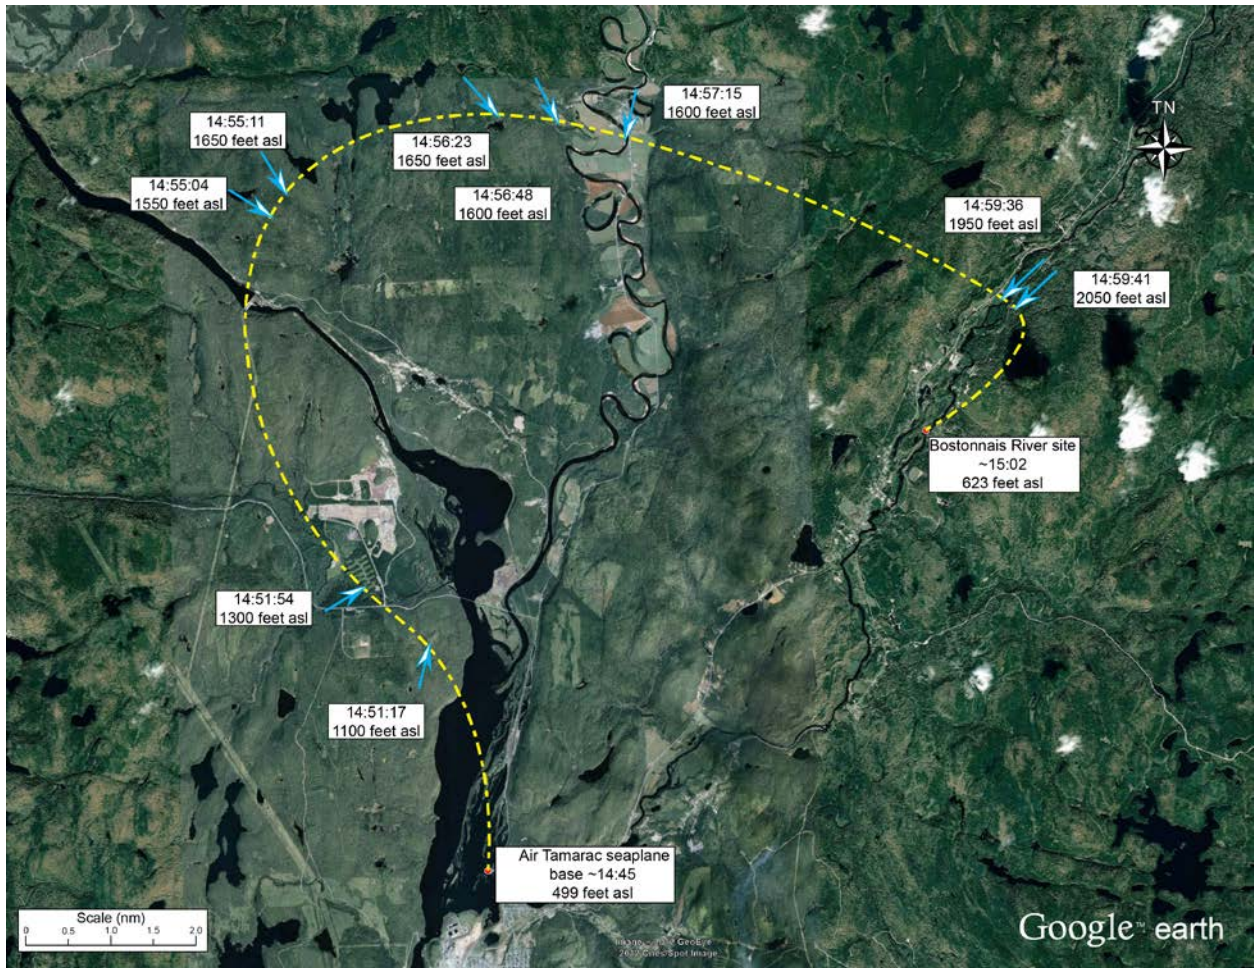
Figure 1. Approximate course of the aircraft, based on photos taken in flight

The pilot started the engine and left the dock. During the taxi, the pilot continued to provide the safety briefing, explaining how to lock and unlock the doors. The fuel tank selector was in the BOTH position to fuel the engine from both tanks. At approximately 1449, the aircraft took off and headed northward over the Beaumont dam. Approximately 5 minutes after take-off, the pilot placed the fuel tank selector in the LEFT position to fuel the engine from the left tank. The aircraft began a wide right turn towards the Croche River and then flew over the Bostonnais River (Figure 1).

At approximately 1501, or 12 minutes after take-off, the engine stopped. At this point, the aircraft was flying at approximately 1600 feet above sea level (asl). The propeller began spinning in the air, and the aircraft lost altitude. The pilot carried out emergency procedures from memory. The pilot returned the fuel tank selector to the BOTH position. The pilot then attempted several combinations and adjustments involving the power and engine mixture controls and different fuel tank selections. The attempts to restart the engine were not successful. During the descent, the pilot attempted radio communication with the company twice to inform them of the situation. He received no response. The pilot directed the aircraft towards the Bostonnais River to attempt an emergency ditching. The Bostonnais River is a narrow and winding river, with an approximate elevation of 620 feet asl.

At approximately 1502, the aircraft was observed taking a sharp left turn over the trees along the river bank. The aircraft nose-dived, struck the water and tumbled before coming to rest inverted with its floats on the surface of the water.

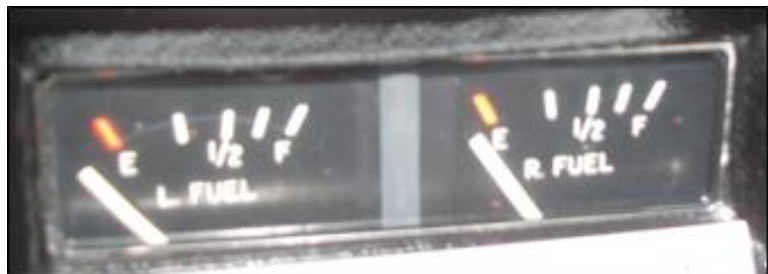
Photo 1. Example of Cessna A185E fuel quantity indicators

C-FZNK was equipped with 2 long-range fuel tanks. Since the fuel system included a tank selector valve, the total capacity of the tanks was 78 gallons. According to the manufacturer, each tank contains 3.0 gallons of unusable fuel. ⁴ Two indicators, one for each tank, transmit fuel levels to the pilot (Photo 1).

Fuel amounts are measured by quantity transmitters located in each tank. They, in turn, transmit the information to the fuel quantity indicators. The indicator displays empty (E) or its needle points to the red line when the float lever comes into contact with the transmitter's low

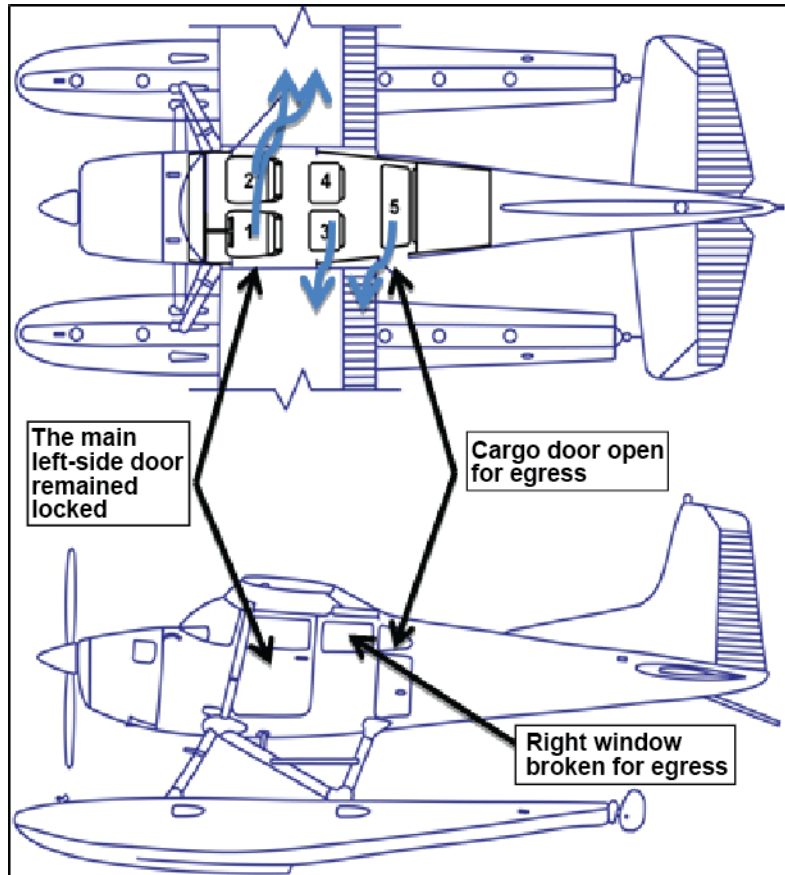
Figure 2. Location of occupants and exit points

After impact, C-FZNK capsized and quickly filled with dark water. The right-side passenger door was torn from the aircraft on impact.

The pilot (No. 1 in the figure) released the seatbelt and moved towards the opening on the right side of the aircraft (Figure 2). In the darkness of the water, the pilot never saw, nor thought to unlock and open, the left-side pilot door. The pilot attempted to remove the front passenger (No. 2 in the figure) when passing by, but the latter was still held into the seat by the seatbelt and shoulder strap. The pilot continued to swim to the surface. The front passenger never thought to release the seatbelt. In the heat of the moment, the front passenger escaped by struggling free to reach the surface. The occupant (No. 3 in the figure) seated to the left behind the pilot, does not recall unfastening the seatbelt or escaping through the broken window on the left side of the cabin. This passenger did not know how to swim.

The pilot and one of the passengers carried out several dives in an attempt to evacuate the 2 children (Nos. 4 and 5 in the figure) trapped in the aircraft. The pilot dove towards the back of the aircraft and opened the cargo door located on the left side of the aircraft. The pilot saw one occupant's clothing (No. 5 in the figure), but ran out of breath before this occupant could be removed from the cabin.

The pilot returned to the surface, and one of the passengers dove and removed the child from the cabin through the cargo door. At that moment, a local resident arrived on the scene and started trying to resuscitate the child. The child (No. 5 in the figure) had major face and head injuries, which may have caused a loss of consciousness after impact.

The pilot and one of the passengers continued to dive for more than 5 minutes before they found the last child (No. 4). The passenger removed this child from the cabin. The child was then stretched out on one of the floats, and resuscitation manoeuvres were performed until emergency responders arrived at approximately 1512. Resuscitation proved unsuccessful. The child did not bear any signs of injury. Having been submerged for approximately 8 minutes, the child could not be resuscitated, and died as a result of drowning.
