**AVIATION INVESTIGATION REPORT  
A11Q0170**

**RISK OF COLLISION**

**SKY REGIONAL AIRLINES INCORPORATED  
DE HAVILLAND DHC-8-402 C-FSRY  
AND  
PROPAIR INCORPORATED  
BEECH A100 KING AIR C-GJLJ  
MONTRÉAL/PIERRE ELLIOTT TRUDEAU  
INTERNATIONAL AIRPORT, QUEBEC  
29 AUGUST 2011**

Report Number A11Q0170

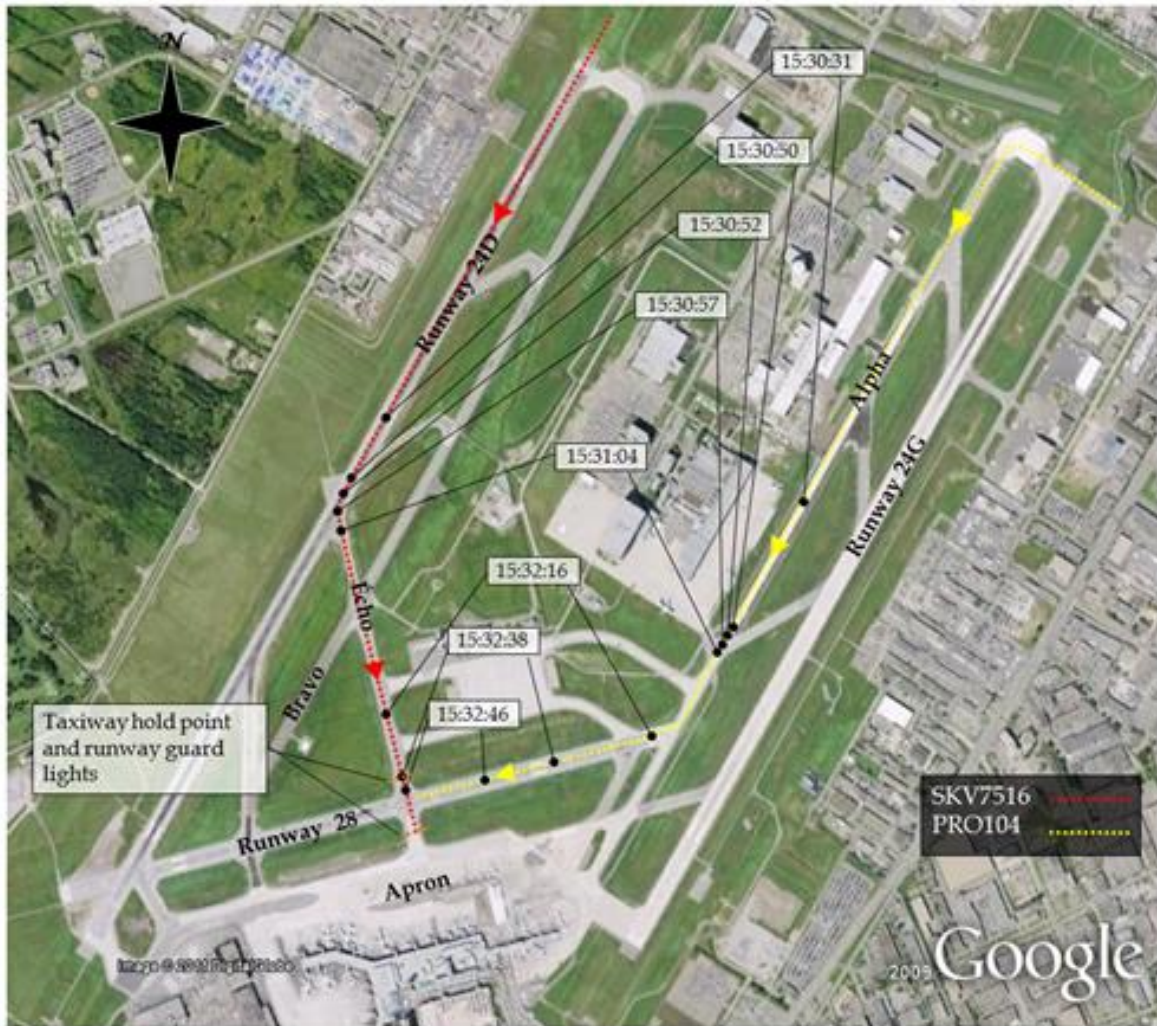
**Figure 1.** Aircraft trajectories and timeline of air traffic control communications

Sky Regional Airlines Incorporated flight SKV7516, a Bombardier DHC-8, took off from Billy Bishop Toronto City Airport, Ontario, on a scheduled flight bound for Montréal/Pierre Elliott Trudeau International Airport, Quebec, with 4 crew members and 25 passengers on board. When the flight left Toronto, the first officer, who was sitting in the right-hand seat, was at the controls. The aircraft touched down on Runway 24R at 1530:20<sup>1</sup> after an uneventful flight. At 1530:31, the airport controller instructed SKV7516 in English to exit the runway on Taxiway Echo and to hold short of Taxiway Bravo, and then to contact ground control. On the runway, the captain took the controls,<sup>2</sup> then exited to the left on Taxiway Echo (Figure 1).

At 1530:57, the ground controller instructed SKV7516 to give way to an Embraer (ACA187) before continuing to taxi on Taxiway Echo, and to hold short of Runway 28. The Embraer was taxiing in the opposite direction on Taxiway Echo, allowing it to use Taxiway Bravo eastbound. The first officer repeated the instruction as required. The purpose of a readback is to ensure that crews receive an instruction correctly. The aircraft slowed almost to a stop, allowed the Embraer to pass, and then resumed taxiing at a ground speed of approximately 17 knots.

- 1530:31 – Tower instructs SKV7516 to hold short of Bravo and contact ground
- 1530:50 – Tower clears PRO104 to take off from Runway 28
- 1530:52 – SKV7516 informs ground taxiing on Echo short of Bravo
- 1530:57 – Ground instructs SKV7516 to give way to ACA187 and then taxi on Echo and hold short of Runway 28
- 1531:05 – SKV7516 confirms hold short of Runway 28
- 1532:16 – SKV7516: 17 knots; PRO104: 7 knots
- 1532:38 – SKV7516 crosses hold point at 17 knots; PRO104: 66 knots
- 1532:46 – SKV7516 enters runway; PRO104: 93 kts

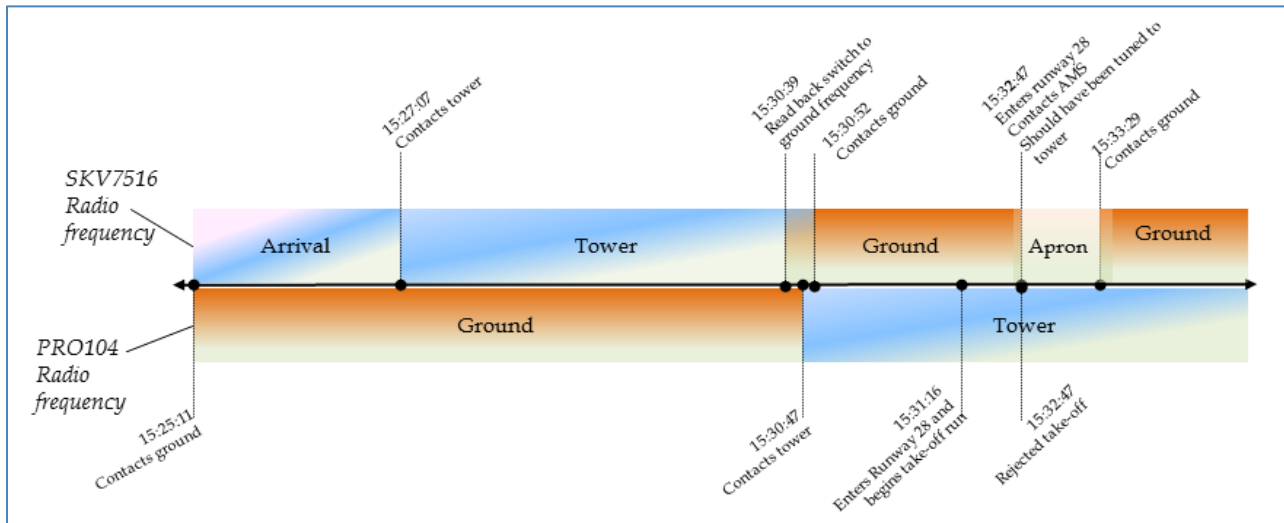
**Figure 3.** Radio frequencies used by the aircraft

The audio recordings allow determination of the radio frequency used by the flight crew of each aircraft during the occurrence (Figure 3). However, the audio recordings do not allow determination of the exact time of frequency changes on board aircraft. Consequently, the investigation was unable to identify the frequency to which SKV7516 was tuned at the time when the airport controller cleared PRO104 to take off from Runway 28.

SKV7516 should have progressively switched from the airport controller to the ground controller and finally to the AMS. The ground controller is responsible for all movements of ground traffic on manoeuvring areas. The synchronization of ASDE and ATC recordings confirmed that SKV7516 was tuned to the AMS radio frequency when it crossed Runway 28. Given that an aircraft is not deemed to have left the runway until all of its parts have crossed the taxi hold line, located 200 feet from the edge of the runway, SKV7516 should still have been tuned to the ground control frequency. Furthermore, in accordance with the company's standard operating procedures (SOPs), SKV7516 should also have remained tuned to the airport frequency when it crossed the runway.

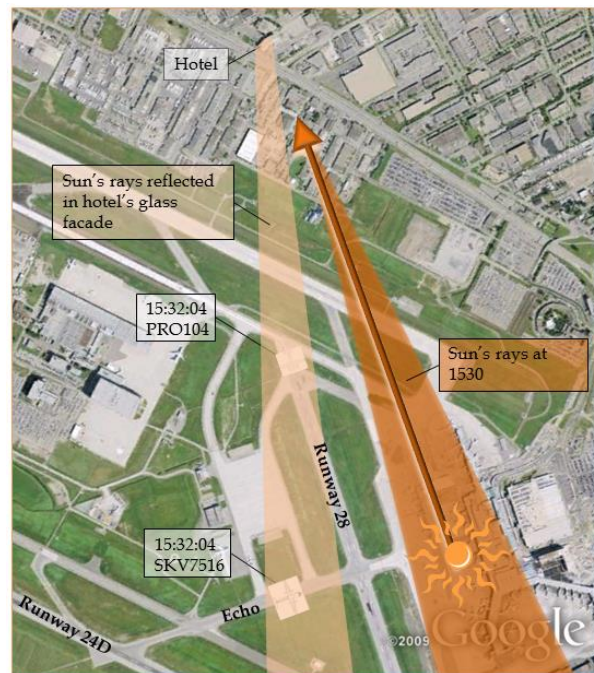
Figure 4. Reflection of solar rays

- Although visibility problems have never been reported, the structures indicating the positions of the de-icing bays can momentarily hamper the vision of pilots taxiing south on Echo and obstruct the threshold of Runway 28. However, proper visual scanning makes it possible to see the runway

- The King Air and its landing light were clearly visible from the runway hold line.
- The sun's rays were reflected in the windows of a building standing in the background of the runway threshold (**Erreur ! Source du renvoi introuvable.**Figure 4).
