**AVIATION INVESTIGATION REPORT
A12P0008**

ENGINE POWER LOSS AND HARD LANDING

**ROYAL CANADIAN MOUNTED POLICE
EUROCOPTER AS 350 B3 (HELICOPTER), C-FMPG
CULTUS LAKE, BRITISH COLUMBIA, 1.5 NM E
17 JANUARY 2012**

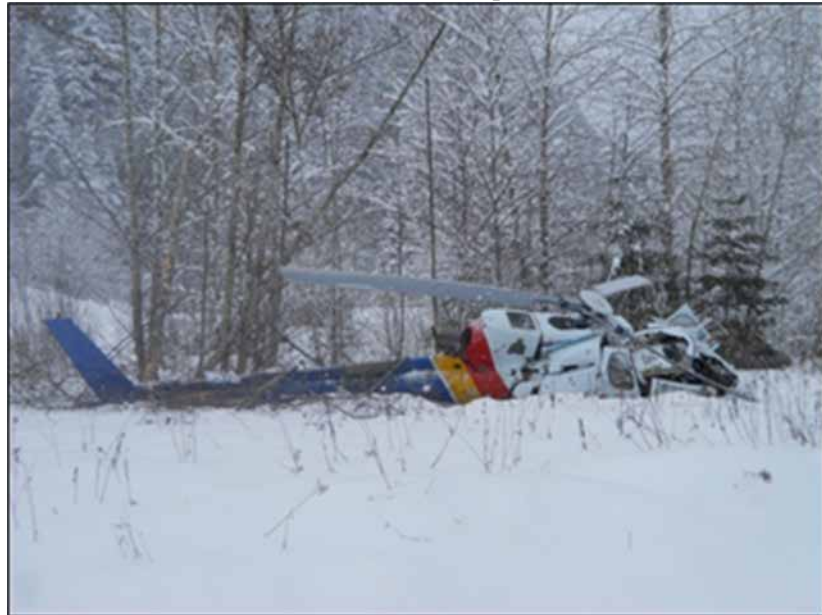
Photo 3. Wreckage (Source: RCMP)

Due to the force of the impact with the ground, the right landing skid broke, and the cabin, engine/transmission platform, and main airframe structure collapsed (Photo 3). The internal fuel cell was also shattered by contact with the attached belly hook and sling unit upon ground impact. The tail boom and tail-rotor blades struck the ground, buckling the whole structure. Two of the main-rotor blades were intact and exhibited little damage, whereas the third rotor blade suffered extensive ground-impact damage. The tail-rotor blades were both damaged. One blade showed no damage except for evidence of wood in its striker tab. The other blade was almost completely fractured near its root/hub. The main-rotor and tail-rotor blade damage was characteristic of extremely low rotor rpm at impact. However, there was no mechanical

Trees at the edge of the impact site exhibited damage consistent with vertical shearing of the branches as the fuselage descended toward the ground. There was no indication of either main-rotor or tail-rotor blade

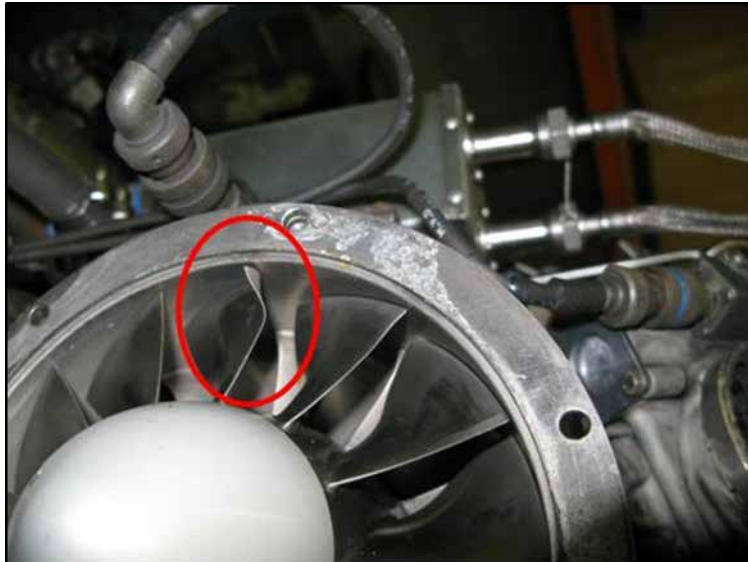
Photo 4. Compressor blades

Visual examination of the engine inlet section revealed damage to 1 of the compressor blades (Photo 4). The investigation determined that the blade became bent during the loss-of-power event. However, nothing prevented engine test cell runs following the occurrence.

All of the compressor blades were found bent forward of the vertical plane of rotation normally travelled by the blade tips, but only 1 blade was bent significantly and was visibly obvious.

The Laboratory examination of the noticeably bent compressor blade did not reveal any evidence typical of foreign object damage, such as sharp dents, gouges, tears, or material transfer. The examination did determine that the appearance of the bent blade was similar to that of the blades bent during the water/snow/ice instantaneous ingestion testing for engine certification. Given the similarities in blade damage, the Laboratory report concluded that the damage to the axial compressor blade, as well as the flame-out of the engine, occurred as a result of the ingestion of accumulated snow or ice, or both, into the engine compressor after take-off.

The damage appeared similar to the bending incurred by the axial compressor blade(s) during certification testing when snow and ice was purposely ingested in the engine at maximum continuous power. The bending of the accident compressor blade was somewhat greater than that seen in the test compressor blades, so the TSB concluded that the engine in C-FMPG was operating in a similar, high power condition when the ingestion occurred.

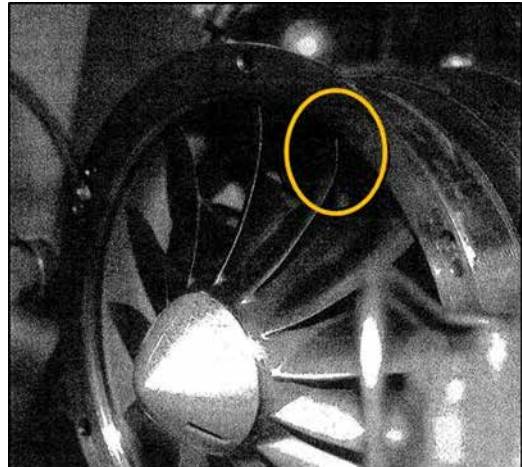
Photo 5. Ice test engine damage

In 2002, Turbomeca prepared a technical report (Note Technique No. 218-2002) regarding ice ingestion and engine performance tests for the Arriel 2C2 engine, so as to verify compliance with the *Joint Aviation Regulations*² certification requirements. According to the report, the ingestion of approximately 83 grams of ice was required to cause the engine to flame out. As in this investigation, damage was observed on 1 of the axial compressor blades (Photo 5). It was determined that this damage was a direct result of ice ingestion and flame-out. In comparison with the engine blade damage found in C-FMPG (Photo 4), the characteristics are very similar.

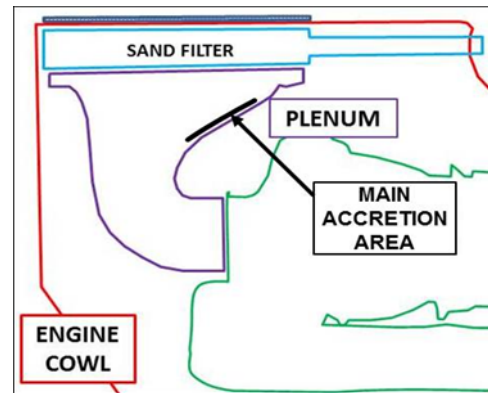
Figure 1. Ice accretion area

The tests, done with and without a filter, identified the location of snow or ice accretion in the intake and concluded that the air intake plenum was vulnerable to ice accretion during engine operation in certain snow/ice conditions. The tests showed that substantial ice accretion occurs on the upper rear section of the plenum (Figure 1), resulting from direct impact of the snowflakes in the area followed by a merging/refreezing phenomenon after making contact with the metal air intake wall.

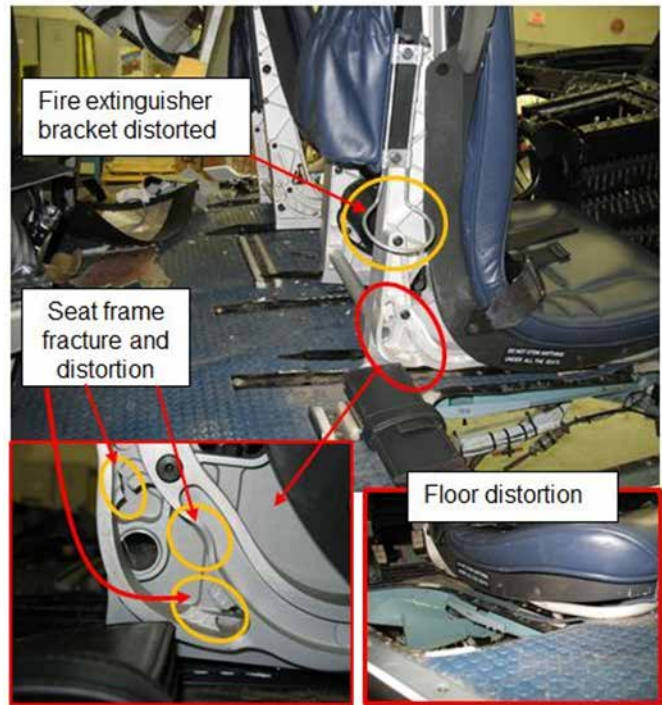
Photo 6. Seat and floor damage

attenuating pilot seats rated at 25 g.²¹ The occupied right-hand pilot seat was severely damaged during the occurrence (Photo 6). By design, the seat absorbs vertical impact energy by progressively collapsing and deforming (stroking). The seat back fitting on both sides of the seat had yielded in this manner, leaving characteristic fracture and distortion evidence. As well, the floor and support beams beneath the seat had buckled significantly, adding to the bending forces imposed on the seat attachment fittings and floor tracks.

The investigation determined that the accident helicopter struck the ground with a vertical velocity of 16.4 metres per second (m/s), which exceeded the designed structural capacity of the airframe. Even after the landing gear skids absorbed about 2 m/s, the airframe experienced a vertical velocity of 14.5 m/s. Mathematical modeling of the helicopter structural deformation revealed that the impact load factors on the airframe were between 15 g and 20 g forward, and between 40 g and 50 g downward.

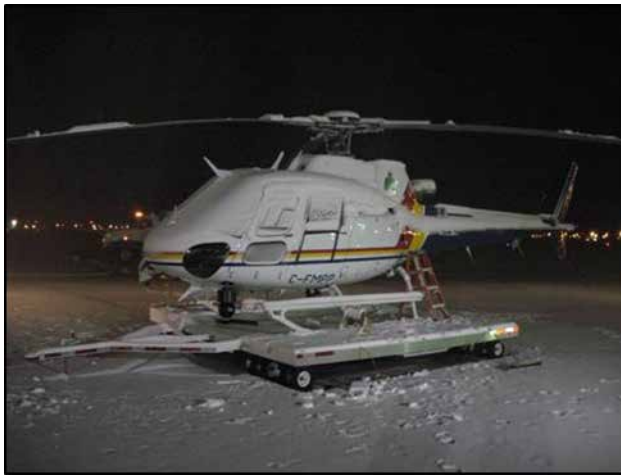
Photo 7. Snow trial with AS 350 B3 ([Source: RCMP](#))

The team created a snowfall environment for the test helicopter using a large capacity, commercial snow-making machine. After the helicopter was shut down, the snow machine began to lay snow onto the helicopter, and for the next 90 minutes, the temperatures in the plenum and engine compartment were recorded every 5 minutes. After 90 minutes, the accumulated snow had built up to an amount similar to that seen on the accident helicopter before start. With the outside air temperature remaining at -10°C throughout the test, this process closely replicated the conditions on the day of the accident (Photo 7).

During the trial, it was noted that, in the cold outside air, the inlet grill and sand filter unit at the top of the engine cowling did not cool down after engine shutdown. Instead, following engine shutdown, the temperatures increased quickly from 0.2°C at shutdown to 10°C, dropping only to 8.5°C at the 90-minute mark. Similarly, the temperatures inside the plenum itself, after peaking to about 33°C, fell to no lower than 17°C during the test. Figure 4 shows the temperature drop in °C over 19 increments of 5 minutes. During testing, an opening appeared in the snow layer on the top of the engine cowling and engine intake grill. This opening was created by rising hot air from the engine, which passed up the plenum and out of the intake, causing a small area of melting in the layer of snow that had formed.

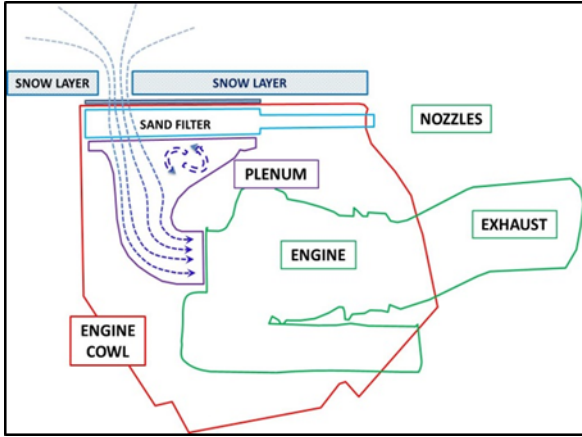
Figure 5. Airflow at engine start

In testing, residual heat following an engine shutdown was enough to cause a narrow opening to appear at the forward edge of a snow-covered intake grill (Figure 5). The high airflow through the air inlet would then have begun to progressively erode the snow layer rearwards, increasing the aperture size and causing the airflow to gradually change (Figure 6). As the size of the opening on the grill increased, the airflow pattern would have likely started to form recirculating eddy currents on the rear face of the plenum, increasing in intensity as the opening grew. The intake air contained moisture—from both the atmosphere and the melting snow layer on top of the grill—and probably became colder due to pressure reduction in the plenum resulting in slush gathering on the rear face of the plenum (Figure 6). This soft ice buildup phenomenon is not unheard of—it is the very contamination development seen in the French certification tests described previously in this report. The only significant contributing factor not present in the test regimes, however, was the increasing surface area of the air intake as a result of the snow layer eroding gradually in the airflow stream. At some stage in this process, the airflow pattern likely changed to impinge on the accumulation deposited on the rear face of the plenum, and perhaps in combination with vibration, caused the deposit to separate from the plenum surface and be sucked into the engine inlet (Figure 7 and Figure 8).

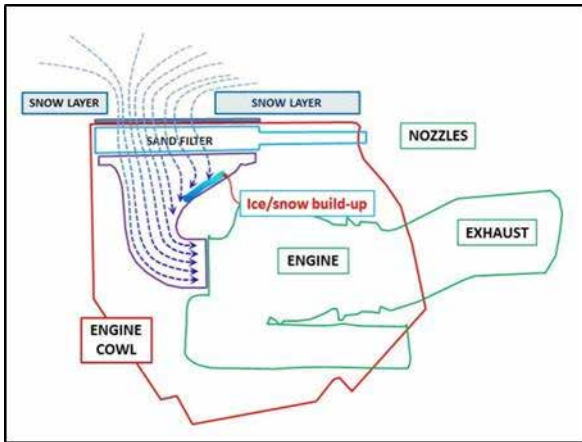
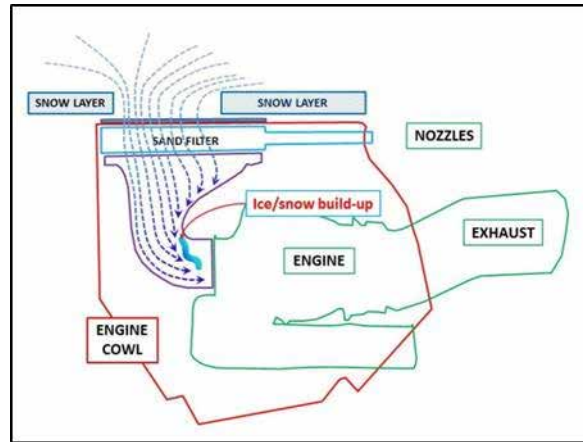
Tests and previous accidents have shown that under certain winter conditions, the air flow into the engine progressively deposits ice or slush contamination onto the rear wall of the intake plenum, thereby creating a buildup of snow/ice/water mixture (soft ice), which eventually detaches and strikes the inlet axial compressor disc, bending blades, interfering with the airflow, and causing the engine to shut down.
