**AVIATION INVESTIGATION REPORT  
A13H0002**

**COLLISION WITH WATER**

**GOVERNMENT OF CANADA, DEPARTMENT OF TRANSPORT  
MBB BO 105 S CDN-BS-4 (HELICOPTER) C-GCFU  
M'CLURE STRAIT, NORTHWEST TERRITORIES  
09 SEPTEMBER 2013**

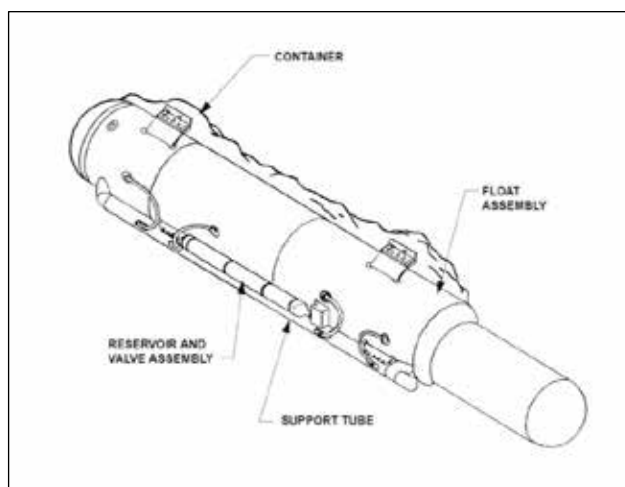
Figure 4. Float subsystem general arrangement  
(Source: Air Cruisers, BO-105 Float Subsystem, Part Numbers D24873-101, D24873-102, *Component Maintenance Manual with Illustrated Parts List*, Revision No. 11 [18 January 2010], p. 5)

Both float subsystems remained attached to the helicopter during the accident sequence and were found within their respective containers. Both reservoirs that store nitrogen were charged within the manufacturer's specification. With the exception of damage related to impact and water submersion, no anomalies or pre-existing defects were noted that would have prevented the flotation system from operating normally. There was no indication that the flotation system was activated prior to or at the time of the impact. A review of the maintenance records indicated that both float subsystem

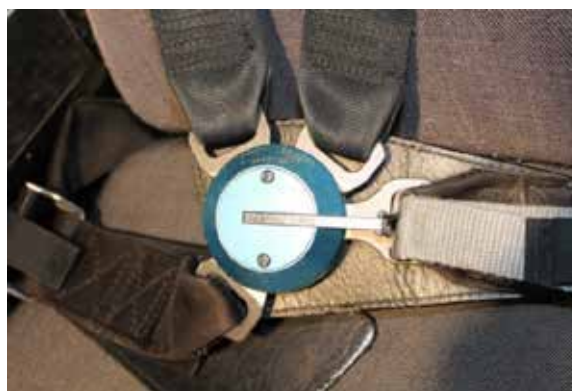
Photo 2. Front seat 4-point safety harness

When the helicopter was recovered, it was noted that all of the occupants' seat harnesses were released. There was no indication that any of the lap belt or shoulder harness tongues had been forced from the buckle assembly. Examination of occupants' safety harnesses did not identify any discrepancies that would have prevented normal operation.

The pilot's seat had been pushed back to the end of the right (outboard) rail and slightly short of the left rail end. The seat frame was deformed and buckled in a way that was consistent with the back having been forced backward. These observations suggest that a backward force had been applied to the upper body of the occupant and transmitted to the back of the seat. The left front seat was found secured with no sign that it had been displaced during the occurrence. No deformation of the seat frame was observed. The absence of significant damage to the left front seat suggests it had not been exposed to the same rapid ingress of water that the pilot's seat had. The rear bench seat's left supporting strut had fractured and was deformed forward. It is considered likely, therefore, that the left-front vertical strut fractured due to the dynamic loading caused by the vertical deceleration of the occupant at the time of impact.

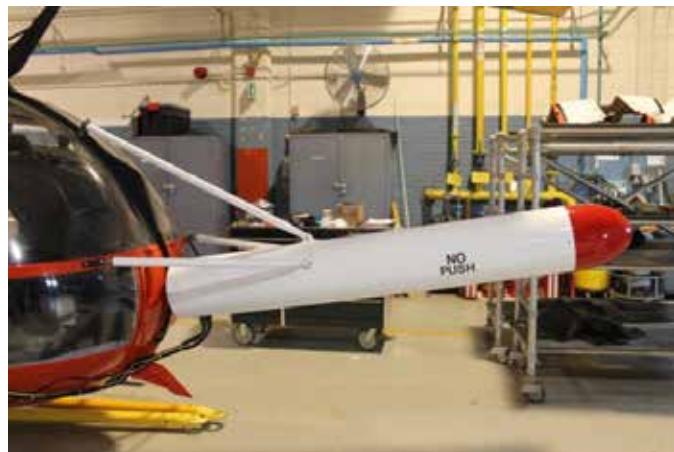
Photo 3. Ice probe attached to the nose of the helicopter

The helicopter was equipped with an ice survey system, which included a forward-facing boom (ice probe), a computer system, and interconnecting cables. The ice probe, which housed a laser altimeter and sensors for measuring the depth of snow and ice, was attached to the nose of the helicopter (Photo 3). The computer system connected to the ice probe was retained in the rear seat and recovered with the wreckage. Only pieces of the ice probe were recovered; none of the housed equipment was retrieved.

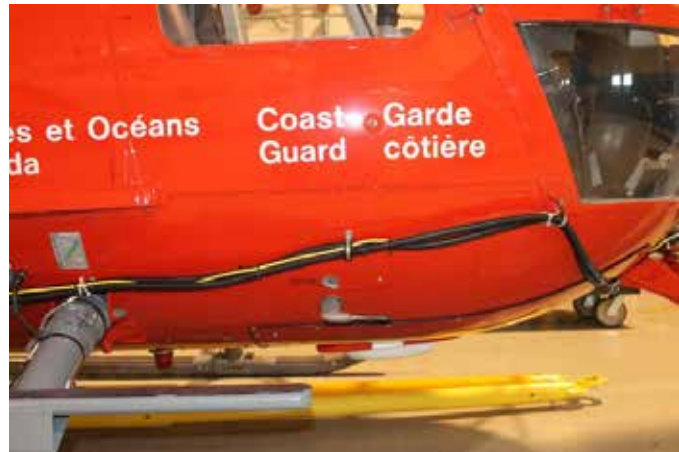
Photo 4. Example of cable bundle routing as in August 2013

During the first use of both the ice probe and the video pod after the reconfiguration to allow for the movie camera system to be installed on the left skid in August 2013, it was decided that the ice probe cables would be routed along the right side of the fuselage. Although there were no published instructions for routing the cables in this manner, ASD maintenance personnel positioned the cables such that the routing was similar to the routing used on the left side. In doing so, the cable bundle was routed above the right side static port and Pitot tube (Photo 4).

During the first flight with the cables installed in this manner, erroneous airspeed indications were noted. The helicopter returned to the vessel and landed without further incident. ASD maintenance personnel concluded that the location of the cable bundle was likely interfering with the airflow in the area of the Pitot tube and static port, resulting in the erroneous airspeed readings. It could not be determined if the altimeter was also affected by the discrepancy.

During the occurrence flight, the cables had been routed in a manner similar to the first installation along the right side of the helicopter in which erroneous airspeed indications were observed. It was not possible to determine if the airspeed indications were accurate during the occurrence flight.

The cable bundle was then re-routed along the lower right side of the fuselage, below the Pitot tube and the static port. During subsequent flights, there were no indications of erroneous airspeed indications. There was no record made in the journey log for either the change in cable routing or for the erroneous airspeed indications experienced during the first flight. Additionally, ASD had no record of a modification proposal for the change in cable routing.

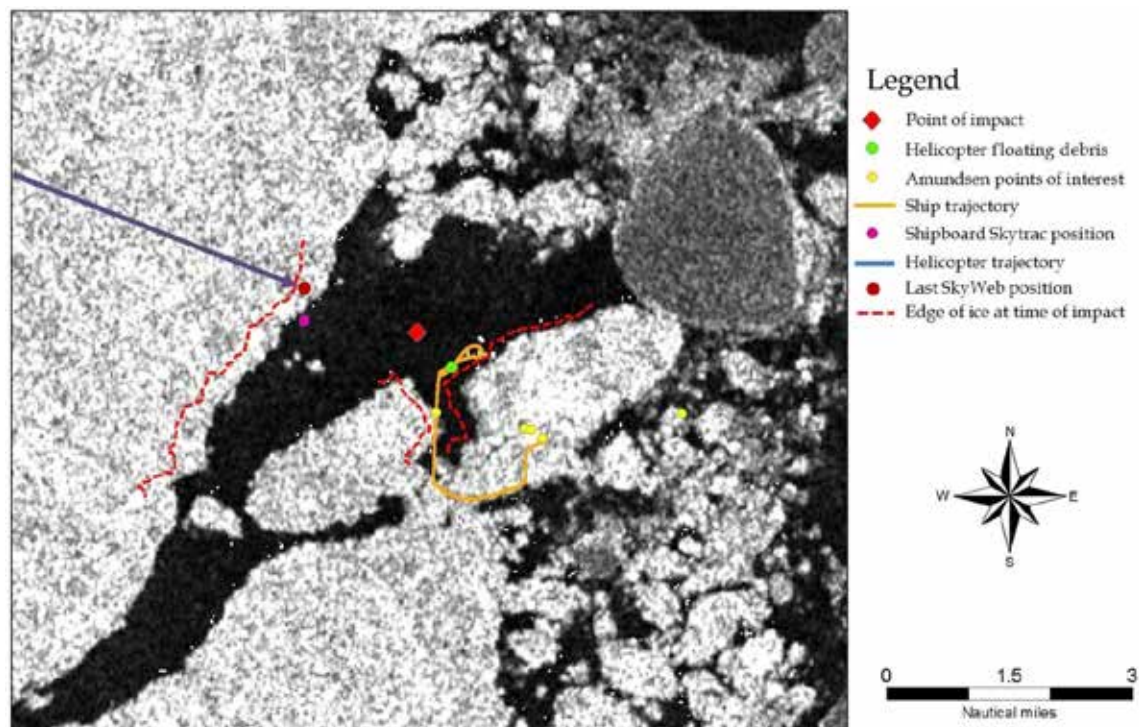
Figure 5. RADARSAT-2 imagery taken on the day of the occurrence, indicating the helicopter and ship trajectories (Source: Canadian Ice Service, with TSB annotations)

Ice movement (flow) was measured from the image taken at 1403:36 on 09 September 2013, 3 hours and 40 minutes before the accident. The use of images taken before and after the occurrence allowed investigators to determine an approximate position of the edge of ice at the time of impact, which is represented by the red dashed lines in Figure 5.

The imagery indicates that the open water area the helicopter was overflying was about 2.3 nm wide. Based on the actual wreckage position indicated on the RADARSAT-2 imagery, the helicopter crashed about 0.7 nm before reaching the next ice edge.

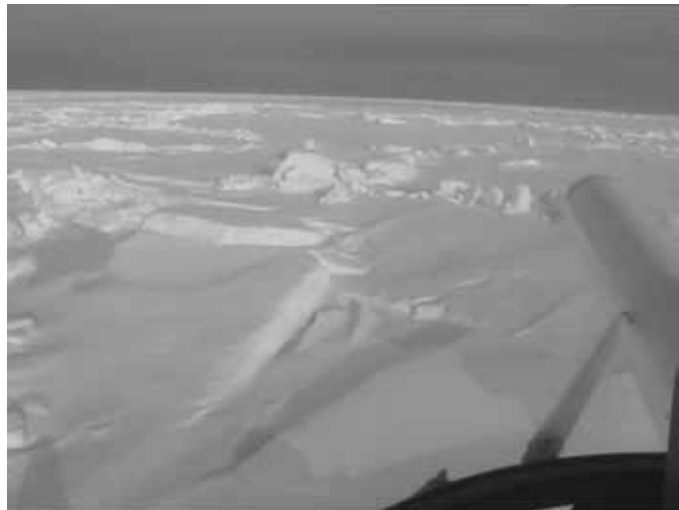
Figure 6. Screen capture taken at 1733:34 in video 3

The review of the 3 video clips found that visual cues varied throughout the flight, but improved during the third leg. The video of the third leg showed that:

- the light was brighter than in the previous 2 videos;
- shadows were discernible and the sun was low in the sky, at approximately the helicopter's 5 o'clock position;
- dark overcast sky ahead created a distinct horizon against the white ice surface;
- the texture of the ice varied from smooth to jagged and broken; and
- no open water was in view.<sup>39</sup>

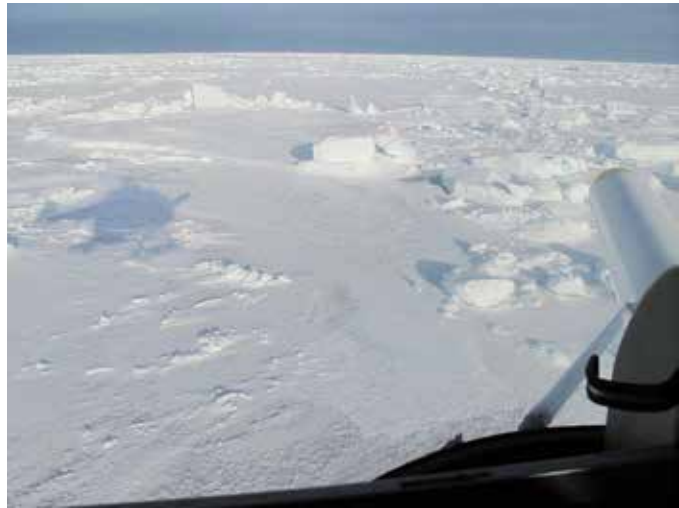
Photo 5. Still image taken approximately 10 minutes before the occurrence

No images or videos showed evidence of an imminent accident. However, the last image from the photos taken at 1732:57—approximately 10 minutes prior to the accident—was used for the photogrammetric analysis (Photo 5).

Using a 3-dimensional computer-aided design model of the BO 105, and based on the time the picture was taken as well as the sun's altitude and azimuth, the helicopter model was oriented to match the shadow seen in the picture to determine the helicopter's altitude and the direction it was facing at the moment the image was taken. It was determined that the helicopter was heading eastbound on a track of 96°, at an altitude of approximately 16.5 feet above the ice to the lowest point on the skid, with a bank of approximately 1 degree left and a pitch of approximately 1.5 degrees down. These parameters are consistent with aircraft attitude and altitude related to ice measurement operation.

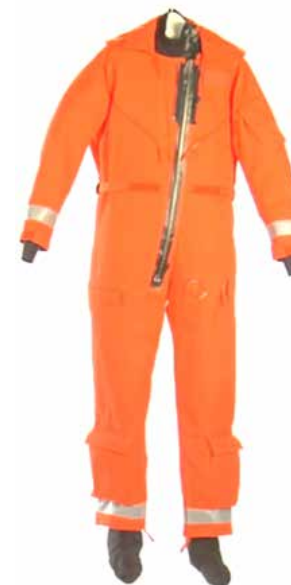
Figure 8. Viking PS4089

During recovery, it was noted that pilot's suit was full of water and that the zipper was done up to about the mid-sternum position. Examination of the suit noted that the hood and gloves were in the storage pockets and that the pockets were closed. Additionally, a small tear was noted on the back of the right upper sleeve. To completely close the zipper requires the use of both hands: one to pull the zipper, the other to ensure the zipper does not get caught on the suit material. As the zipper is being pulled past the neck, the wearer must bend their head back and to the right, which allows the zipper to be pulled straight.
