**AVIATION INVESTIGATION REPORT
A13Q0186**

**BELT LOADER FIRE LEADING TO CABIN SMOKE AND
EVACUATION OF PASSENGERS**

**BOEING 767-36N/ER, CN-RNT
OPERATED BY ROYAL AIR MAROC
AT MONTRÉAL-PIERRE ELLIOTT TRUDEAU
INTERNATIONAL AIRPORT, QUEBEC
04 NOVEMBER 2013**

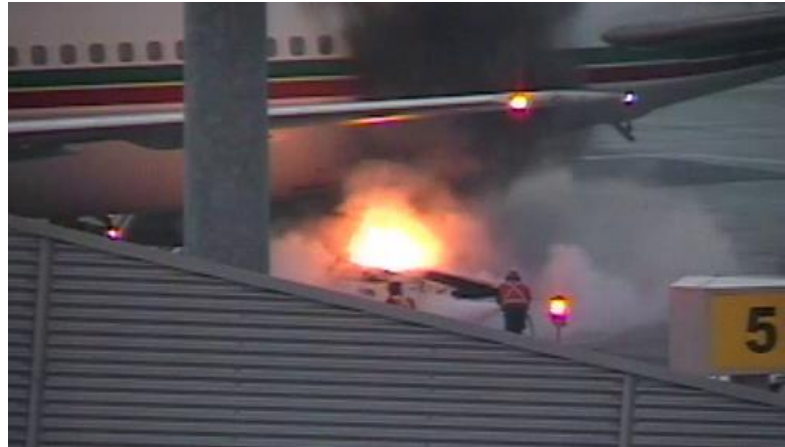
Meanwhile, a co-worker went to get a wheeled dry chemical fire extinguisher under the boarding bridge. With the help of another ground crew member, he wheeled the fire extinguisher to the fire and for 1 minute, 10 seconds sprayed the flames, emptying the chemical contents of the extinguisher, but was unsuccessful in putting out the fire (Photo 1).

Photo 1. Ground crew trying to put out the fire with a wheeled dry chemical fire extinguisher (Source: Aéroports de Montréal)

The fire extinguisher mounted on the belt loader was not used. Because this extinguisher was quite close to the flames, the ground crew opted to use the larger-capacity and more easily accessible wheeled fire extinguishers. However, although the first wheeled extinguisher operated as intended, it did not extinguish the fire. As for the second wheeled fire extinguisher, the airport firefighters found that it initially failed to work because there was a kink in its hose. However, it was not possible to determine whether this extinguisher could have put out the fire before the firefighters arrived.

Providing ground service employees with more comprehensive training on the features and use of available equipment would allow for a more effective response in the first few minutes of a fire while awaiting the arrival of airport firefighters. If ground crew have no practical training on the use of emergency equipment, there is a risk that the response will be inadequate in the first few minutes of an occurrence such as a fire.

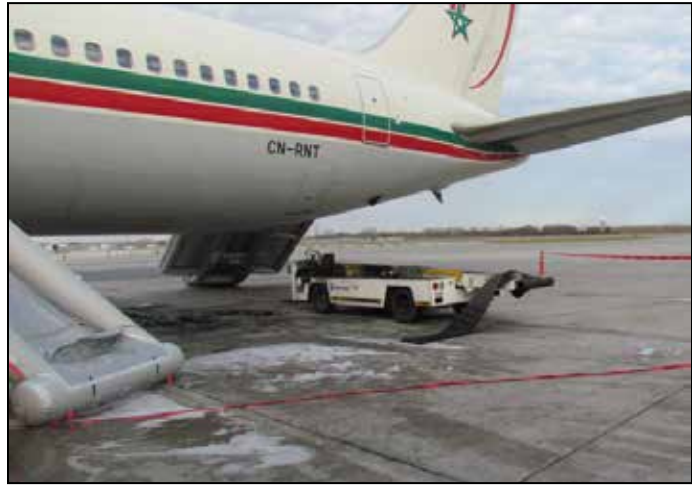
Photo 2. Belt loader after the fire

The belt loader, model 660-42, manufactured by TUG Technologies, was purchased new by Servisair Inc. in 2005. It sustained heavy damage in the fire (Photo 2).

The fire started in the rear part of the engine. The engine and auxiliary systems were heavily damaged, causing the fuel lines and fittings, electric harnesses, air intake system and conveyor belt to melt. An exhaust pipe runs transversally under the gear box located immediately below the filter regulator.

After the fire, the fuel line connecting the electric fuel pump to the filter regulator was found disconnected from the filter regulator. The laboratory analysis of this line showed that the end was not particularly burnt although soot was found, but there was no trace of the plastic push-lock connector which should have been on the line. However, the crimped steel ring attaching the connector to the line was still in place. The other end of the line, at the electric pump, was intact.

Based on the location of the damage and the traces of soot that were fairly centered in relation to the longitudinal centreline of the belt loader and concentrated in the area immediately behind the engine block, it is likely that the fire was caused by the fuel line becoming disconnected from the inlet of the filter regulator. If the break had occurred at the outlet of the filter regulator, signs of the fire would have been more pronounced on the right side, because the fuel flows through the filter regulator from left to right. The fuel would have gushed out of the filter regulator, which is centered on the engine, towards the right platform, which it did not in this case. If a fuel filter regulator and the lines connected to it are not properly protected, they can become damaged or weakened and eventually malfunction, causing a large amount of fuel to spill.

1. The connector between the fuel line and the inlet of the filter regulator disconnected while the engine was running. Consequently, fuel sprayed onto the hot surface of the exhaust pipe, starting a fire.
2. The smoke blown by the wind entered the cabin through the air conditioning and ventilation system both via the auxiliary power unit's air intake and the intake of the air recirculation fans in the main aft cargo compartment whose door was open.
3. The presence of smoke in the cabin led to the evacuation during which some passengers were injured and had to be hospitalized.

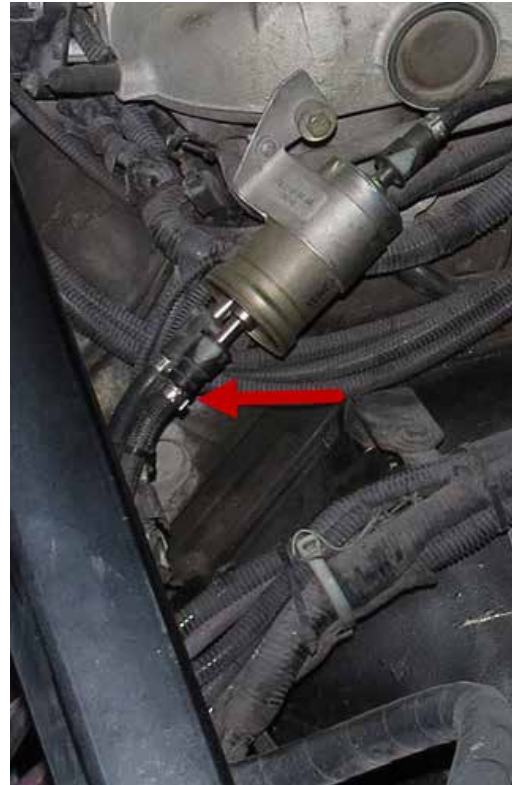
Photo 3. View showing crimped steel ring securing the connector of an identical, undamaged, belt loader

The fuel system includes a gas tank, mounted on the left platform between the front and rear wheels and an electric pump mounted on the frame next to the gas tank that feeds a fuel filter regulator through a flexible polymer line with an inside diameter of 7.9 mm. When the electric fuel pump is operating, the pressure inside the line is 448.15 kPa (65 psi). A fibre-glass reinforced plastic push-lock connector is affixed to each end of the line with a crimped steel ring installed at the time of manufacture (Photo 3).

During the TSB laboratory examination, the connector was removed from the intact end of the line to determine whether it could be easily inserted in the defective end still fitted with the ring. It was impossible to do so without removing the ring and exerting significant pressure, suggesting that the ring was quite likely correctly crimped at the time of the occurrence.

The company's inspection program was stricter than the inspection and maintenance program recommended by the manufacturer (TUG), which did not require any special verification of the fuel system or its lines. The missing line connector was to be inspected at 500 hours/120 days under Part A of the company's inspection program. The belt loader only had 12 hours of operation since its last Part A inspection. This connector had to have been in place at the time of the inspection, otherwise it would have been impossible to supply fuel to the engine. Given that during examination of the line, the steel ring had to be removed and significant pressure exerted to insert the connector from the intact end of the line into the defective end, it is quite likely that the ring was correctly crimped.

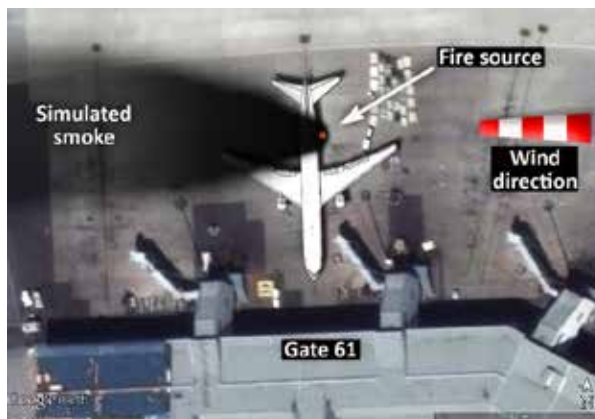
At the time of the occurrence, the outside ground temperature was 1°C, the sky was clear, and visibility was good. The aircraft was parked in a north-south direction, with the nose pointing south (Figure 4). Winds were easterly at 7 km/h. As a result, the smoke from the fire moved laterally above and below the aircraft, engulfing the fuselage between the tail and the wing and dissipating to the west.

Figure 4. Position of the aircraft and wind direction (Source: Google Earth, with TSB annotations)

The fire produced thick, acrid black smoke blown towards the right side of the aircraft by the wind enveloping the aft part of the fuselage. Smoke likely entered the main aft cargo compartment since the main aft cargo door was open. The smoke spread into the cargo compartment and moved up to the cabin through the air recirculation fans, which take their air source from between the cargo compartment wall and the outer fuselage skin. At the same time, the air drawn by the auxiliary power unit's (APU) intake probably spread some of the smoke to the ventilation system. This led to the evacuation during which some passengers were injured and had to be hospitalized.
