AVIATION INVESTIGATION REPORT

A14O0218

Risk of runway excursion on landing

DHC-8-400, C-FSRN

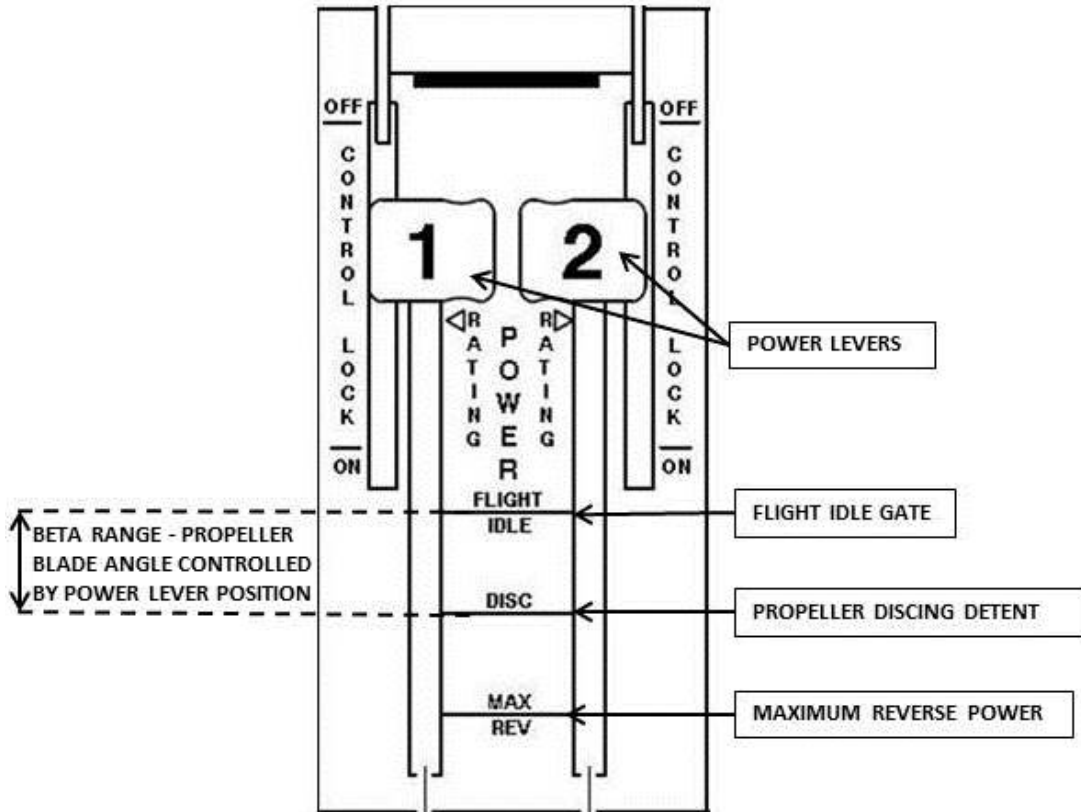
Figure 1. DHC-8-400 power levers and console (Source: Bombardier DASH 8-Q400 *Aeroplane Operating Manual*, Volume 4, Chapter 6, page 6.24-11, 31 May 2011, with TSB annotations)

During touchdown, the PLA was at 47°, above the FLIGHT IDLE gate – contrary to Sky Regional Airlines standard operating procedures (SOPs), which state that the power levers are to be brought to the FLIGHT IDLE (35°) position just prior to the touchdown.⁶

About 2 seconds after the full main-gear WOW, the PLA was held at 29° (below the FLIGHT IDLE gate, but not in the DISC detent [20°]), engine torques were at 0%, and the aircraft was approximately 1360 feet past the runway threshold, with 2628 feet of runway remaining.

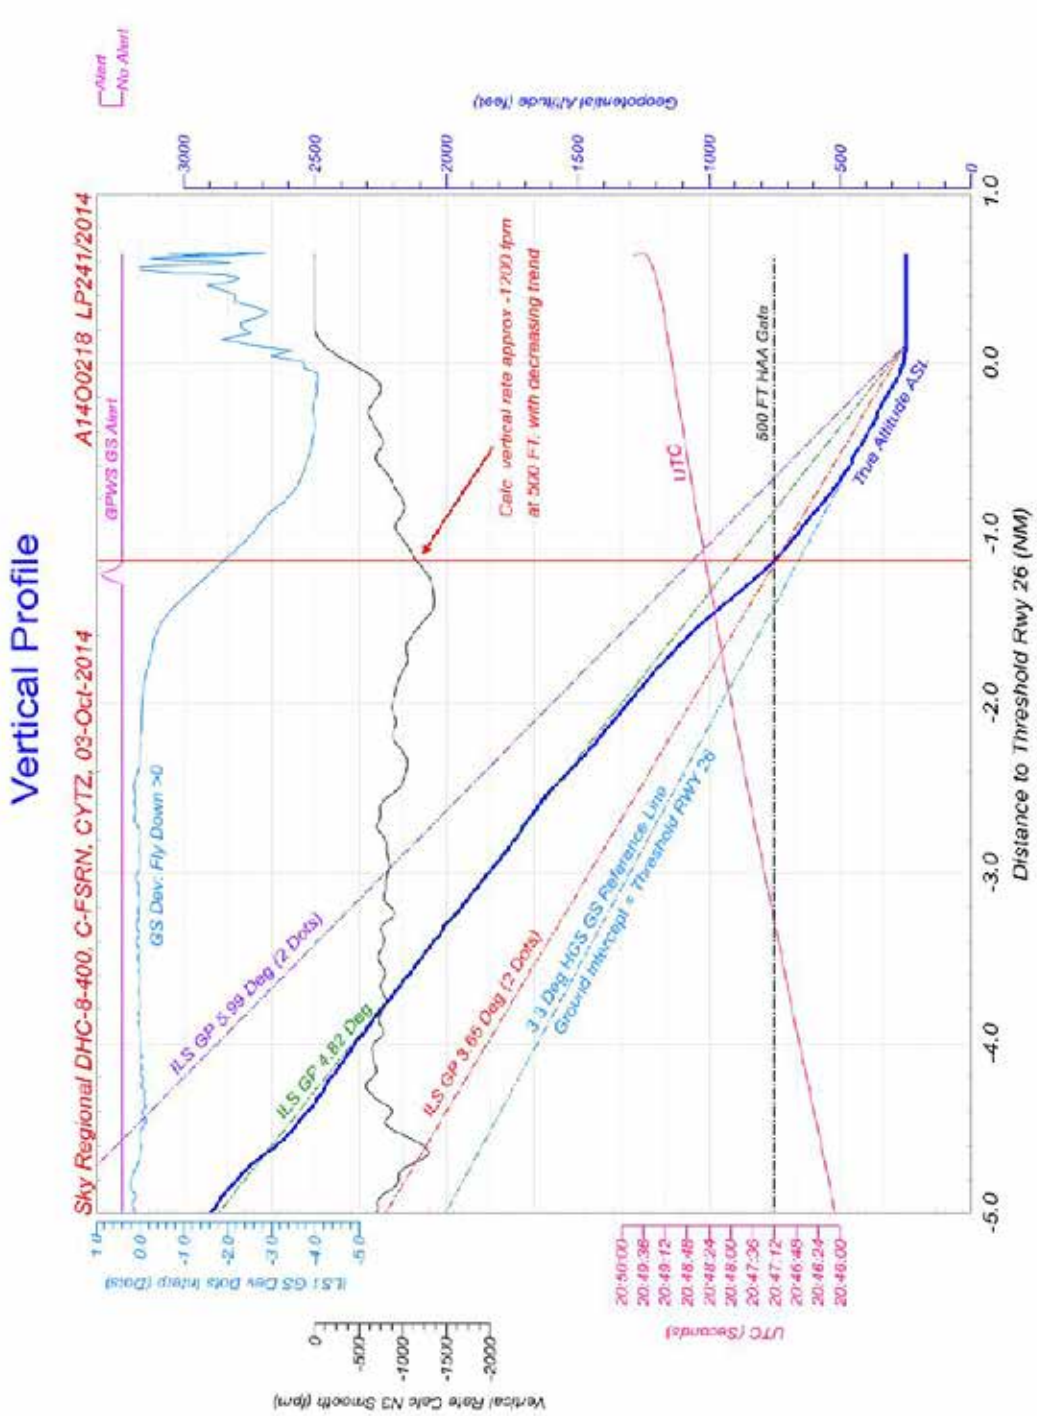
Appendix A – Vertical profile

At 1648:30, the aircraft descended through 500 feet agl. The aircraft did not meet the stabilized approach criteria because it was not established on a constant or planned profile and the sink rate was decreasing through 1200 fpm. In addition, as the aircraft transitioned to the 3.3° flight path angle, it was no longer on the steeper 4.8° glideslope, and therefore the sink rate was also in excess of the 1000 fpm requirement (Appendix A).

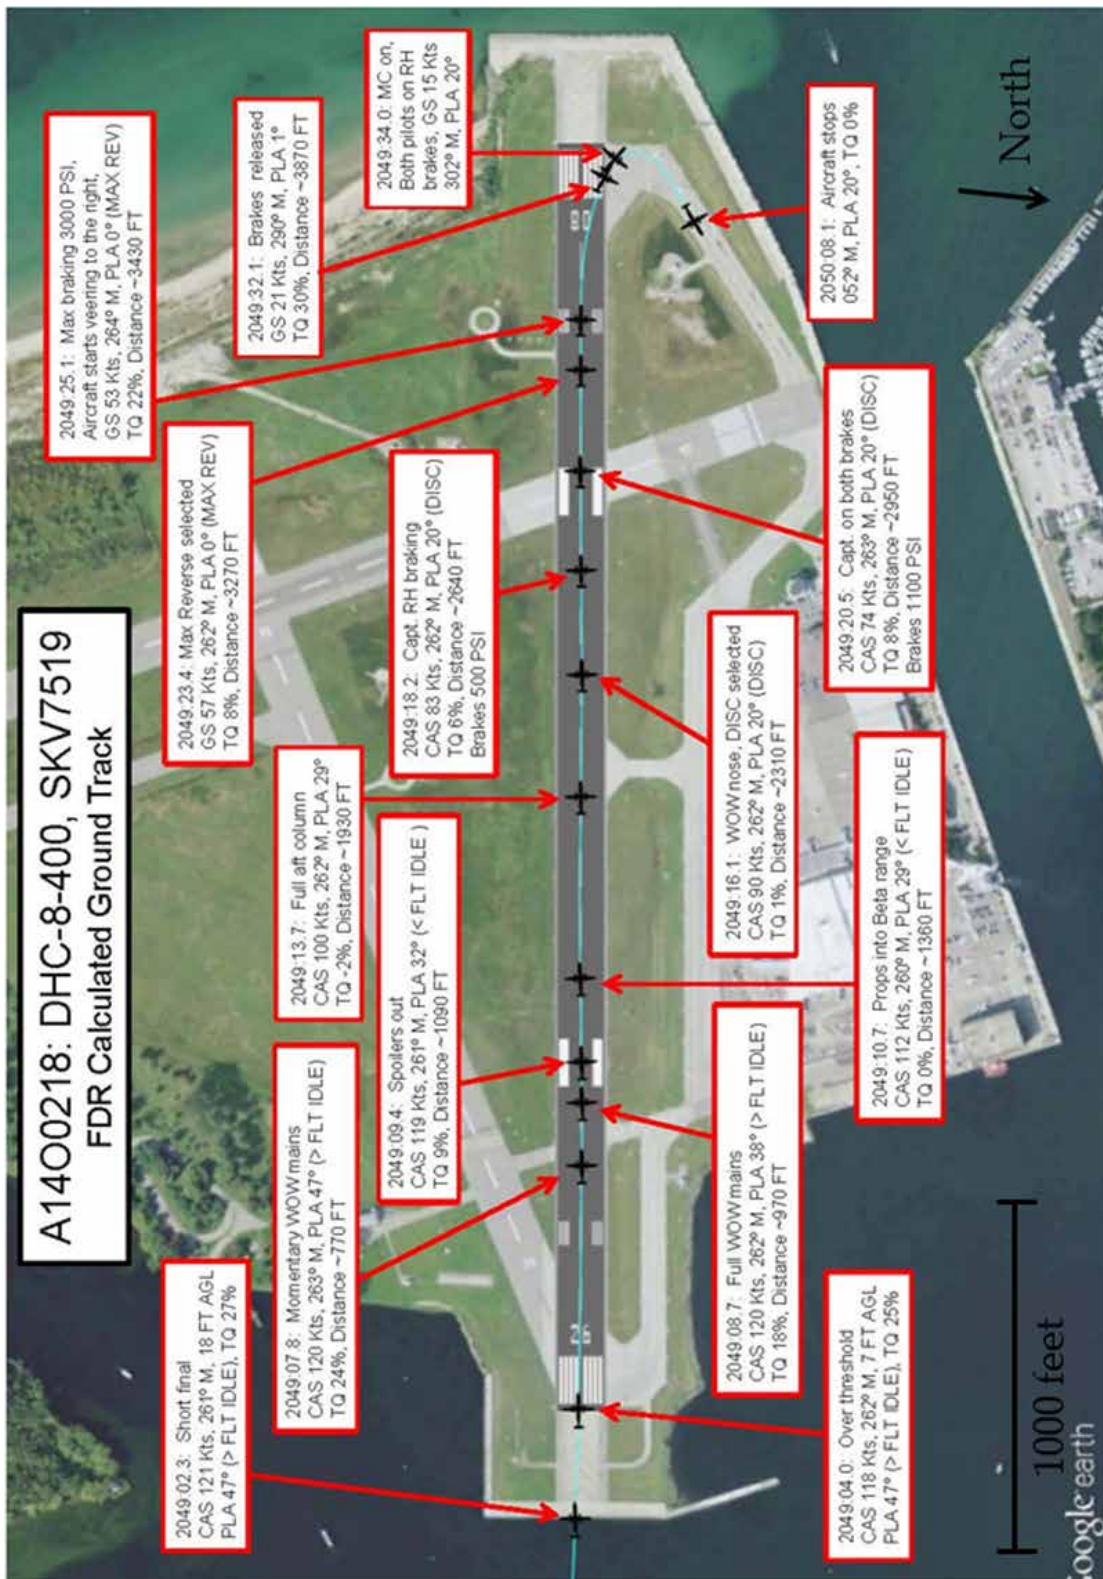
Appendix C – TSB calculated ground track with annotations

A momentary main gear weight-on-wheel (WOW) was recorded by the FDR at 1649:08, although the vertical acceleration data indicated that the main gear had contacted the runway up to 0.6 seconds earlier. During the WOW recorded at 1649:08, a vertical load factor of approximately +1.2 g was recorded, and the airspeed was 120 knots. The aircraft touched down approximately 770 feet past the runway threshold, with 3218 feet of runway remaining (Appendix C).

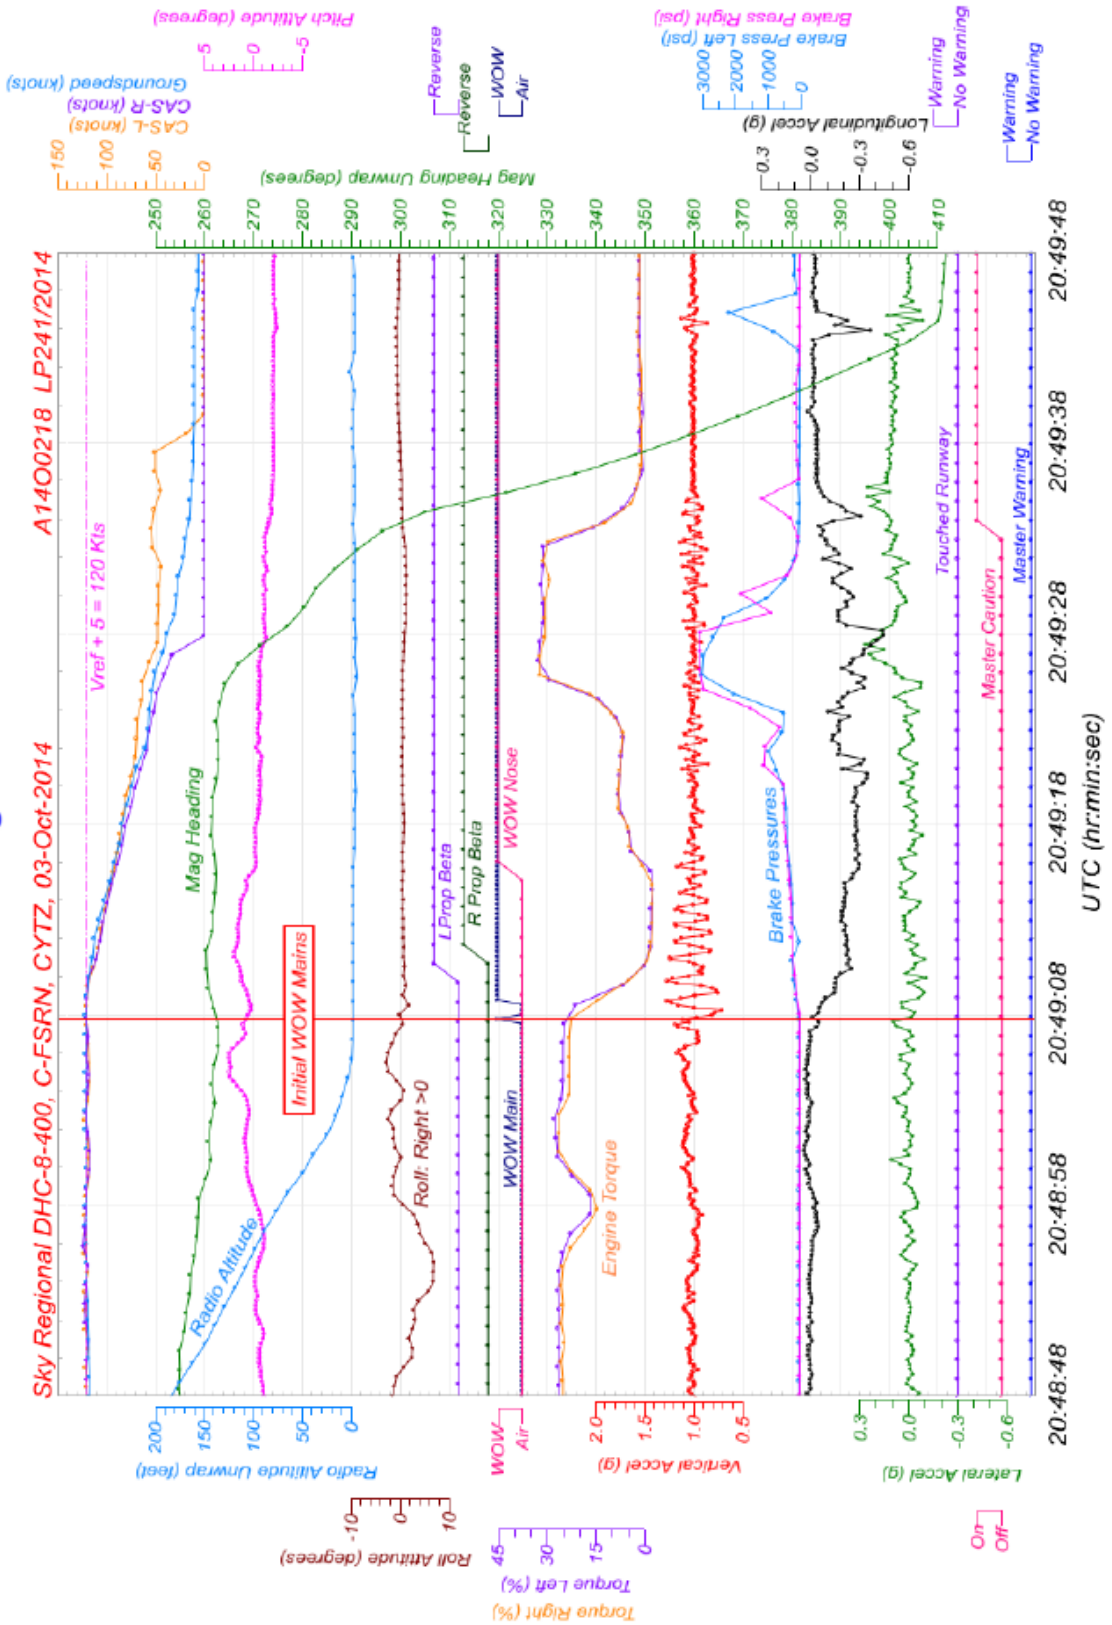
Appendix D – Landing overview

After the main gear touched down, the PF maintained the nose-up pitch inputs (Appendix D). About 3 seconds after the full main-gear WOW, the nose-up pitch inputs were increased to full nose-up and the power levers were retarded. The nose gear WOW indication occurred at 1649:16, indicating that the nosewheel touched down 7.2 seconds after the second main gear WOW. At this point, the airspeed was 90 knots, the heading was 262° magnetic (M), the PLA was at 20° (DISC detent), and the aircraft was approximately 2310 feet past the runway threshold, with 1678 feet of runway remaining.

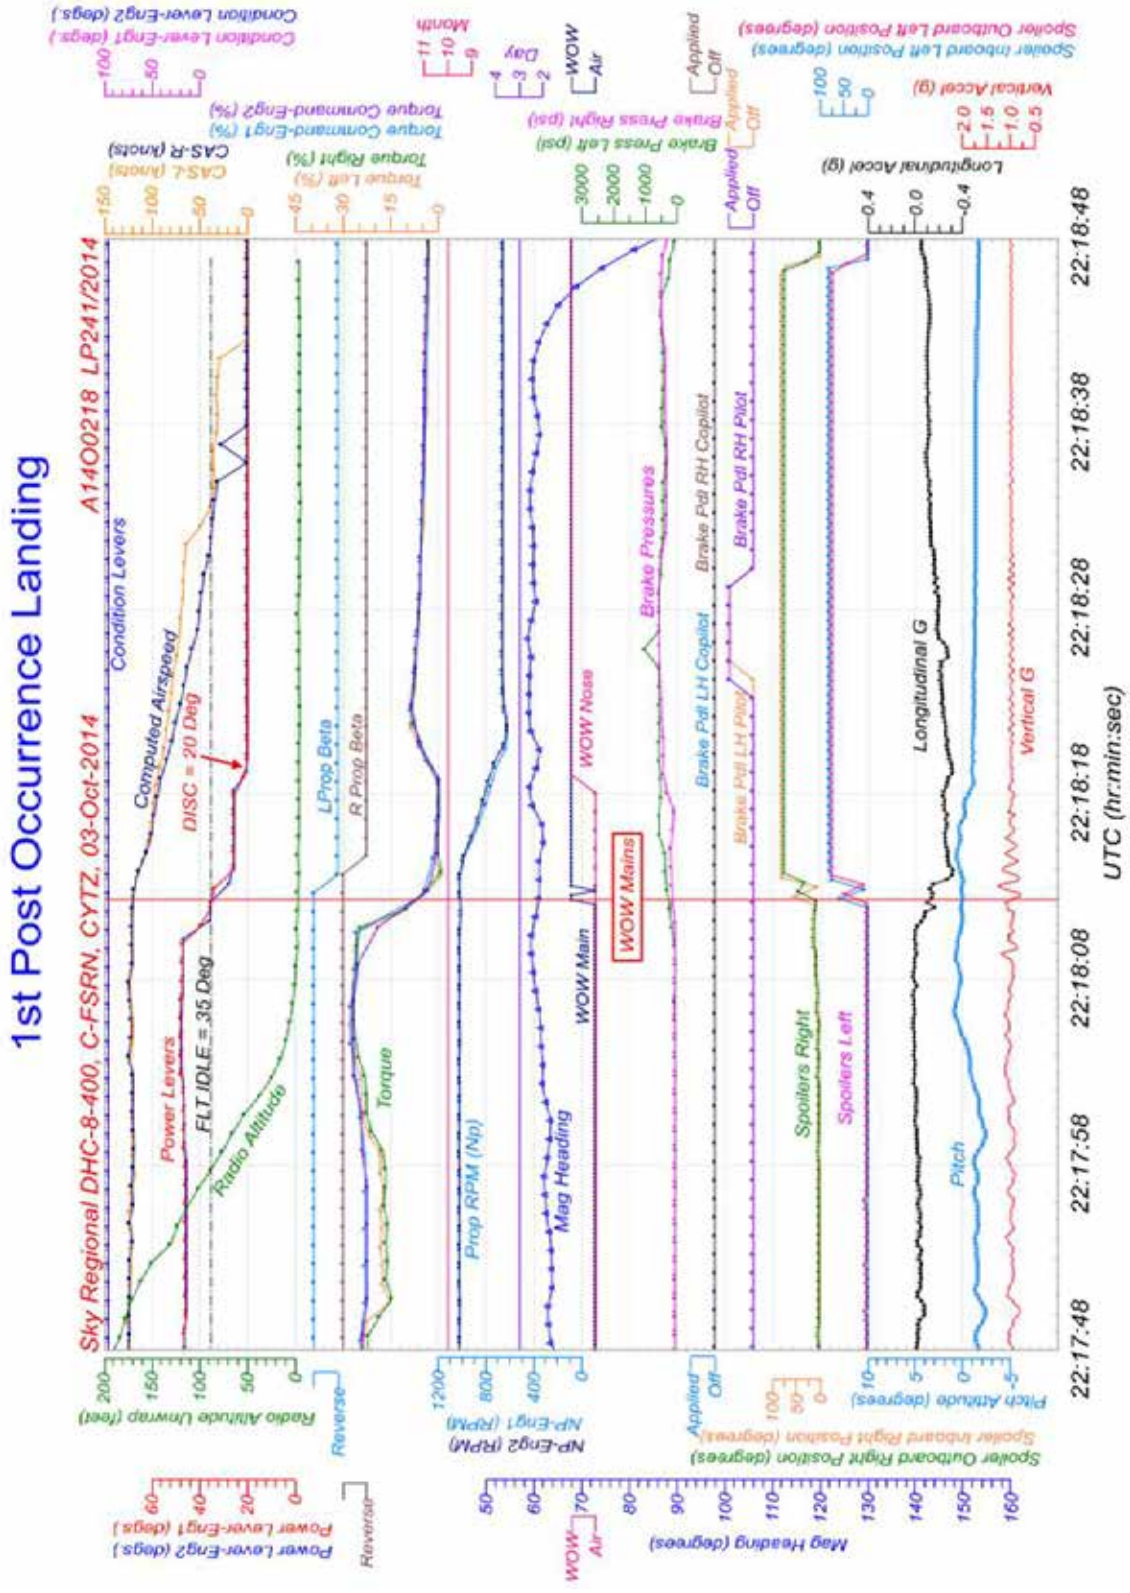
Appendix E – First post-occurrence landing

During the landing at CYUL, the nosewheel touchdown and power lever movements were the same as on the occurrence flight (Appendix E).
