**AVIATION INVESTIGATION REPORT  
A14W0046**

**RUNWAY INCURSION**

**AIR GEORGIAN LIMITED  
BEECH 1900D, C-GWGA  
CALGARY INTERNATIONAL AIRPORT, ALBERTA  
29 MARCH 2014**

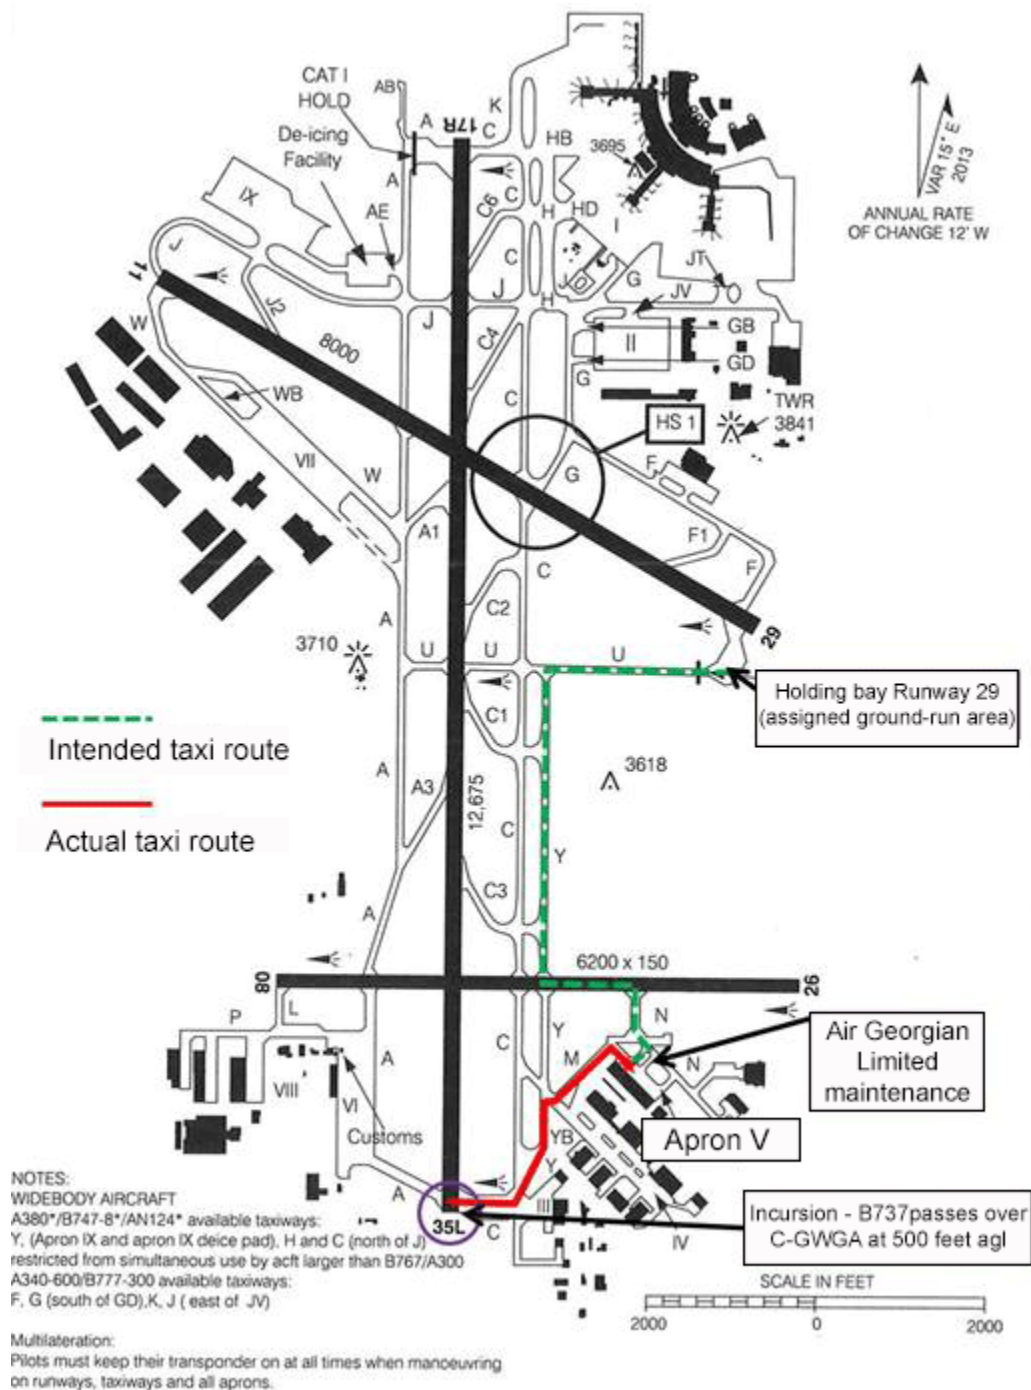
## Appendix A – Calgary International Airport diagram and taxi routes

C-GWGA exited Apron V at the north end and turned left on Taxiway M heading west. It then continued on Taxiway M to Taxiway Y, and then turned left heading south for Taxiway C. At 0022:12, the crew of a Boeing 737-700 (B737) called the tower controller for take-off clearance on Runway 17R. The controller visually scanned the runway from south to north and then confirmed the scan by looking at the airport surface detection equipment (ASDE) display from north to south (Appendix B). The controller noticed a primary target on Taxiway Y near the intersection with Taxiway M, but concluded it was a vehicle heading for the access road that passes south of the threshold of Runway 35L. At 0022:22, the controller cleared the B737 for takeoff on Runway 17R.

C-GWGA continued to taxi on Taxiway C, and at 0024:10, crossed the hold line at the threshold of Runway 35L as the B737 crossed overhead climbing through 500 feet above ground level (agl). C-GWGA continued on to Runway 35L, and at 0024:49, called on ground

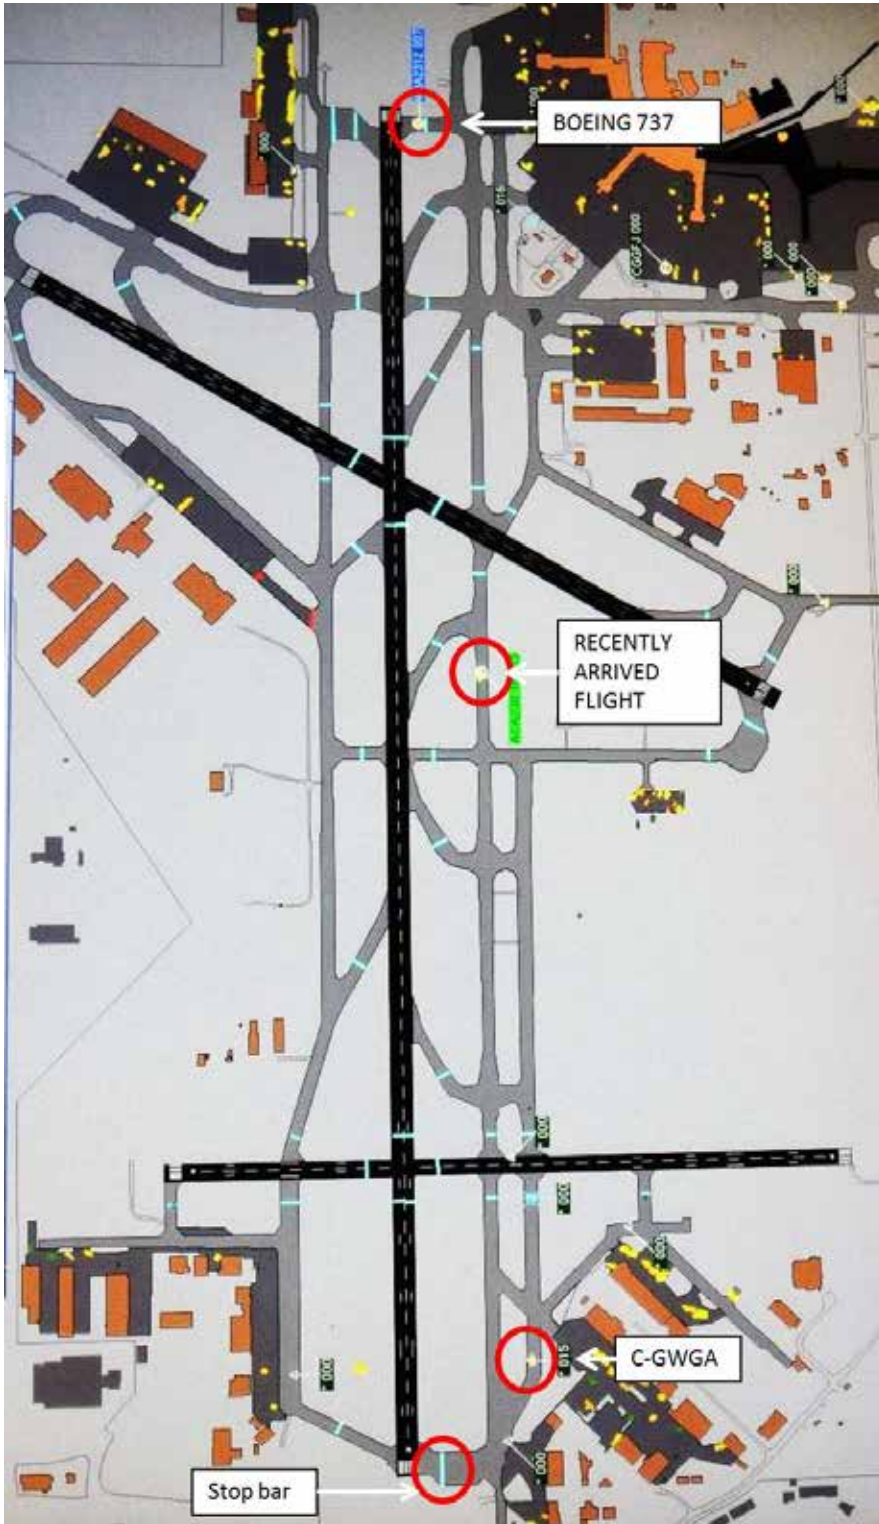
*Appendix B – Airport surface detection equipment (ASDE) display at 0022 when Boeing 737 was cleared for takeoff*

Prior to issuing a take-off clearance to the B737, the controller conducted a scan of the ASDE display to confirm the runway was clear. When he saw a primary target heading south from the intersection of Taxiway Y and Taxiway C, he made the assumption that it was a vehicle. This determination was based on the controller's experience observing vehicles behaving similarly in the past. This assumption was further reinforced by the fact that controllers are used to seeing uncorrelated ASDE targets on the taxiways in CYYC generated by vehicles that are not in contact with air traffic services (ATS). CYYC has a low number of vehicle incursions despite the fact that not all vehicle traffic is controlled by ATS. Consequently, controllers may assume an uncorrelated target is most likely a vehicle.

Except for reduced/low visibility operations, the Calgary Airport Authority does not require positive control over vehicles operating on a taxiway. This resulted in the controller making an incorrect assumption that C-GWGA was a vehicle.
