AVIATION INVESTIGATION REPORT A15H0002

Collision with terrain

Air Canada

Airbus Industrie A320-211, C-FTJP

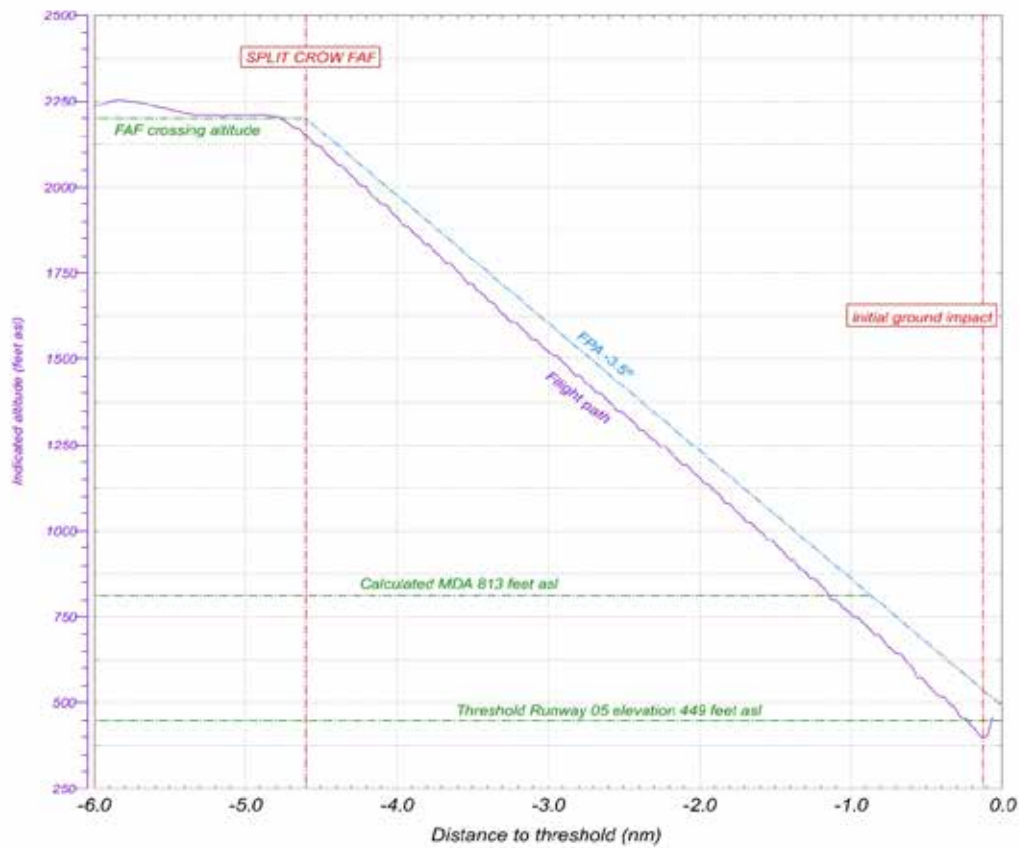
Figure 1. Flight path angle (FPA) versus aircraft flight path

The aircraft started to descend about 0.2 nm from the FAF. The aircraft crossed the FAF at 2170 feet indicated altitude (Figure 1).

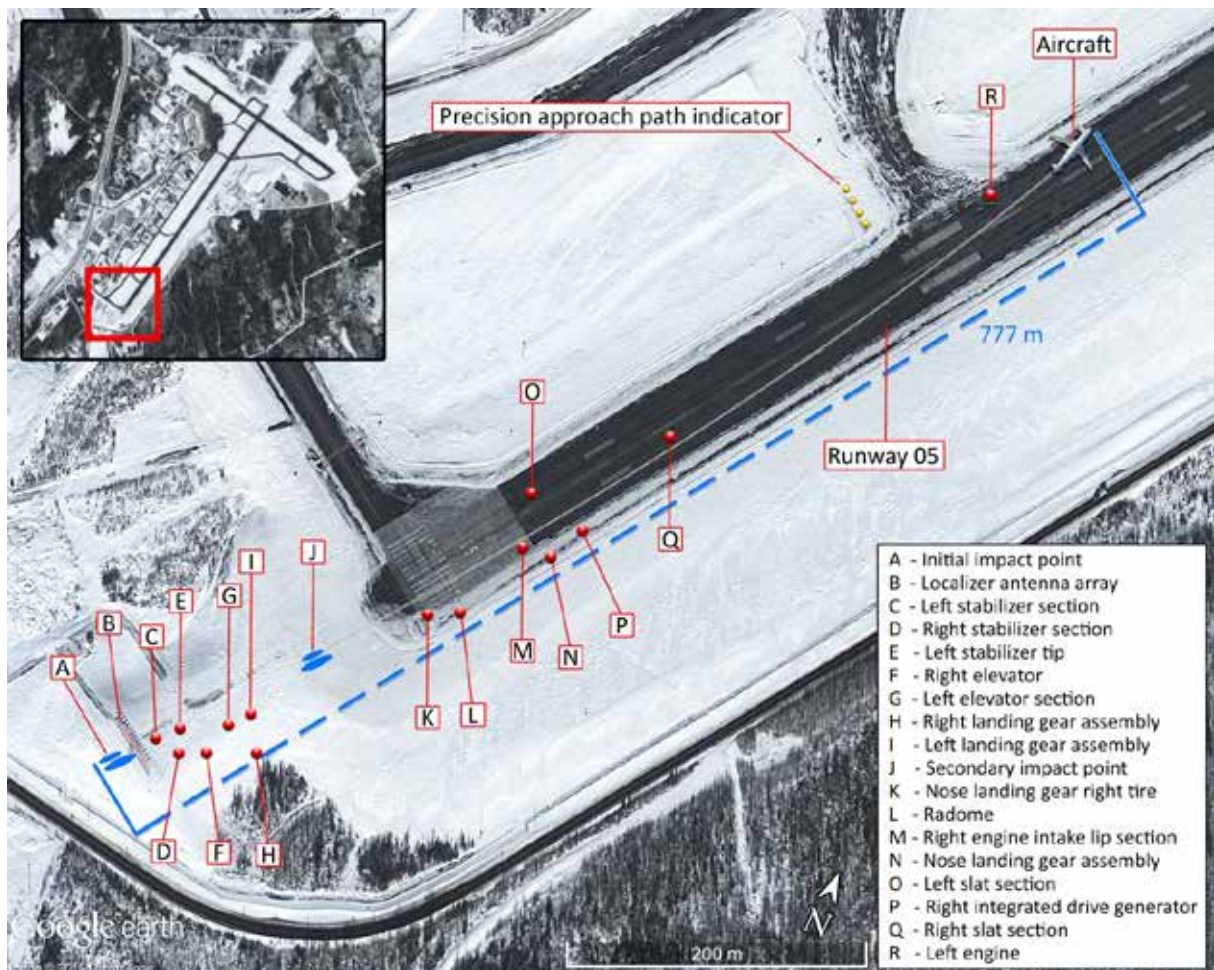
Figure 7. Site survey and wreckage distribution on Runway 05 (Source: Google Earth, with TSB annotations)

After striking the ILS localizer antenna array, the aircraft continued airborne until the right engine and nose section struck the snow-covered ground. The right engine mounting pylon fractured; the separated engine was retained under the right wing. The nose landing gear collapsed rearward, and its lower portion fractured and separated.

The aircraft then bounced before contacting the runway. The left engine completely detached from the wing and came to rest on the left side of the runway. The aircraft stopped on the left side of the runway in a slight nose-up and left-bank attitude, on an approximate heading of 025°M (Figure 7).

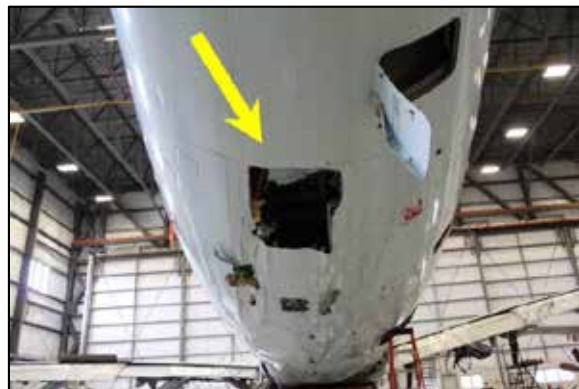
Figure 8. Fuselage damage

The nose wheel well area was forced upward and rearward, buckling and fracturing many of the internal structural components. The fuselage sustained multiple dents, tears, and punctures, including a large hole located just forward of the aft pressure bulkhead, where the fuselage skin and internal structure had fractured when forced up and aft (Figure 8).

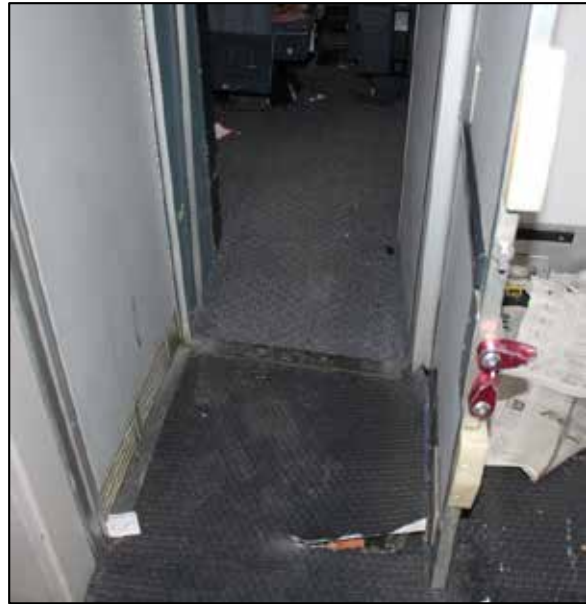
Figure 9. Floor damage aft of cockpit door

The entire nose landing gear bay had extensive damage that caused the structure to be forced rearward and upward. The floor aft of the cockpit door was forced upward by displacement of a pulley resulting from this structural damage. The cockpit door frame was also buckled as a result of the floor having been pushed upward, thereby restricting the movement of the cockpit door (Figure 9).

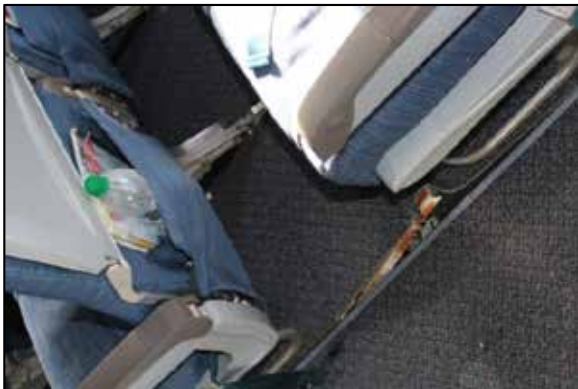
Figure 10. Floor damage forward of passenger seat 31D

Striking the snow-covered ground caused some of the aft lower fuselage stringers and formers to fracture and break, and caused the floor of the bulk cargo compartment to buckle and to be forced upward. The cabin floor was punctured forward of seats 31D and 33D when the stanchions of the forward and aft nets of the bulk cargo door were forced upward (figures 10 and 11).
