**AVIATION INVESTIGATION REPORT
A15P0147**

**ENGINE POWER LOSS AND FORCED LANDING
BEEHCRAFT A36, C-GPDK
OSOYOOS, BRITISH COLUMBIA
07 JULY 2015**

Aviation Investigation Report A15P0147

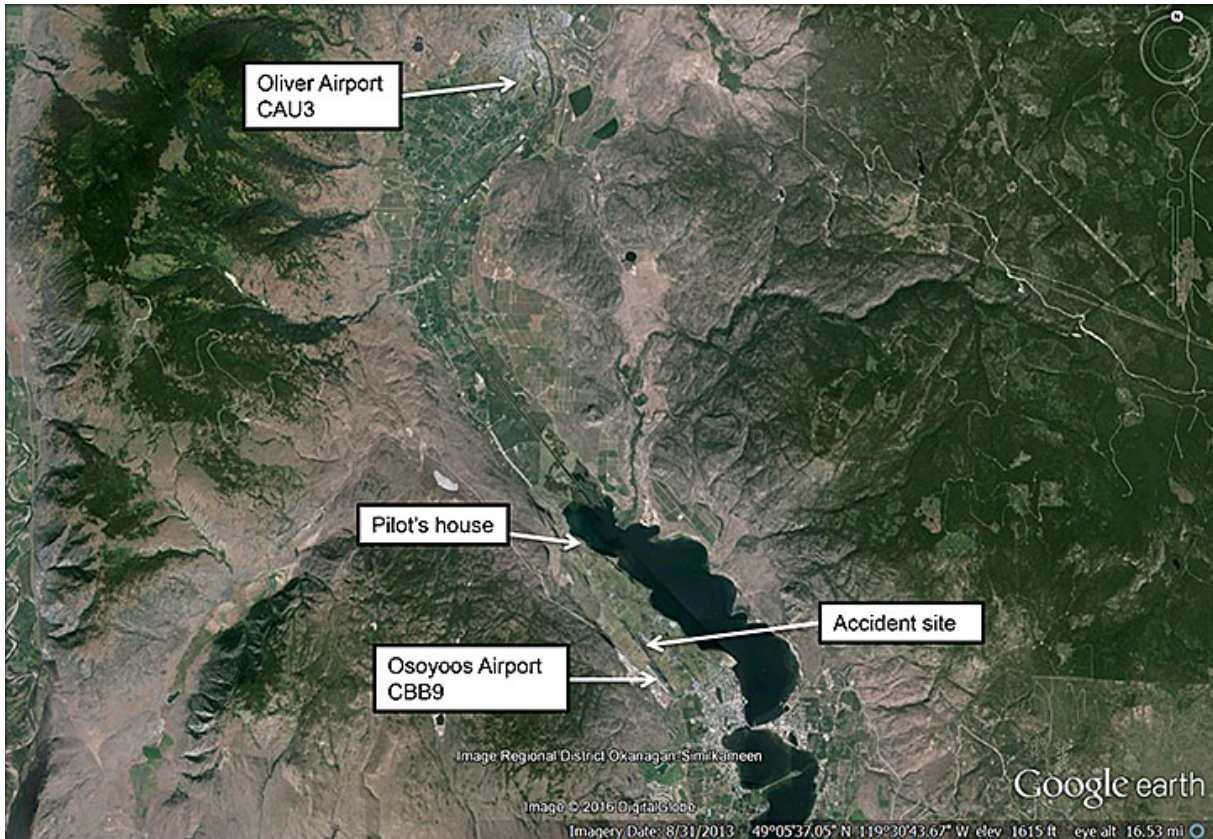
On 07 July at 1532,² the pilot filed a visual flight rules (VFR) flight plan with the Kamloops Flight Information Centre (FIC), with a planned altitude of 10 500 feet above sea level (asl). The CAU3 fuel transaction log showed that the pilot made a fuel purchase of 57 litres of 100LL aviation fuel (AVGAS) at 1608. The aircraft departed CAU3 at approximately 1640 in a southbound direction (Figure 1).

Figure 1. Aerial view of the general flight area (Source: Google Earth, with annotations by TSB)

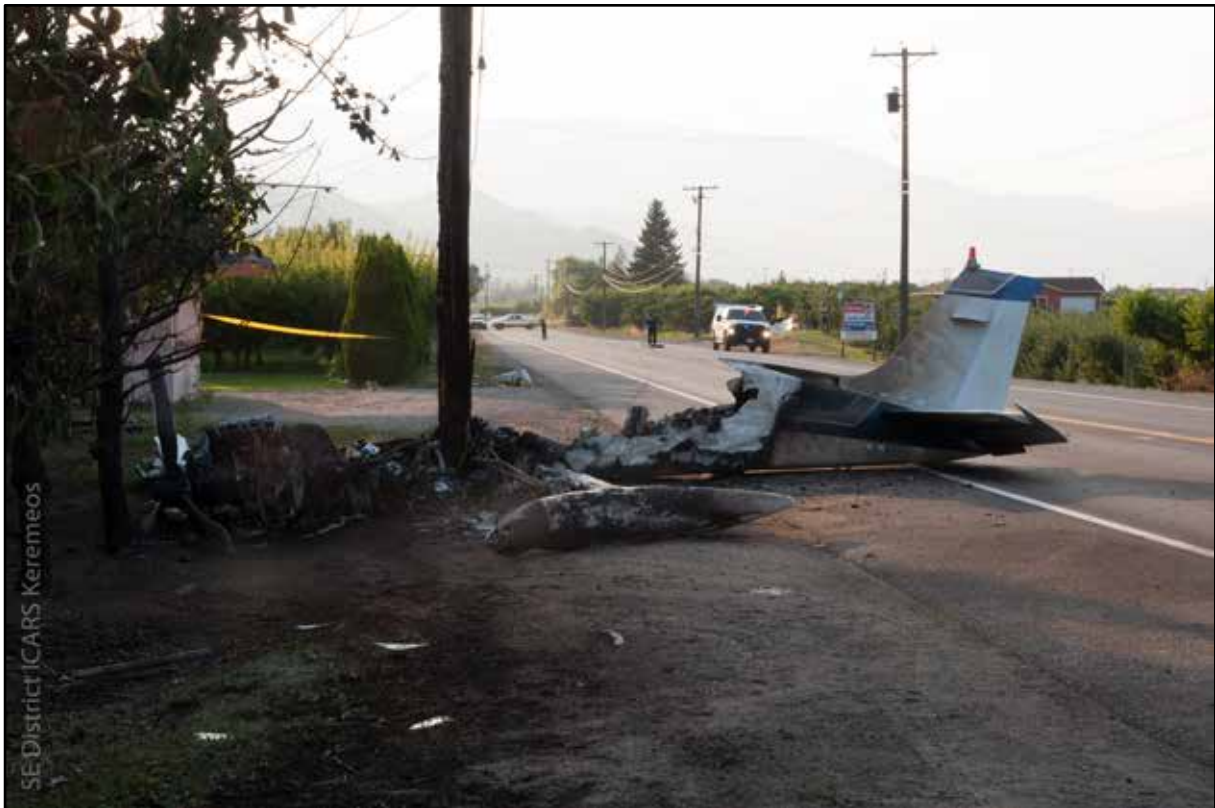
Investigators examined the accident site and the aircraft wreckage (Photo 1) in Osoyoos on 08 July.

Impact damage on the highway surface indicated that the nose wheel of the aircraft made the first ground contact, approximately 275 feet after striking the semi-trailer. This evidence is consistent with the aircraft being in a steep nose-down attitude. Upon impact, the nose wheel, including a part of the shock strut fork, separated from the aircraft. The nose wheel was found approximately 100 feet north of the point where the aircraft came to a rest. The separation of the nose wheel caused the propeller to strike the road surface, leaving 3 ground scars. These ground scars and the propeller damage are consistent with the aircraft's engine rotating at a slow speed on impact. The right wing-tip tank separated from the wing and was found on the west side of Highway 97, approximately 40 feet north of the wreckage. The aircraft struck the power pole at the most inboard portion of the leading edge of the left wing. The forward two-thirds of the fuselage and most of the left wing were destroyed by the fire. There was only minor fire damage to the right wing.

Photo 1. Accident site showing the aircraft wreckage (Source: Keremeos RCMP Integrated Collision Analysis and Reconstruction Service [ICARS])

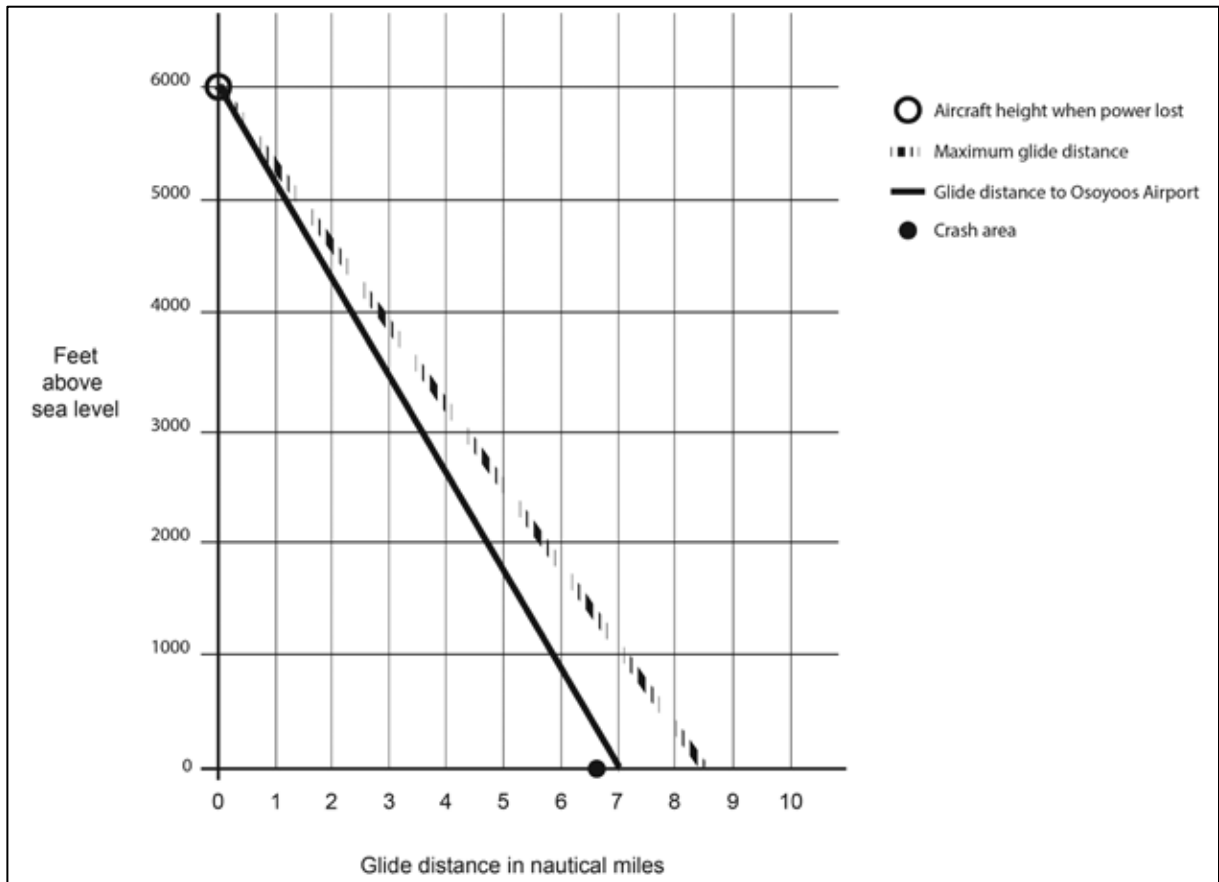
Appendix A – Glide performance

The engine power loss occurred at approximately 6000 feet asl (5000 feet above ground level [agl]). This altitude should have allowed the aircraft to glide a total of 8.5 nautical miles (nm) (Appendix A). The Osoyoos Airport is at an elevation of 1100 feet asl and is approximately 7 nm from the estimated location of the engine power loss. The accident location was 0.27 nm from the Osoyoos Airport.

The engine power loss occurred at approximately 6000 feet above sea level (asl) (5000 feet above ground level [agl]). This altitude should have allowed the aircraft to glide a total of 8.5 nautical miles (nm) (Appendix A). The Osoyoos Airport is at an elevation of 1100 feet asl and is about 7 nm from the estimated location of the engine power loss. The pilot's previous success in regaining full engine power may have delayed selection of a forced landing area. The nearest airport was then not an option, and Highway 97 was chosen as the next best emergency landing area.
