AVIATION INVESTIGATION REPORT

A16O0016

Runway incursion and risk of collision

Air Canada, Embraer 190-100IGW, C-FNAW
and

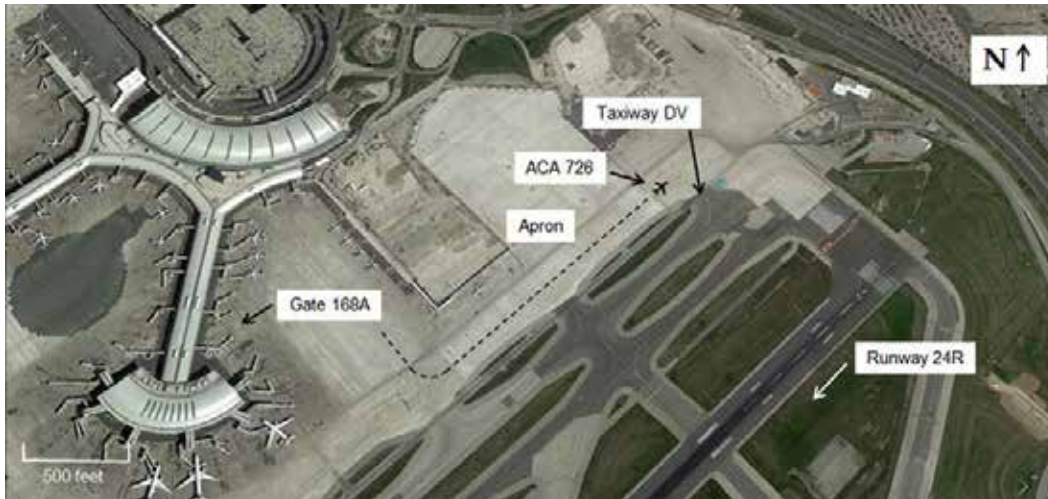
Figure 1. ACA726 on the apron at Taxiway DV (Source: Google Earth, with TSB annotations)

At 2058:40, the FMS data error was corrected, just as ACA726 arrived at Taxiway DV. Based on their close proximity to Runway 24R, the flight crew completed the pre-takeoff checks while on the apron before requesting further taxi instructions to Runway 24R.

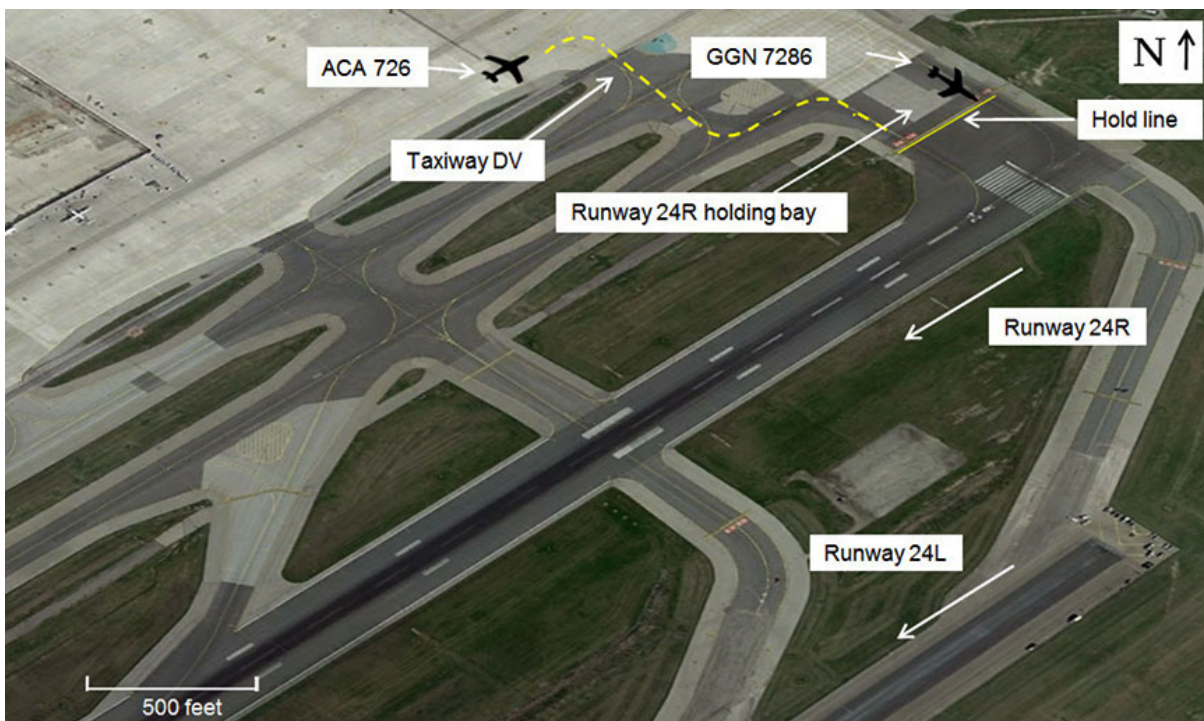
While ACA726 was taxiing, both the captain and FO observed an aircraft on final approach and believed it to be landing on Runway 24L, which is parallel to Runway 24R (Figure 2).

Figure 2. ACA726's taxi instructions (indicated by dotted line) into the Runway 24R holding bay (Source: Google Earth, with TSB annotations)

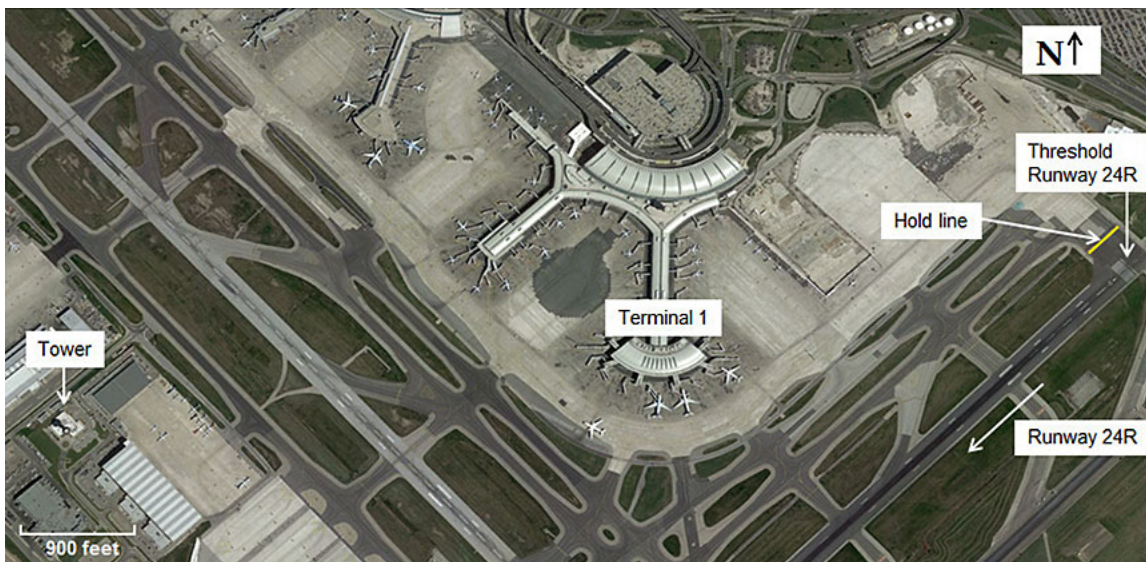
The airport controller observed on the A-SMGCS display that ACA726 was taxiing toward the hold line in the holding bay, but never saw the aircraft when looking outside of the tower toward the threshold of Runway 24R. ACA1259 reported that there was an aircraft on the runway, and the ACA726 FO confirmed when asked by the airport controller that they were on the runway. From the south tower controller work position, the airport controller was unable to see ACA726 on the runway given the light saturation at night.

Figure 3. Location of CYYZ tower and threshold of Runway 24R (Source: Google Earth, with TSB annotations)
