# AVIATION INVESTIGATION REPORT

## A16P0069

### **Loss of tail-rotor effectiveness**

Bell 206B Jet Ranger-III (Helicopter), C-GOPK

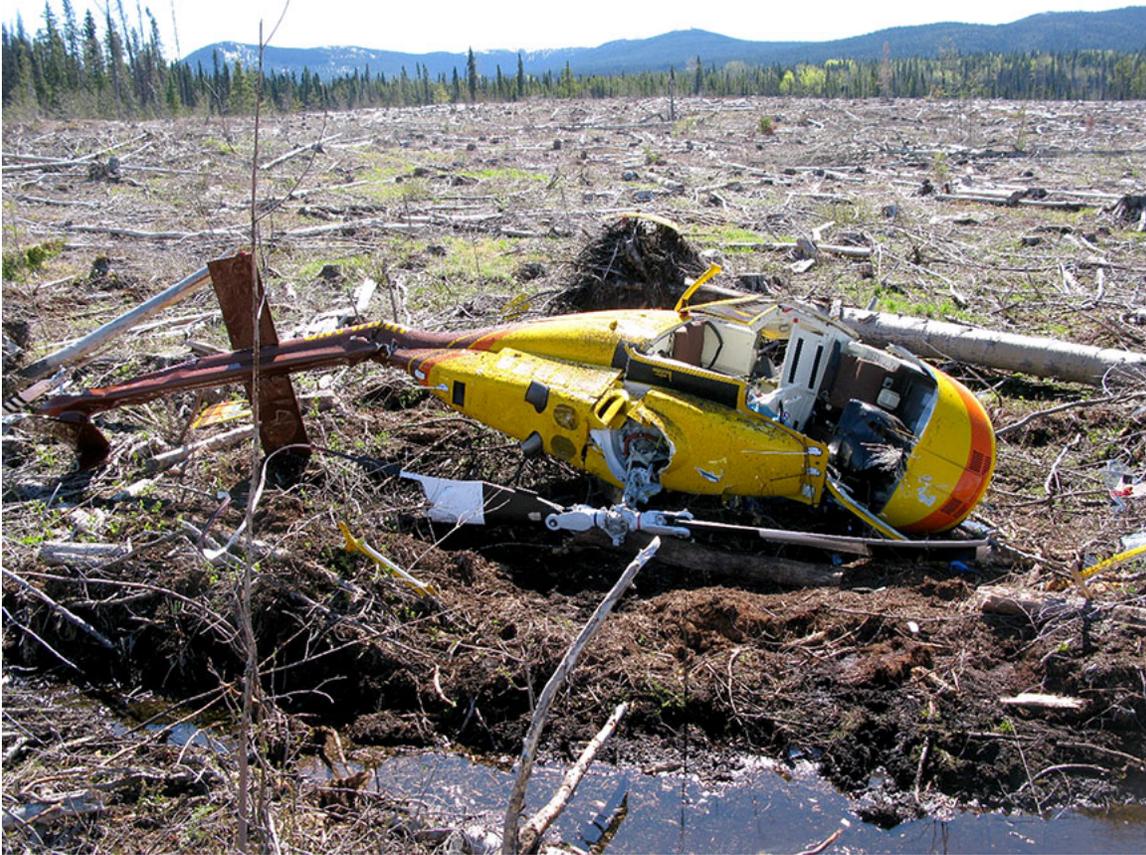
Figure 2. Wreckage and accident site

The helicopter was destroyed on impact with the ground (Figure 2). Both main-rotor blades broke several feet outboard of their root ends. The main-rotor gearbox had broken its mounts, and the aft coupling on the driveshaft between the engine and the main-rotor gearbox had pulled apart. The tail boom remained attached to the fuselage, but was severely bent upward and to the right, about 6 inches aft of the tail-boom-to-fuselage attachment point. The vertical stabilizer (fin) remained attached to the tail boom, but the lower 10 inches of the fin were bent about 90° to the right, and the remaining fin had rotated several degrees counterclockwise as viewed from aft of the helicopter, twisting the tail boom immediately forward of the fin. The upper portion of the fin had been struck by a main-rotor blade.
