# AVIATION INVESTIGATION REPORT

## A16Q0020

### **Temporary difficulty with aircraft control**

DHC-8-102, C-GJMO

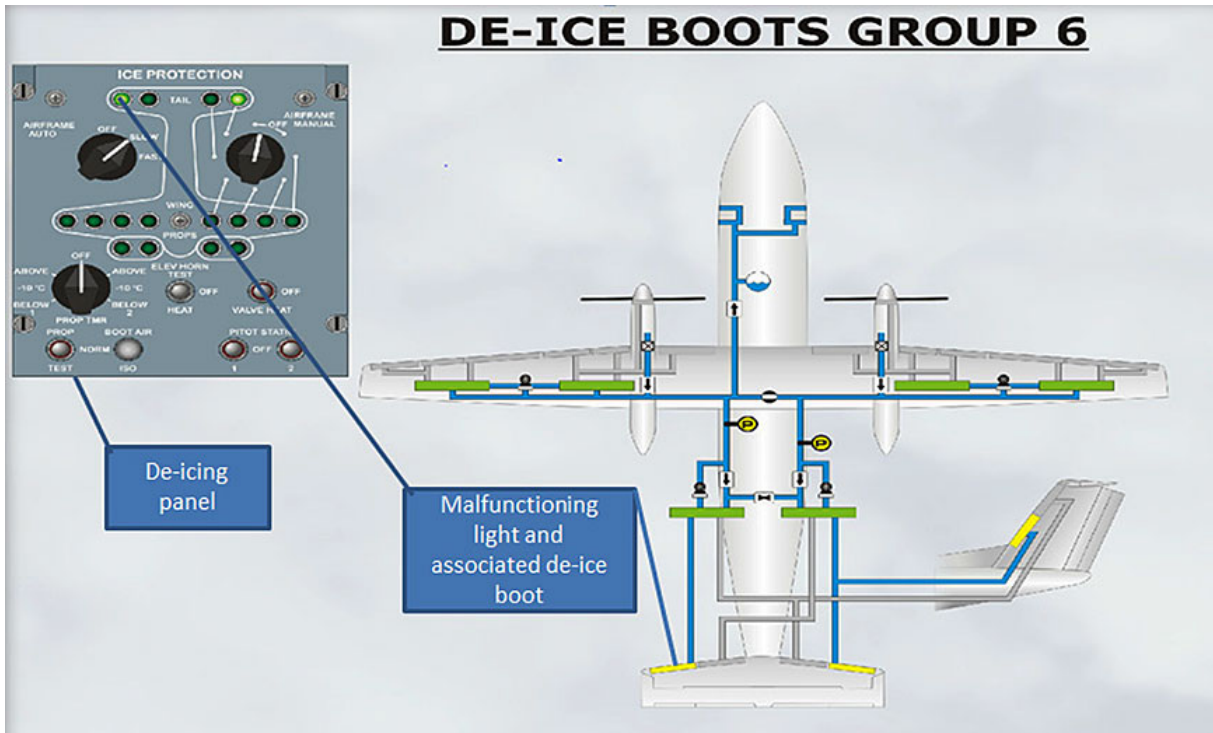
Figure 1. Wing and tail de-icing—normal operations (Source: Jazz Learning System, Dash8-300/100 ground school, Ice and Rain Protection, with TSB annotations)

A pressure reading on the de-ice dual pressure indicator of  $18 \pm 1$  pounds per square inch (psi) indicates that the system is working normally. Should the pressure on either side fall below 5.5 psi, the DEICE PRESS caution light will illuminate. There is no indication that the DEICE PRESS caution light illuminated during the occurrence flight.

During the approach, shortly after the temporary difficulty with aircraft control, the PF noticed that the TAIL advisory light for the outer left de-ice boot on the de-icing panel did not illuminate. The exact time that the light stopped functioning could not be determined. Because the aircraft was established on final approach, and considering the workload associated with this critical phase of flight, the de-ice boot failure procedure indicated in the QRH was not performed at that time.

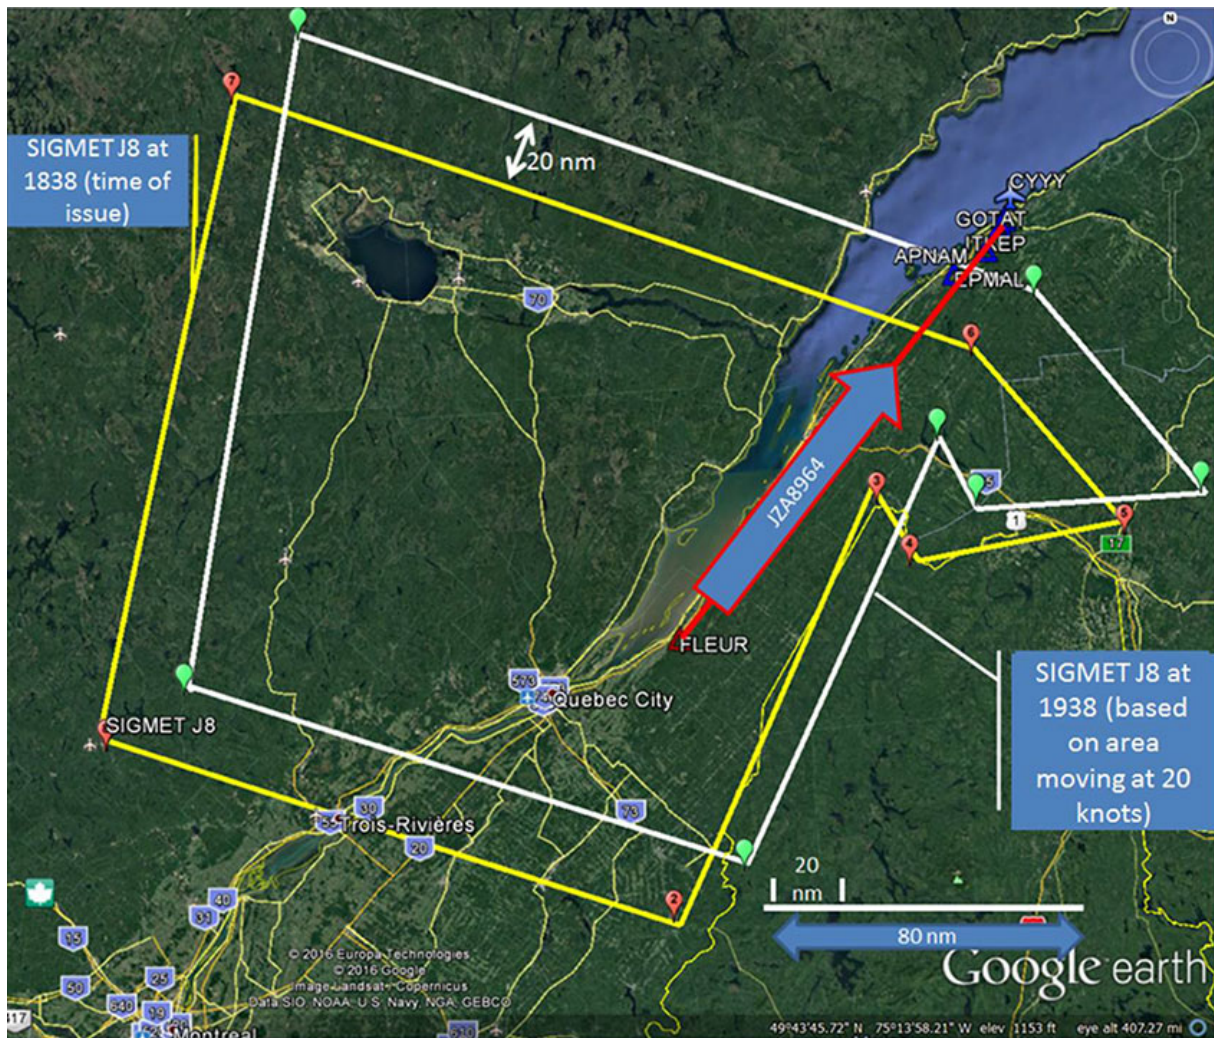
Figure 2. Approximate position of SIGMET J8 with JZA8964's flight path (Source: Google Earth, with TSB annotations)

On the evening of the occurrence, the meteorological watch office issued SIGMET J8 at 1838 with a validity period starting at 1835. The SIGMET depicted an area of severe icing from the surface up to an altitude of 6000 feet. This area was forecast to move northeastward at a speed of 20 knots. Figure 2 shows the approximate location of the area of freezing rain and severe icing below 6000 feet AGL, as stated in SIGMET J8, when JZA8964 was approaching CYYY. See Appendix C for SIGMET J8 issued on the occurrence date.

The aircraft overflew the edge of the SIGMET J8 area, located approximately 20 nm from CYYY, as it was descending through 7800 feet, therefore avoiding the forecasted area of severe icing.

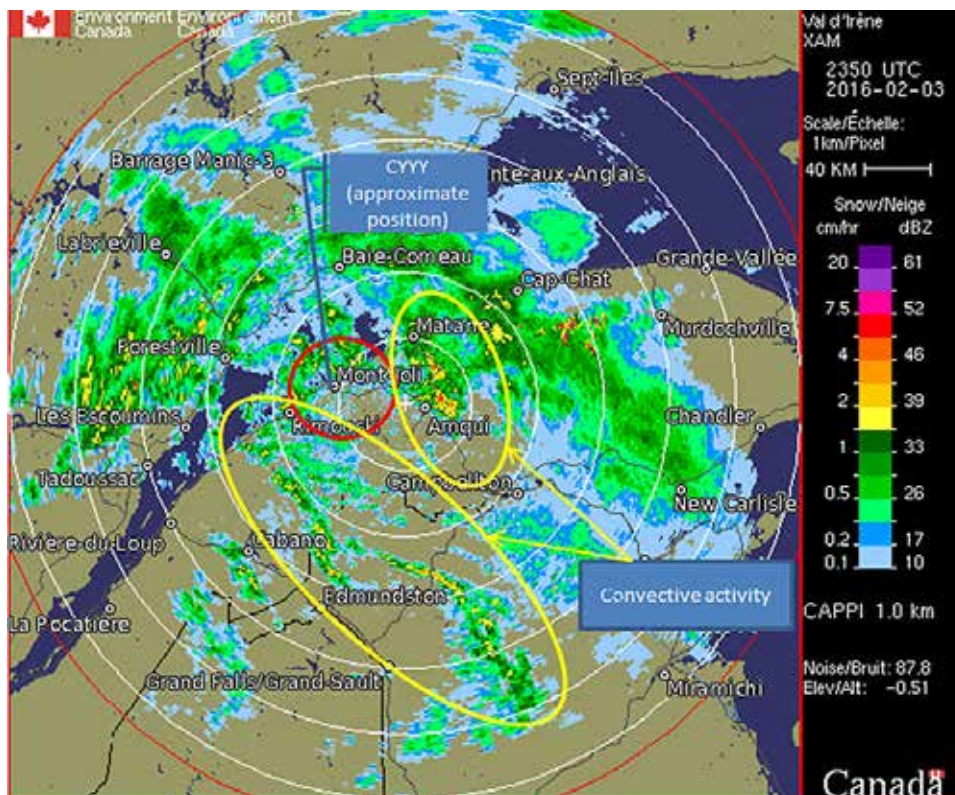
Figure 3. Radar image from 1850 (2350 UTC) on 03 February 2016 (Source: Environment Canada, with TSB annotations)

Data from the Val d'Irène, Quebec, weather radar, located approximately 24 nm southeast of CYYY, displayed precipitation bands sweeping over the Gaspé Peninsula between 1900 and 1940. In particular, the images showed 2 distinctive convective lines near Mont-Joli and to the southwest (Figures 3 and 4).

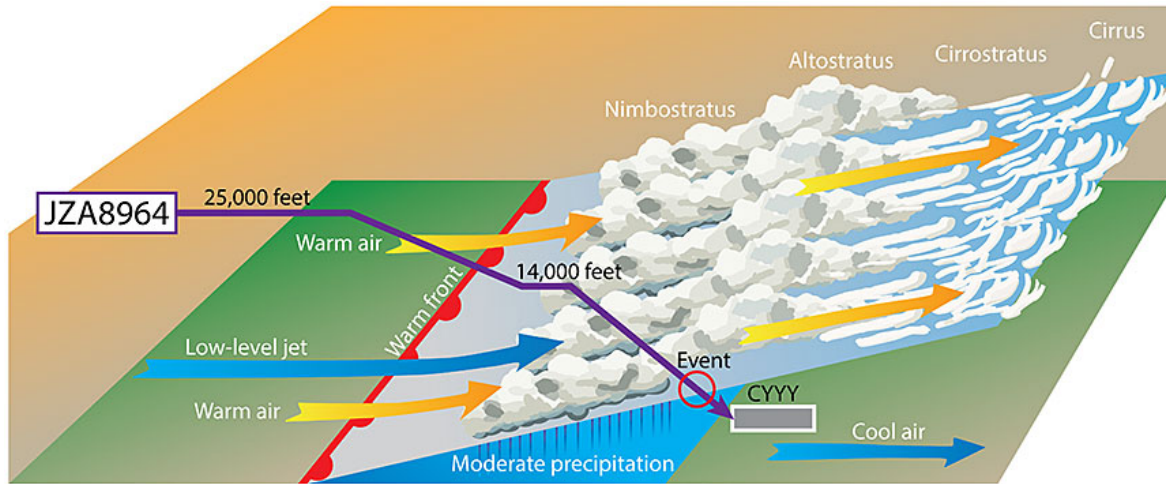
Figure 5. Cross-section of warm front and descent trajectory

JZA8964 departed CYUL at 1757 and was scheduled to land at CYYY at 1915. Although the aircraft would descend through the warm front, the approach path (Figure 5) remained above the area of severe icing conditions and JZA8964 was scheduled to land at CYYY prior to the onset of the freezing precipitation.

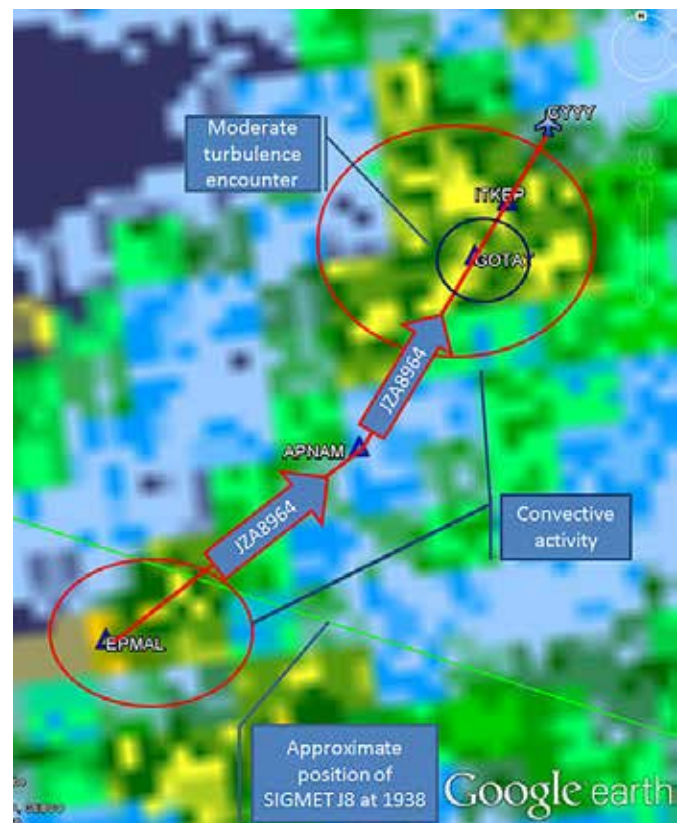
Figure 6. JZA8964 final approach path with 1900 radar image overlay (Source: Google Earth and Environment Canada Val d'Irène station, with TSB annotations)

The crew was unaware of the presence of convective activity on approach and did not use the weather radar because they did not think that convective activity was a factor during the occurrence flight (Figure 6). Therefore, if crews do not use the weather radar near frontal activity with embedded ACC, there is a risk that convective activity will not be detected and aircraft may be flown into conditions that could affect the safety of the flight.

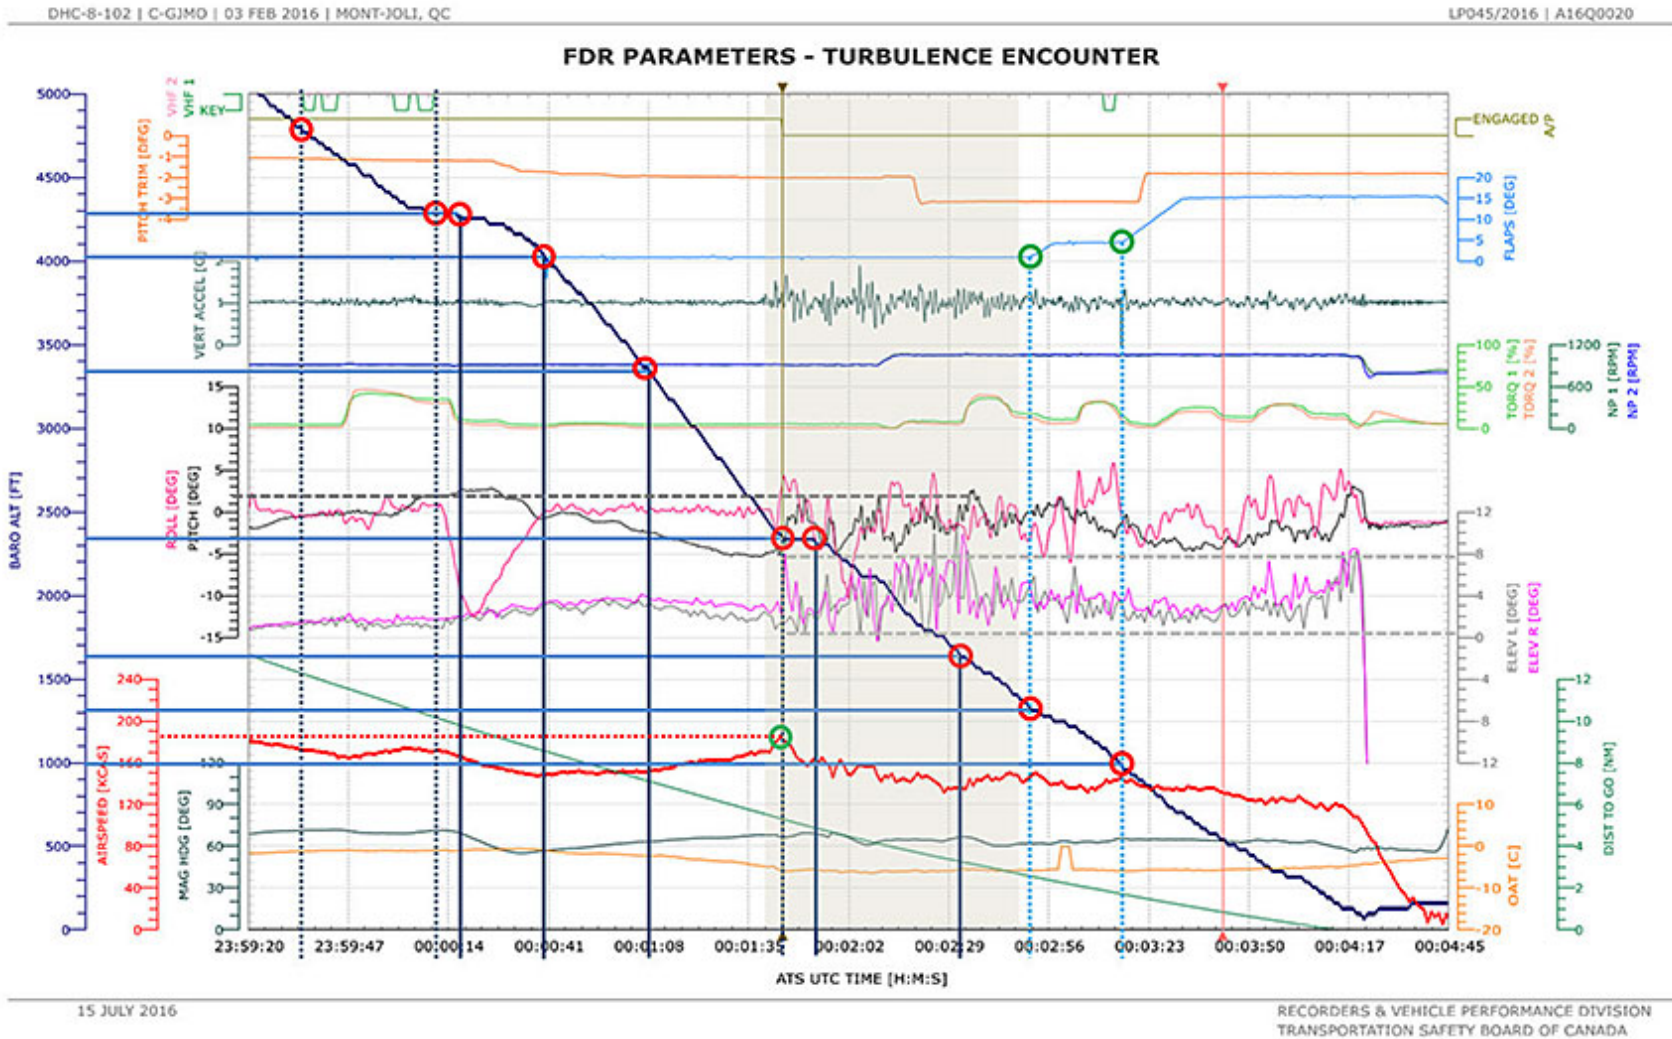
Appendix F – Flight data recorder data

At 2480 feet, the aircraft encountered moderate turbulence. The FDR data confirmed a sudden increase in aircraft oscillations, vertical acceleration up to 1.5g, and an abrupt 15-knot increase in airspeed in 2 seconds, leading to the  $V_{LE}$  overspeed to a maximum of 185 KCAS. No power change was observed during this period. Therefore, it can be concluded that the  $V_{LE}$  overspeed occurred because the aircraft encountered significant increased performance shear while flying out of a low-level jet with the autopilot engaged in vertical speed mode.

The limited FDR parameters do not include control column position or force and, therefore, do not allow for ruling out an elevator jam with FDR data exclusively. However, the FDR data shows considerable elevator movement, the PM observed control column movement, and the PF did not perceive any blockage of the elevator. Therefore, it is unlikely that an elevator jam occurred.
