# AVIATION INVESTIGATION REPORT

## A17Q0059

### **Collision with runway lights on landing**

BD-700-1A10, N888ZJ

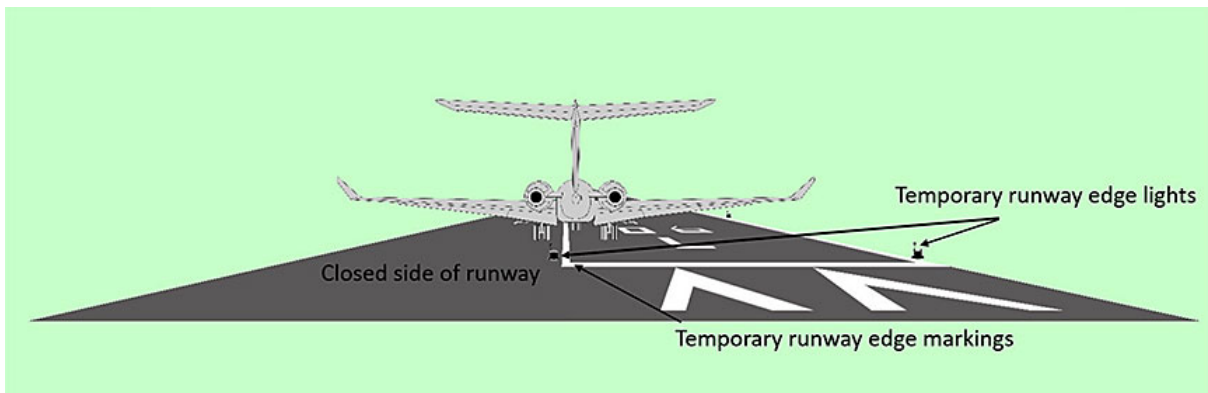
At 1054:38.5, the aircraft touched down 850 feet past the runway threshold, at which point the nosewheel was 36 feet to the left of the temporary runway centreline, i.e., 1.5 feet to the right of the temporary left edge of the runway. Therefore, the left main landing gear was about 5.2 feet outside the intended confines of the runway (Figure 1).

Figure 1. Aircraft position after landing, in relation to temporary runway edge lights and markings

Once on the ground, the crew realized that the aircraft had struck something. The PF corrected the aircraft's course to the right, and the aircraft came to a stop 300 feet from the end of the runway, slightly to the right of the reduced-width runway centreline. There were no injuries.

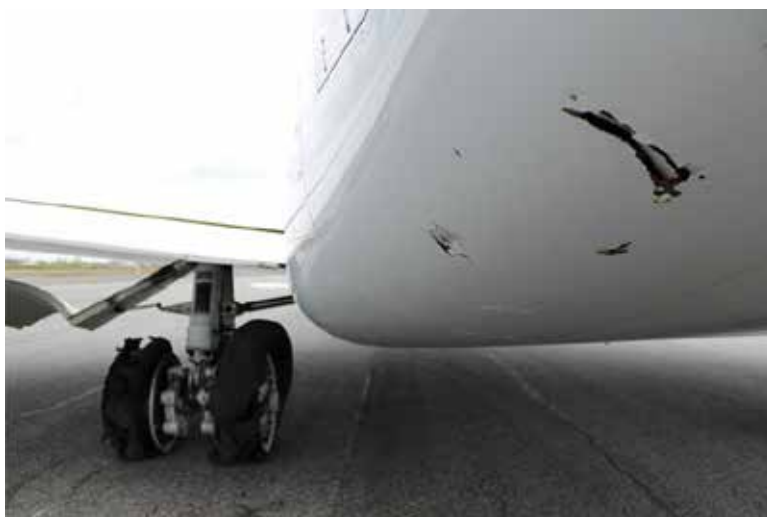
The 2 tires of the left main landing gear of the aircraft burst upon contact with the temporary runway edge lights, and the aircraft sustained substantial damage to the following areas:

- both left main landing gear wheels (Figure 2)
- the left landing gear door
- the top and bottom of the trailing edge panels of the left wing
- the left inboard flap as well as its actuating cylinder and torque tube
- the bottom of the left engine nacelle
- the rear centre fuselage, which was punctured by debris from the temporary runway edge lights (Figure 2)

Figure 2. View of damage to left main landing gear and rear centre fuselage

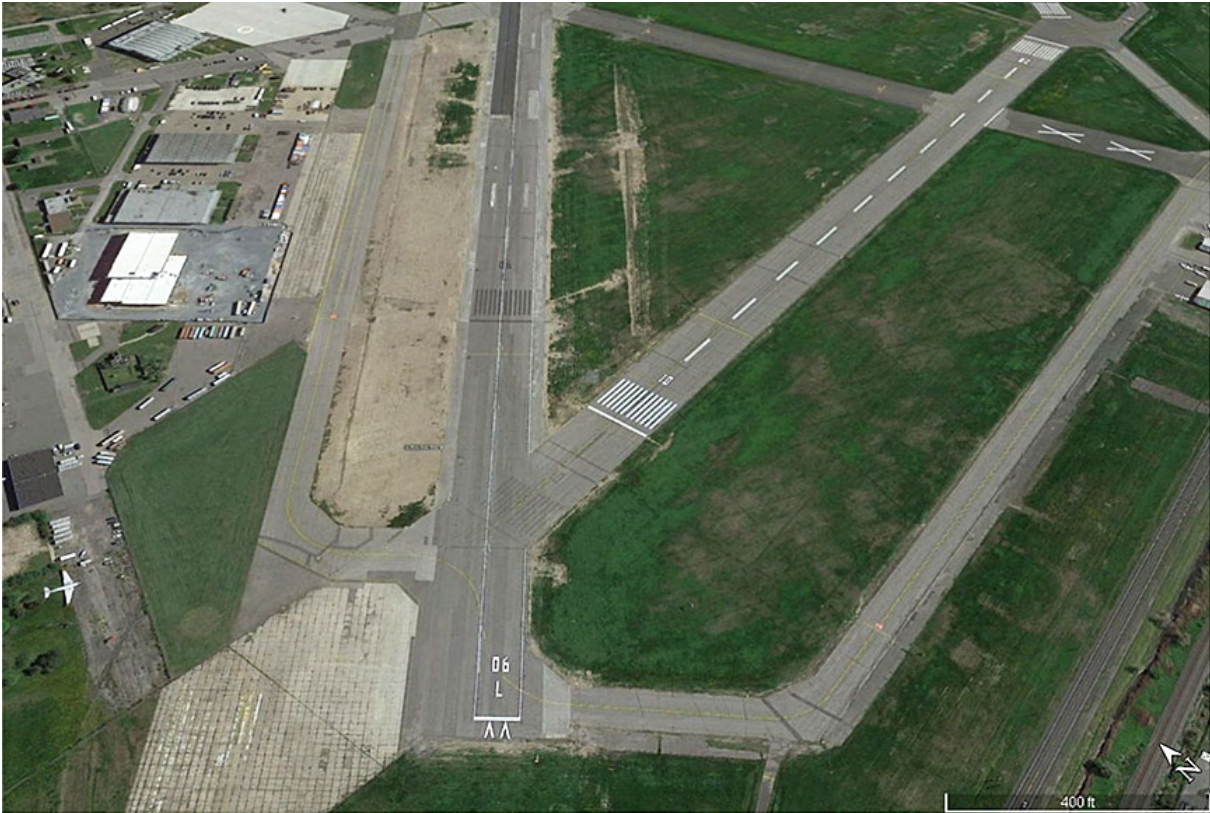
The temporary marking due to construction included an unbroken white line on each side and end of the runway to form a rectangle 75 feet wide by 5000 feet long around the south side of Runway 06L that was usable for landing, as specified in the PEC (Figure 3). The runway number was painted in white at the threshold of the part of the runway usable for landing, and 2 arrows, also painted in white, were placed just before the runway threshold, indicating the landing direction. The original painted touchdown zone and runway centreline markings were still visible, and the temporary left runway edge line overlapped the original runway centreline markings. As specified in the PEC,<sup>25</sup> there were no Xs on the ground for the closed half of the runway width.

Figure 3. Runway 06L markings at Montréal/St-Hubert Airport 4 days after the occurrence (Source: Google Earth)

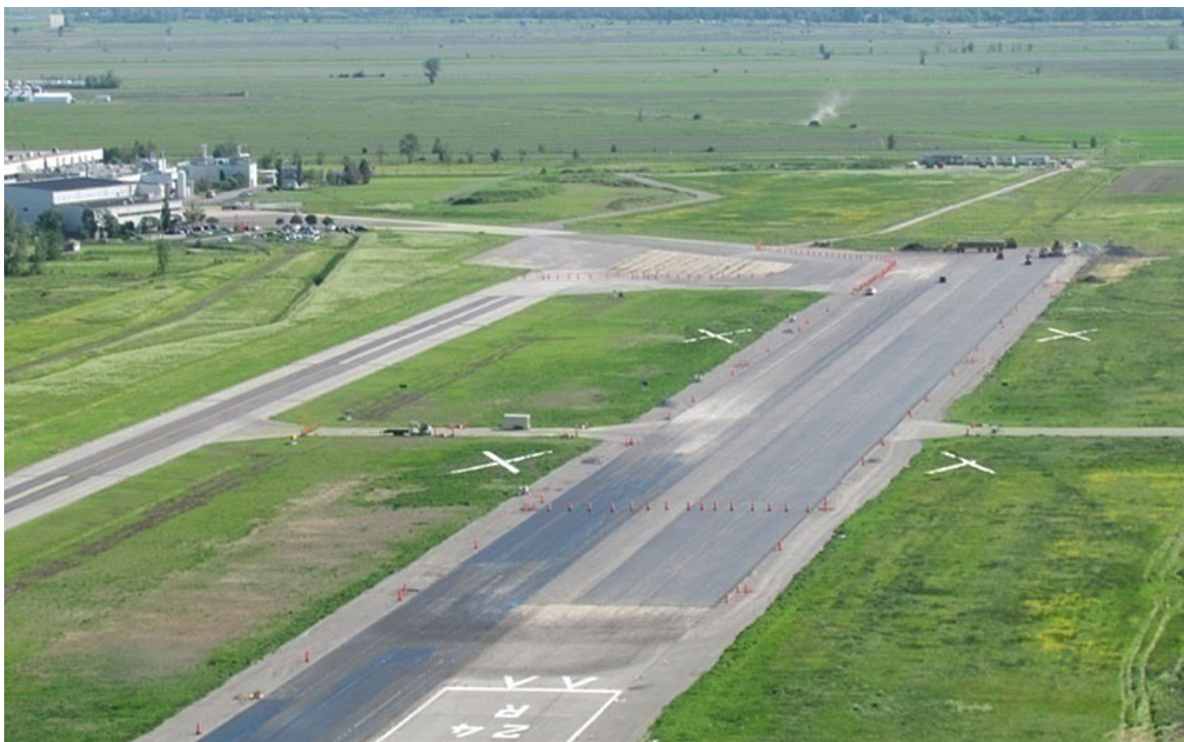
Orange cones had been placed after the end of the runway, across its entire width, to separate the part that was usable for landing from the closed portion of the Runway 24R threshold, where the construction equipment was located. In addition, 2 white Xs had been placed on each side of the last 2801 feet of Runway 06L; the entire width of this portion was closed (Figure 4).

Figure 4. Marking (orange cones and white Xs) on first 2801 feet of Runway 24R, indicating completely closed portion of runway

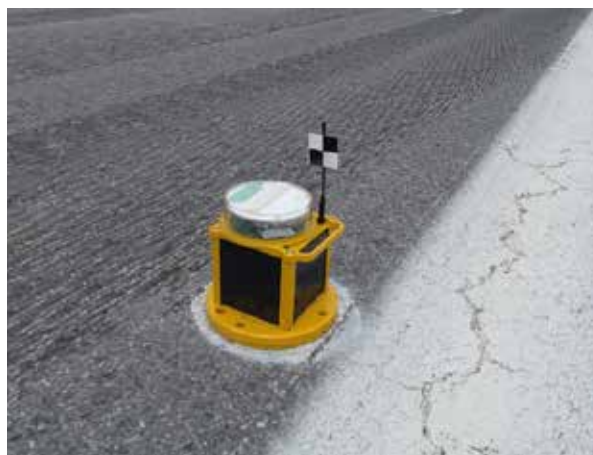
Figure 5. Temporary runway edge light

Despite the NOTAM indicating that Runway 06L/24R of CYHU was closed at night, temporary runway edge lights had been placed near each of the white lines delimiting the runway edges (Figure 5). These lights were not on at the time of the occurrence, and there was no requirement for them to be on.

Moreover, the temporary runway edge lights were not properly secured such that they were frangible, as specified in the *Plan d'exploitation durant une construction (PEC) 2017*,<sup>68</sup> nor were they fixed as specified in section 5.3.10.11 of TP 312.<sup>69</sup> As a result, when the main wheels of the left side of the aircraft struck the lights, the lights were displaced, damaged the rear fuselage, and caused the tires to burst. Debris from the tires also damaged the rear fuselage. If temporary runway edge lights are not properly secured, there is a risk that they will be displaced and damage aircraft during landings or takeoffs.

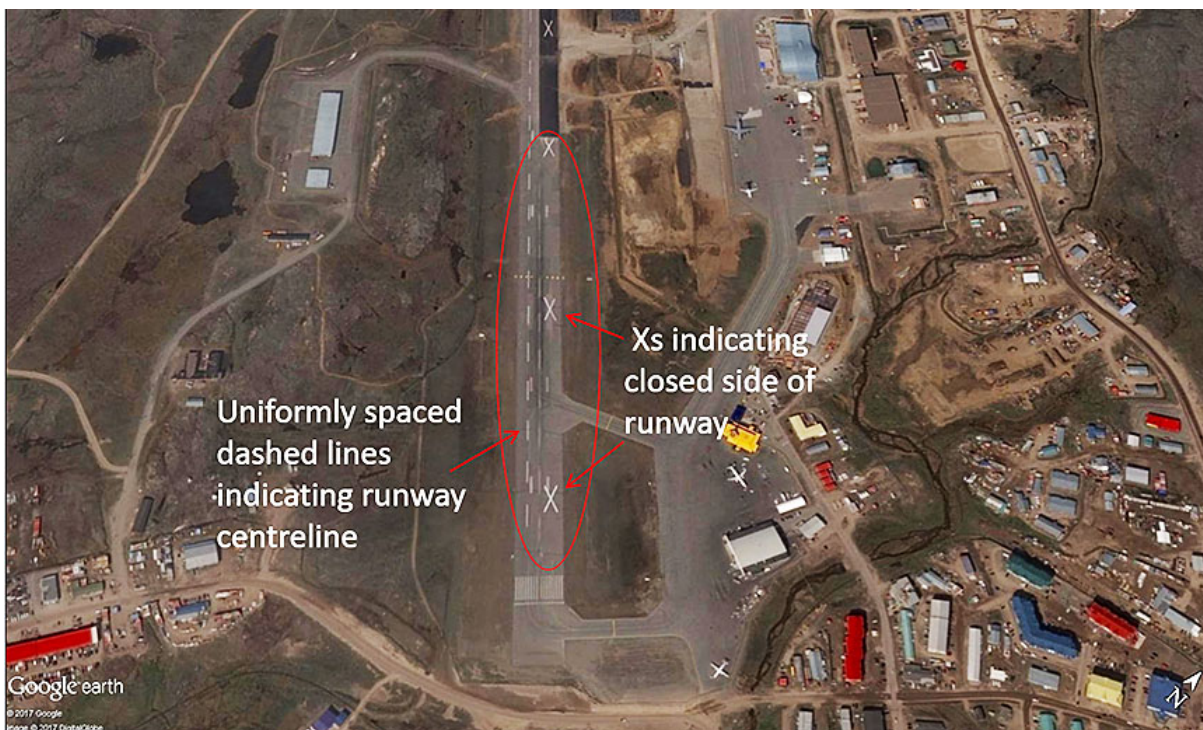
In 2015, Iqaluit Airport (CYFB), Nunavut, underwent work similar to the work at CYHU. The width of the runway was reduced along the entire length of the runway. White Xs indicated the closed side of the runway, and the centreline of the runway had been marked with uniformly spaced dashed lines (Figure 6).

Figure 6. Markings at Iqaluit Airport during construction work in 2015 (Source: Google Earth, with TSB annotations)

Although the marking was different at CYFB, there were 2 incidents<sup>45</sup> involving runway edge lights being struck during construction, on 08 and 11 July 2015. In both of these cases, a Boeing 737-200 was conducting an IFR flight to CYFB. Because of the construction work, half of the entire length of the runway at CYFB had been closed by means of a NOTAM. Temporary lights were placed along the edge of the runway, uniformly spaced dashed lines indicated the runway centreline, and Xs had been placed along the entire length of the closed portion of the runway.
