Air Transportation Safety Investigation Report A18A0053

LOSS OF CONTROL AND COLLISION WITH WATER

de Havilland DHC-2 Mk. I (Beaver), C-FCOO
Goose (Otter Creek) water aerodrome, Happy Valley-Goose Bay, Newfoundland and Labrador
11 July 2018

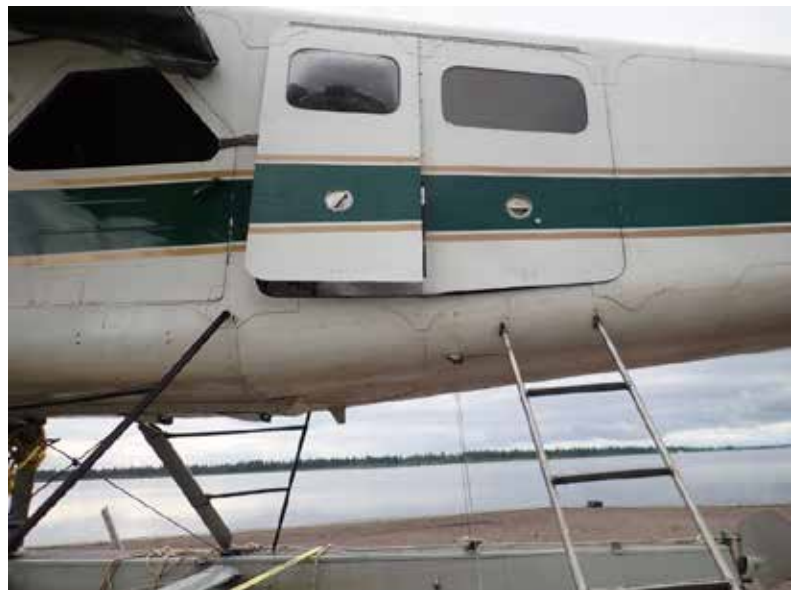
Although the training pilot was unable to open the Alaska cargo door (see "Alaska door" section) from the inside, the trainee was able to open the Alaska door from the outside, which allowed the training pilot to exit the aircraft.

The Alaska door modification is a supplemental type certificate available from Sealand Aviation Ltd. to enlarge the opening to the aircraft’s cargo area. It consists of 2 doors mounted side by side to facilitate the loading and unloading of bulky cargo through an opening of 52 inches by 42 inches when both are open (Figure 1). The rear door can be opened independently to enable access behind the passenger seats.

The Alaska door was designed in 1990, and approximately 185 have been installed on aircraft. The door modification did not originally include an interior door release latch because the manufacturer considered that this area would be separated from the passenger compartment by a cargo net and would therefore not be accessible from the inside. Prior to this occurrence, the manufacturer recognized that the door could

Figure 1. Alaska door on the occurrence aircraft (Source: J. Cooper)

serve as an additional exit and is working with a design approval representative⁸ to have an approved inside door latch available.

Aircraft manufacturers have designed modifications that may assist in exiting an aircraft following an accident, such as changes to the door latches and the passenger push-out windows. The manufacturer of the Alaska door has recognized the benefits of having an inside door latch, as this modification would provide an extra egress point.
