## **AIR TRANSPORTATION SAFETY INVESTIGATION REPORT A18Q0069**

### **LOSS OF SEPARATION**

NAV CANADA – Montréal Area Control Centre  
Montréal/Pierre Elliott Trudeau International Airport, Quebec, 18 nm NE  
16 May 2018

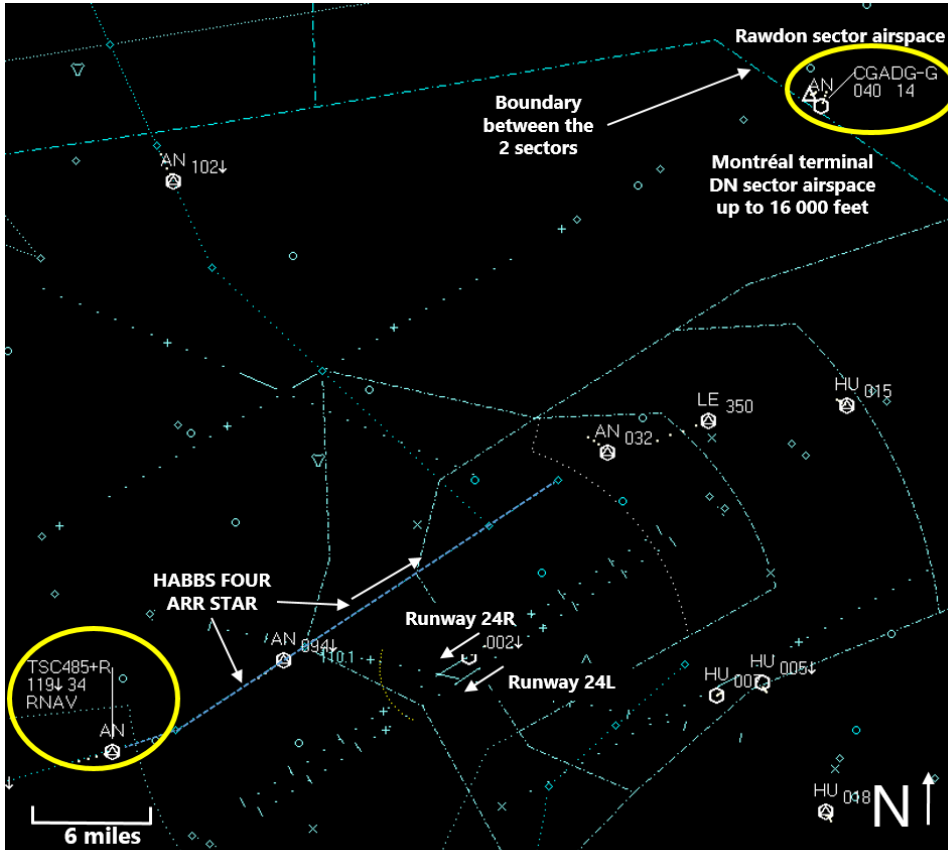
At 1854:20, the Cessna entered the Montréal terminal DN sector airspace, approximately 34 nm northeast of the airport, flying at 4000 feet. At the same time, the Airbus was approximately 18 nm west of CYUL, descending through 11 900 feet to 8000 feet (Figure 1).

Figure 1. Close-up view of the Canadian Automated Air Traffic System Situation Display for the Montréal terminal specialty airspace, showing the Cessna (C-GADG) entering the Montréal terminal DN sector airspace at 4000 feet. The Airbus (TSC485) is 18 nm west of the airport. (Source: NAV CANADA, with TSB annotations)

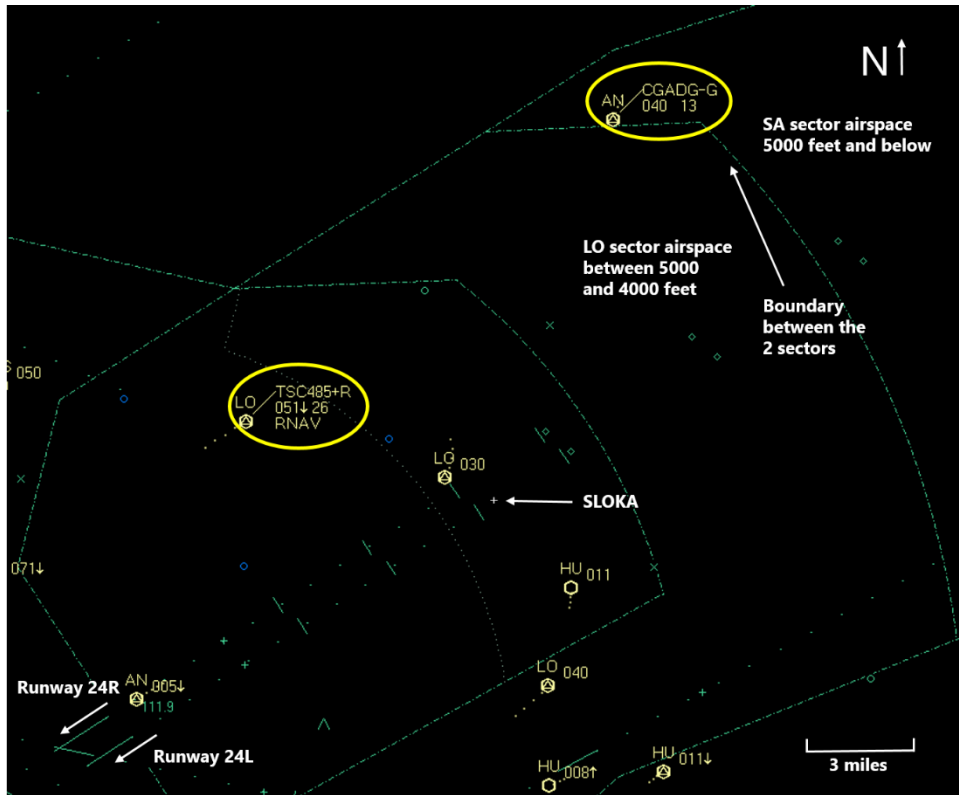
At 1859:30, the Cessna entered the LO sector approximately 23 nm northeast of the airport, heading toward the SLOKA intermediate fix at 4000 feet. The Airbus was approximately 10 nm northeast of the airport, descending to 4000 feet and flying in a northeasterly direction (Figure 2).

Figure 2. Close-up view of the Canadian Automated Air Traffic System Situation Display for the Montréal terminal specialty airspace, showing the Cessna (C-GADG) entering the Montréal terminal LO sector airspace at 4000 feet, flying directly to the SLOKA intermediate fix (Source: NAV CANADA, with TSB annotations)

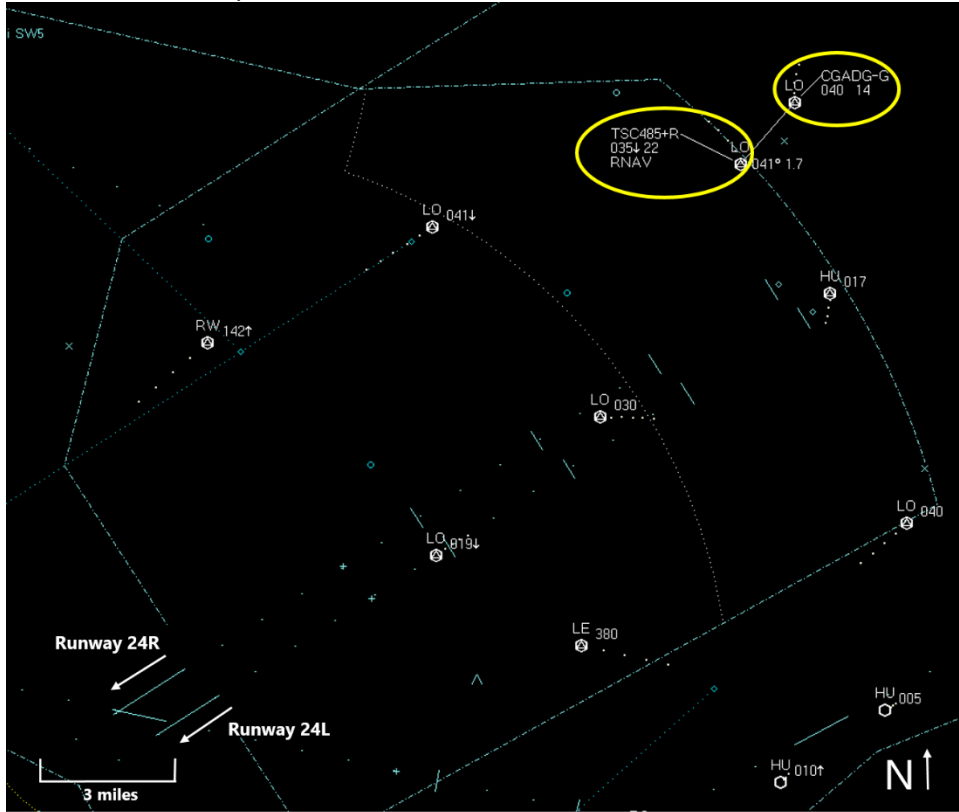
At 1901:17, a loss of separation between the Airbus and Cessna occurred. The aircraft were 200 feet and 2.8 nm from each other, closer than the required minimum separation of 1000 feet vertically<sup>15</sup> or 3 nm laterally.<sup>16</sup>

At 1901:46, when the Airbus was turning right and descending through 3500 feet, the Cessna was turning left at 4000 feet. At that time, the 2 aircraft were separated by 1.7 nm and 500 feet, which is the closest laterally the 2 aircraft came to one another (Figure 3).

Figure 3. Close-up view of the Canadian Automated Air Traffic System Situation Display for the Montréal terminal specialty airspace, showing the Airbus (TSC485) turning right and descending through 3500 feet while the Cessna (C-GADG) is turning left in level flight at 4000 feet. The 2 aircraft are 1.7 nm and 500 feet apart (Source: NAV CANADA, with TSB annotations)

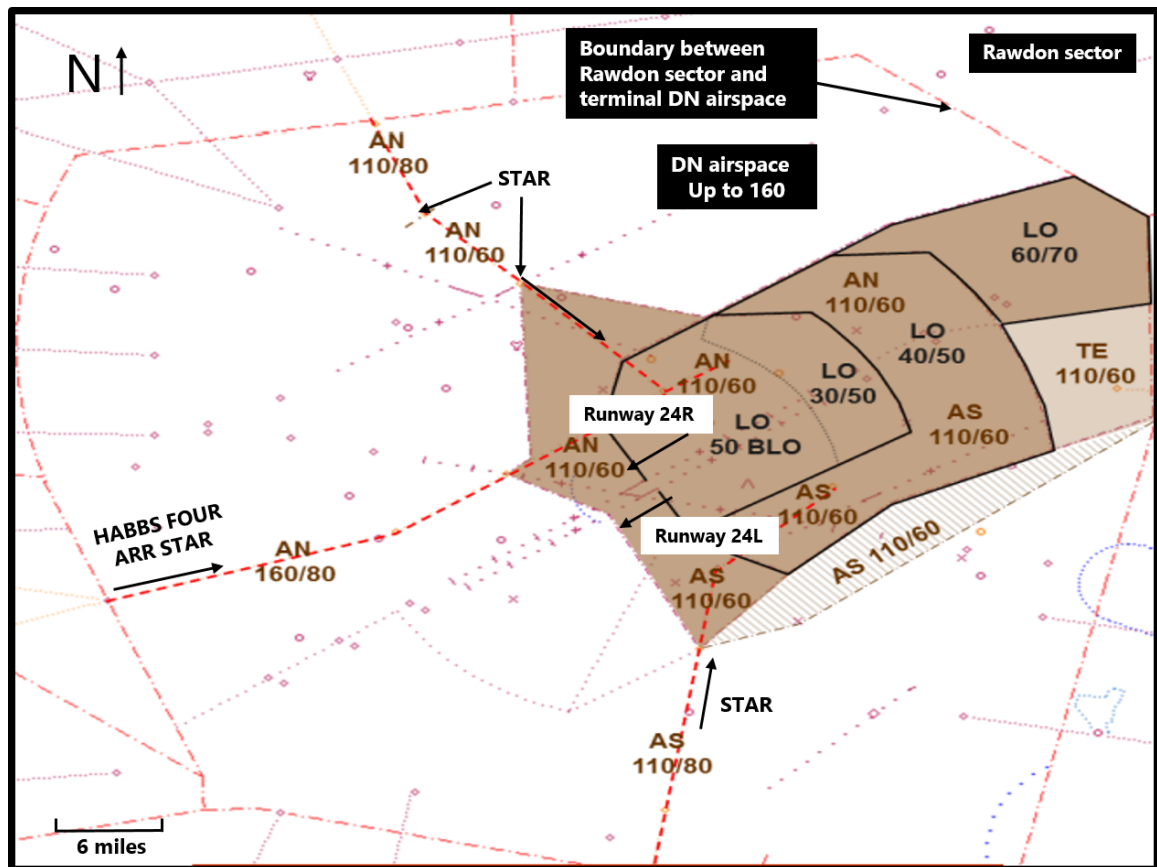
Figure 4. Montréal terminal arrival airspace when runways 24R and 24L are the active arrival runways (Source: NAV CANADA, Montreal Terminal Operations Manual, with TSB annotations)
