AIR TRANSPORTATION SAFETY INVESTIGATION REPORT A18Q0186

COLLISION WITH TERRAIN

Eurocopter EC120B (helicopter), C-FSII
Sainte-Agathe-des-Monts, Quebec, 5 NM W
19 November 2018

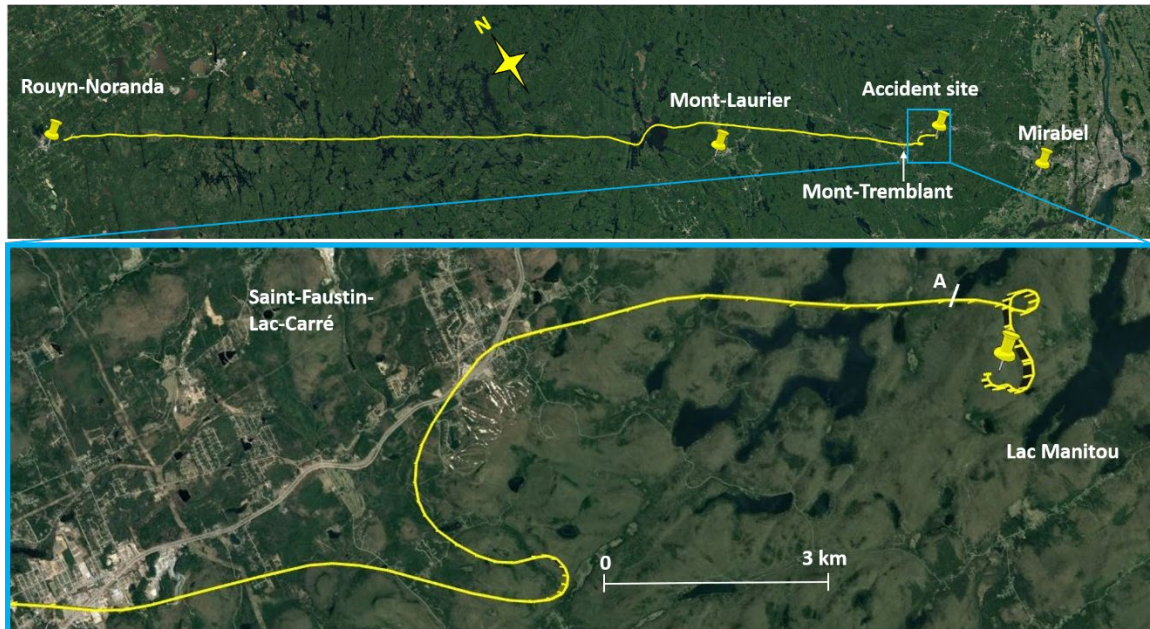
Figure 2. C-FSII's flight path, according to GPS data (upper panel), with enlargement of the accident site (lower panel) (Source: Google Earth, with TSB annotations. Source of map data: Landsat / Copernicus)

The Garmin Aera 796 portable GPS was found and analyzed. Navigational information pertaining to recent flights, including the occurrence flight, was successfully extracted by TSB laboratory specialists. The data show that the flight path was primarily a straight line at an average altitude of 1000 feet AGL proceeding toward Mont-Tremblant, Quebec (Figure 2).

Once the flight had passed to the southeast of Mont-Tremblant, the student pilot flew a path that was no longer linear, and the average altitude was reduced to 900 feet AGL initially, then 500 feet AGL after point A in Figure 2. GPS data indicated significant variations in ground speed and altitude AGL before the impact (Figure 3). The last turn was made while descending at an average rate of 475 feet per minute. The GPS recorded the last data at 1232:54, close to the site of the crash.

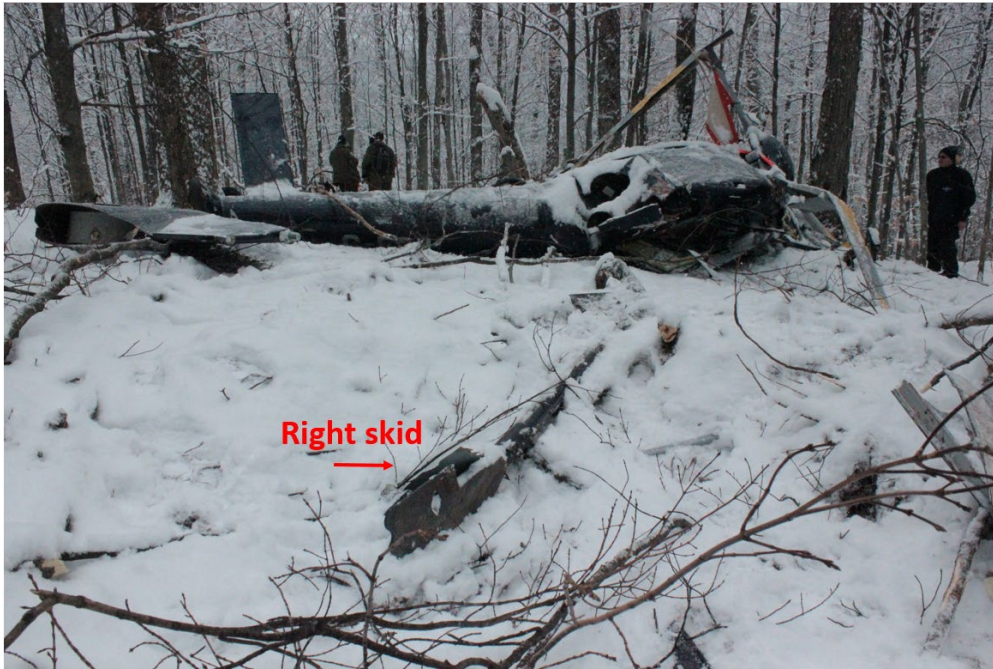
Figure 4. Wreckage of C-FSII (Source: TSB)

The aircraft was found lying on its right side (Figure 4). The doors and roof had been torn off as the helicopter descended through the trees. The instrument panel had been torn off and was found pinned under the nose of the helicopter, which was seriously damaged. The main mast and rotor head were still attached to the main gearbox and, like the engine, exhibited little visible damage. The damage to the main rotor blades was consistent with impact during rotation under power. Although it was damaged, the tail boom was still attached to the fuselage. The aft (fenestron) rotor and its protective cover had been separated from the tail boom following impact with a tree.

The fact that the right skid was found approximately 16 feet from the wreckage and the amount of damage to the cockpit floor suggest that the helicopter hit an initial point of impact, then bounced, and finally came to a stop lying on its right side, approximately aligned with the helicopter's flight path. Signs of impact with the treetops were visible along the flight path, starting approximately 85 feet from the wreckage. The angle of impact was estimated at 16° on a heading of 120° magnetic.

Upon arriving at the crash site, more than 45 hours after the accident, TSB investigators found slight indications of icing on the leading edge of one of the main rotor blades. However, they did not find any other indications of icing on the wreckage.

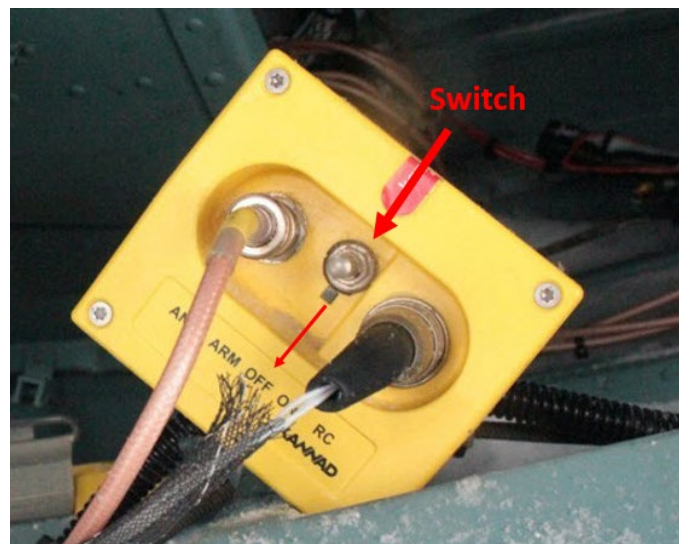
Figure 5. C-FSII's ELT, as it was found after the accident, in the OFF position (Source: TSB)

The initial examination of the wreckage at the accident site revealed that the ELT did not appear to be damaged and was still attached to its support. The switch on the ELT was set to the OFF position (Figure 5).

The investigation was unable to determine why the switch was set to the OFF position.
