## **AIR TRANSPORTATION SAFETY INVESTIGATION REPORT A19C0070**

### **POWER LOSS OF BOTH ENGINES ON INITIAL CLIMB**

North Star Air Ltd.  
Douglas DC-3C Basler Turbo Conversions TP67, C-FKGL  
Eabamet Lake, Ontario  
21 June 2019

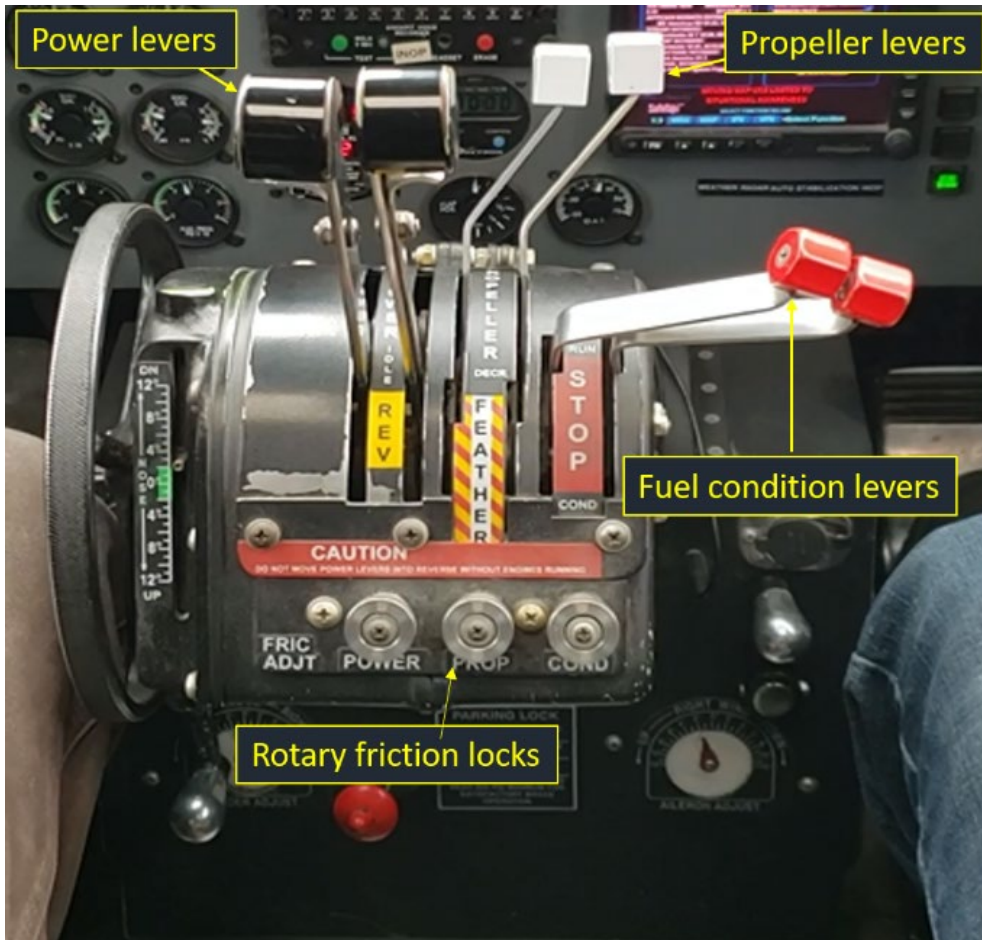
Figure 2. Picture of the throttle quadrant showing the power levers, propeller levers, fuel condition levers and rotary friction locks (Source: TSB)

There is one set of levers for each engine and associated propeller. Both pilots have functional reach to all sets of levers. The design uses varied colours, sizes, and shapes to facilitate visual and tactile identification. A colour and shape coding and grouping for these levers is common throughout the industry.

The fuel condition levers in this aircraft are offset to the right of the quadrant and angled toward the right seat. The offset is to ensure that these levers do not interfere with the

propeller levers. The fuel condition levers stop fuel flow to the engines when they are moved into the down position (STOP). To allow fuel feed to the engines, the fuel condition levers are placed in the up position (RUN) and are secured in that position by means of a gate. The design of the fuel condition levers requires the flight crew to make a dual-axis motion; to bring down each fuel condition lever from the gate, a pilot needs to shift the lever slightly to the left and then down. With this design, it is possible to move both fuel condition levers at the same time with one hand.

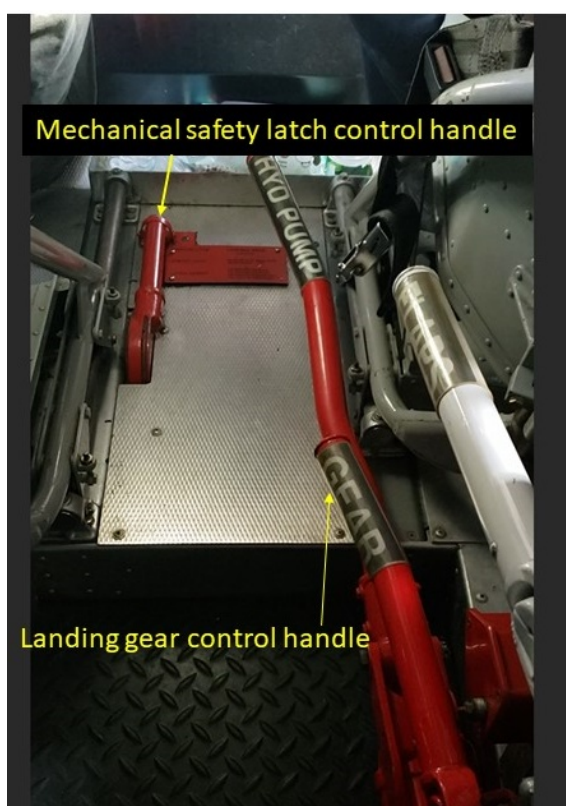
Figure 3. Main landing gear control handle and mechanical safety latch control handle  
(Source: TSB)

The position of the handles can present ergonomic challenges, as some pilots may need to bend over and/or rotate sideways to reach the handles. When the left-seat pilot is tasked with raising the landing gear, they unlatch the mechanical safety latch control handle by pressing down on the handle with their right hand and pushing the safety latch forward with a finger. Next, the left-seat pilot pulls the handle up. He then rotates inboard at the waist to reach back and lift the landing gear control handle with one hand (the right hand).

The left-seat pilot could use their left hand to steady themselves; however, there is no dedicated handle or recommended position for the left hand to grasp while reaching back

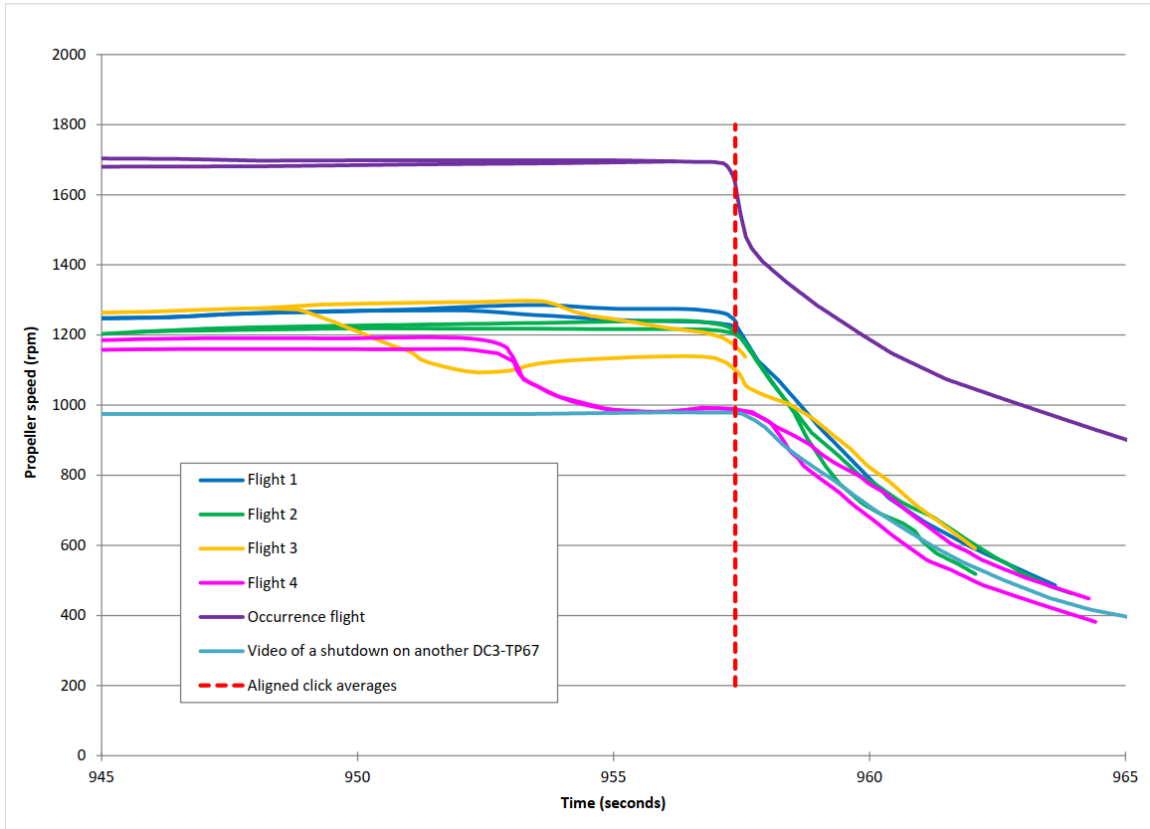
Figure 4. Comparison of propeller speed decays during the occurrence flight, the 4 previous normal engine shutdowns, and a video of a shutdown performed on another North Star Air DC3-TP67 against a common time point (Source: TSB)

A rapid reduction in propeller speed shortly after liftoff was noted in the occurrence flight. No split in propeller speeds between engines was observed as the propeller speed decreased, suggesting a simultaneous loss of propeller speed on both engines.

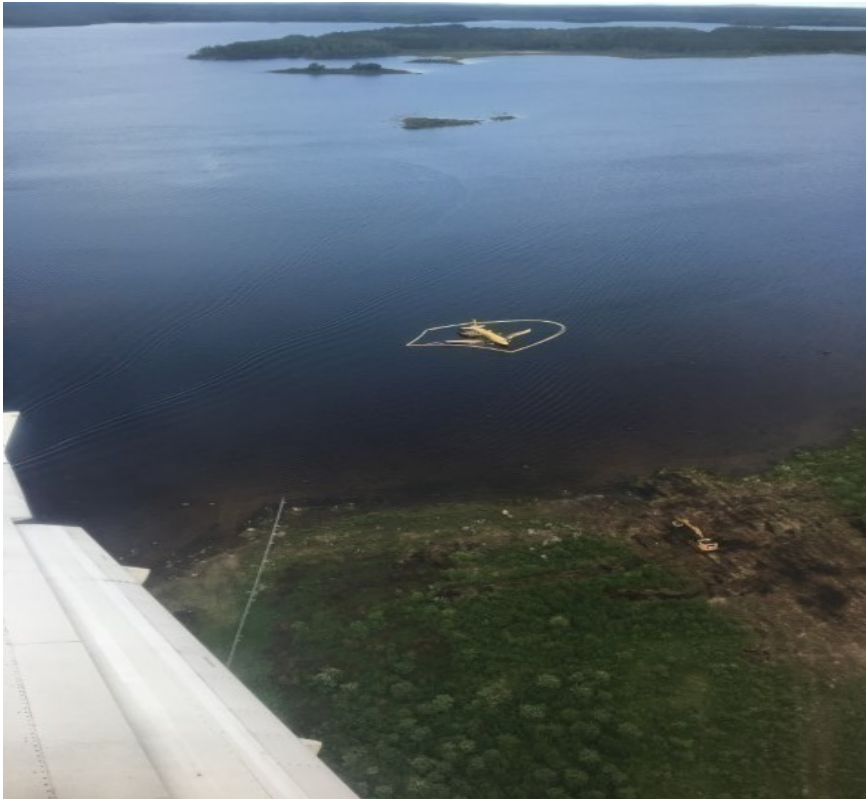
Figure 5. Occurrence aircraft on Eabamet Lake during recovery (Source: Pratt & Whitney Canada)

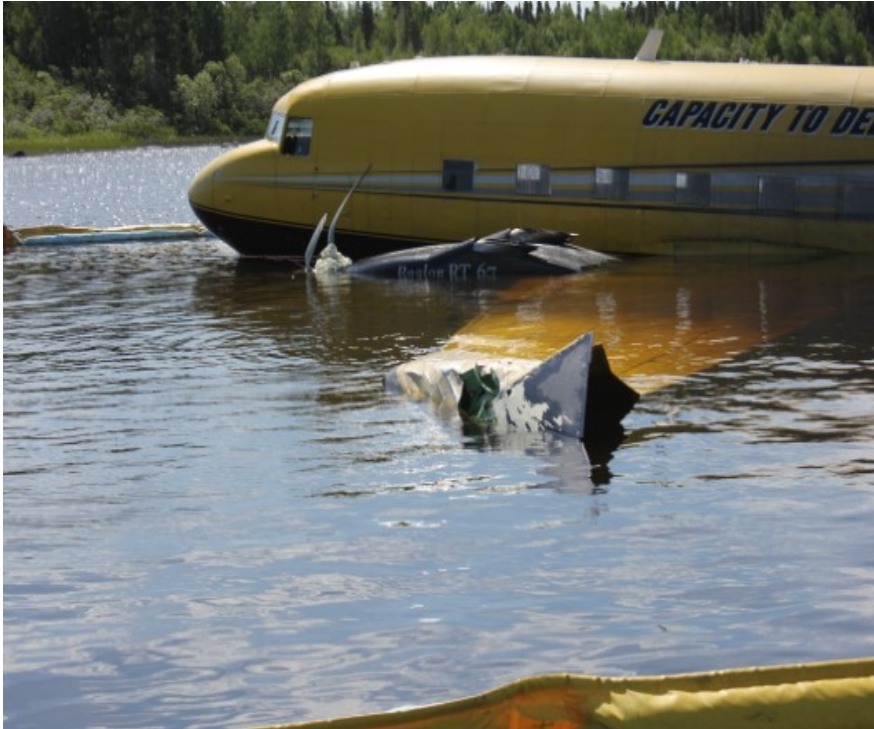
Investigators attended the scene while the aircraft was partially submerged and conducted an examination of the aircraft (Figure 5). The leading edge of the left wingtip had crush damage consistent with the left wing striking the water (Figure 6).

Figure 6. Occurrence aircraft's left wingtip, with crush damage (Source: TSB)

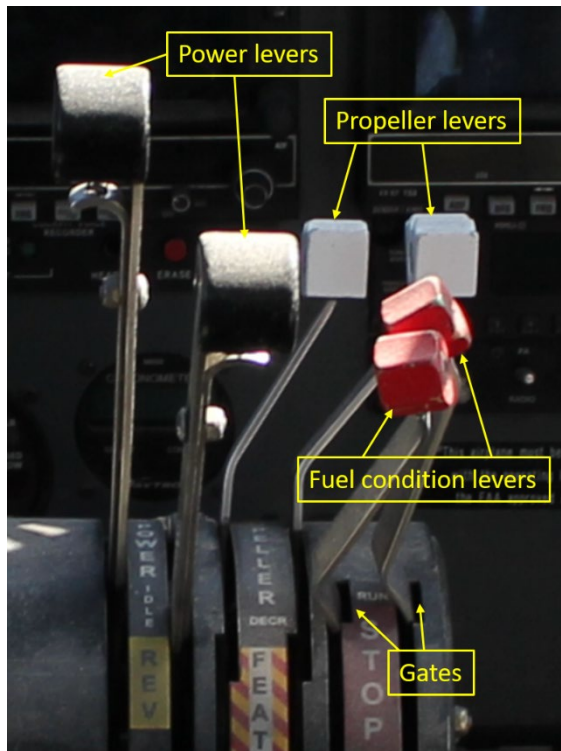
Initial examination of the throttle quadrant (Figure 7) indicated the following:

- The left power lever was in the forward position.
- The right power lever was in the IDLE position.
- The propeller levers were fully forward.
- The left and right engine fuel condition levers were bent and fully forward, but not in the gates.
- Quadrant control friction locks were applied to the engine controls and were in a serviceable condition.

A continuity check of the throttle quadrant controls to their applicable engine control accessories was completed, with no defects found.

Figure 7. Throttle quadrant with the levers and gates labelled (Source: TSB)
