AIR TRANSPORTATION SAFETY INVESTIGATION REPORT A19C0145

CONTROLLED FLIGHT INTO TERRAIN

Douglas DC3C Basler Turbo Conversions TP67, C-FKAL

03 December 2019

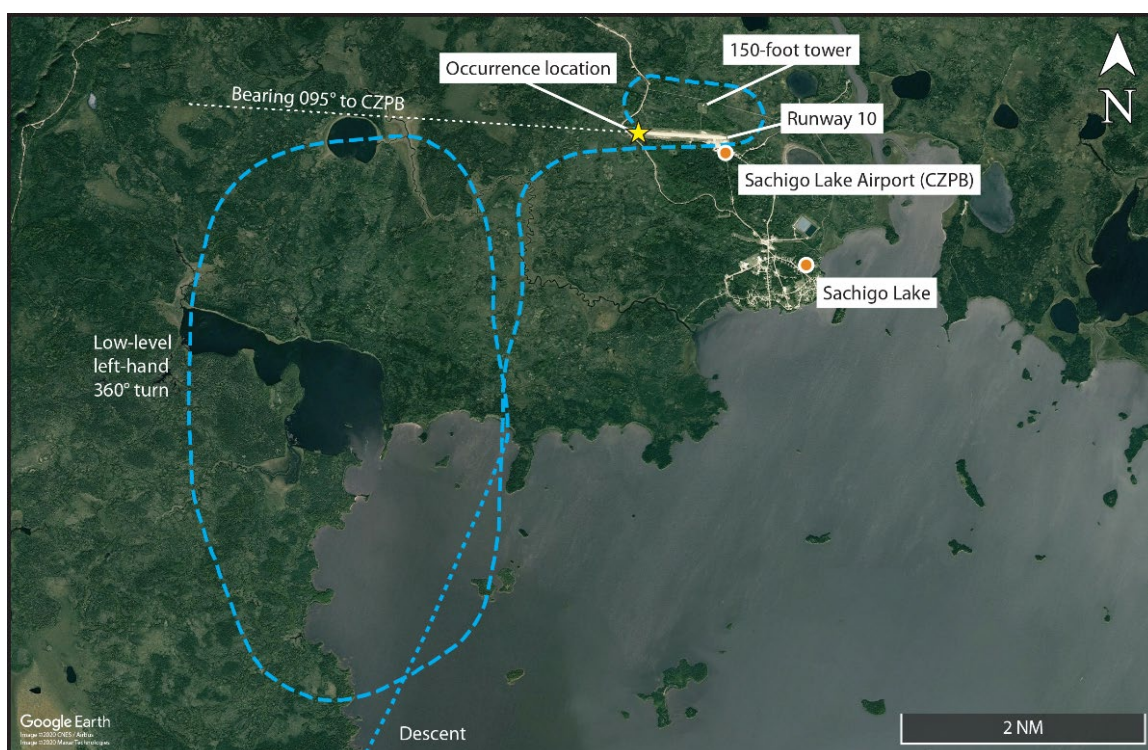
Figure 1. Map showing the initial descent (small-dash line) and the low-level flight path (big-dash line) of the occurrence aircraft (Source: Google Earth, with TSB annotations based on automatic dependent surveillance-broadcast data)

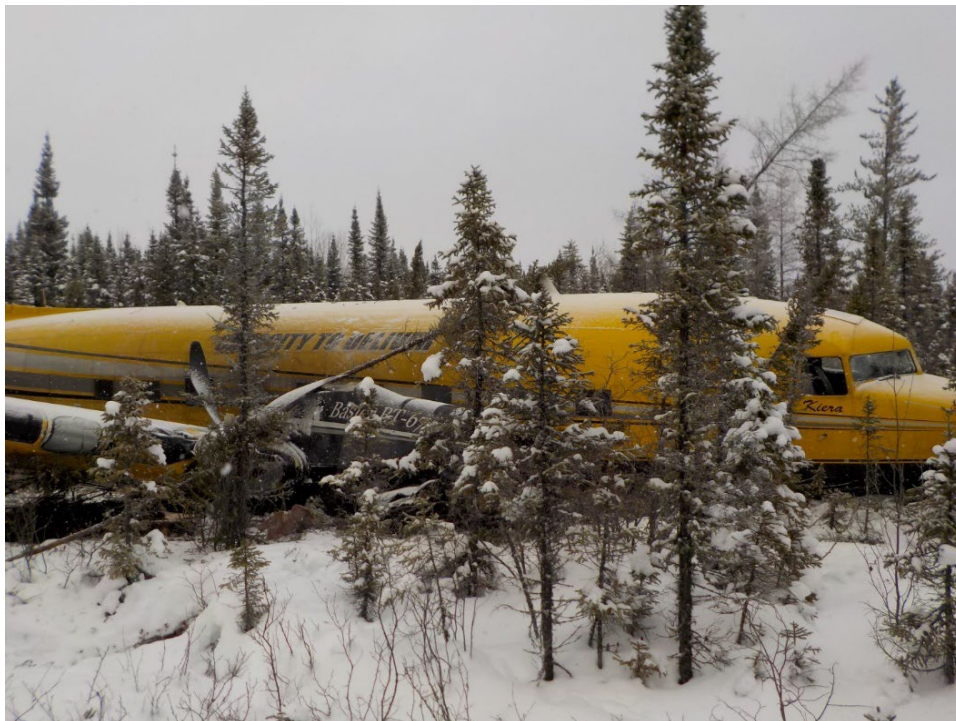
Figure 2. Occurrence aircraft wreckage (Source: Nishnawbe Aski Police Service)

The landing gear, wings, and tail sustained extensive damage, and the fuselage was buckled and damaged from impact with trees. The propellers, which separated from the engines, showed damage consistent with the engines producing substantial power on impact. No fuel leakage was evident.

The investigation could not determine how much ice had accumulated on the aircraft during the occurrence flight. However, the investigation was able to determine, based on the pattern of remaining ice, that the wing de-icing boots had been operated during the occurrence flight.

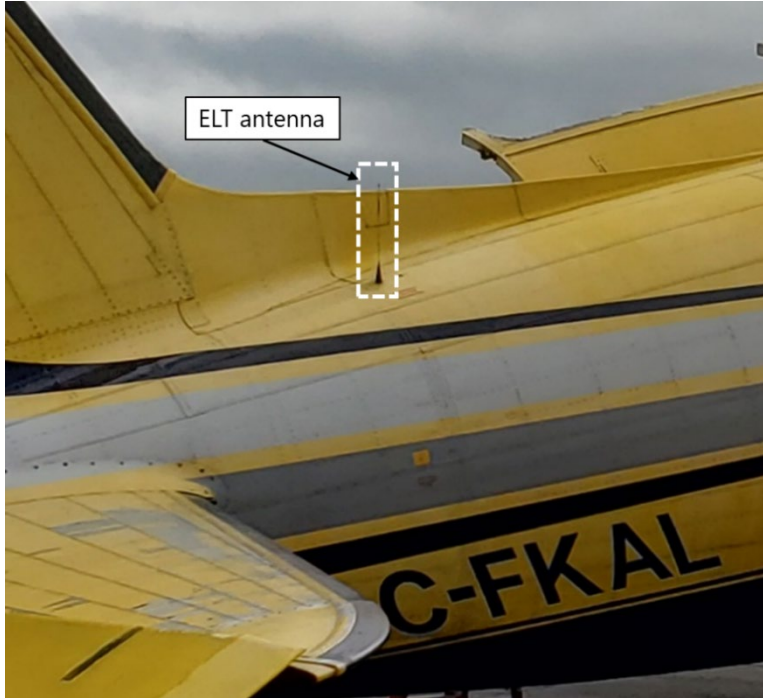
The 406-MHz emergency locator transmitter (ELT) activated; however, the whip antenna had been ripped off during the impact sequence and no signal was detected by the search and rescue satellite system. The TSB had previously recommended that Transport Canada (TC) establish more rigorous ELT system crash survivability requirements, and TC has since implemented updated regulations for new ELT design approvals; however, those requirements do not apply to legacy ELTs like the one the occurrence aircraft was equipped with. If aircraft operate with ELTs approved under legacy design standards, there remains a risk that potentially life-saving distress signals will not be detected because of damage caused to the ELT system during an accident.

below the dorsal fin (Figure 3), was ripped off the aircraft during the impact sequence. As a result, the ELT's distress signal was not detected by the SAR satellite system.

Figure 3. Photo of the occurrence aircraft emergency locator transmitter antenna location before the occurrence (Source: TSB)

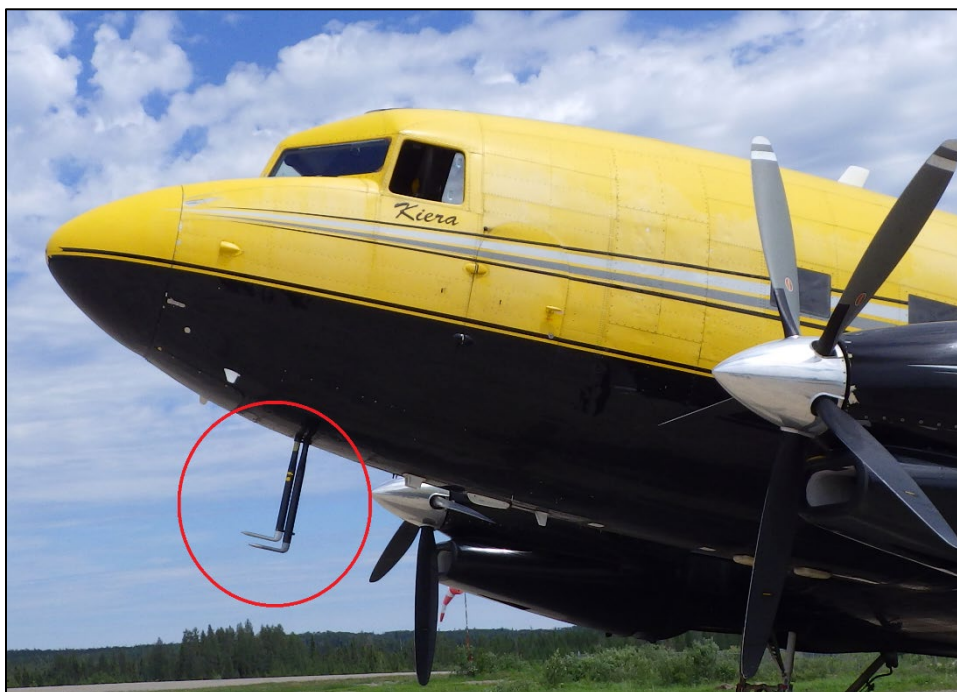
The DC3-TP37 aircraft's air data system uses pitot-static tubes to measure altitude. The tubes are mounted on very long supports that hang unusually low below the fuselage, by about 2 feet (Figure 4). They are vulnerable to damage if there is any contact with treetops.

Since the air data system requires precision calibration to measure altitude correctly, damage to the pitot-static tubes could lead to erroneous altitude measurements.

Figure 4. Pitot-static tubes on a DC3-TP67 aircraft (Source: TSB)

The investigation determined that it is highly likely that the erroneous altitude data in the final seconds of the flight was the result of damage to the pitot-static tubes from contact with treetops north of the runway clearing. The aircraft did not subsequently climb away and it impacted the ground and road adjacent to the runway perimeter fence.
