AIR TRANSPORTATION SAFETY INVESTIGATION REPORT A19Q0109

MAIN ROTOR BLADE FAILURE IN FLIGHT

Robinson R44 (helicopter), C-FJLH

10 July 2019

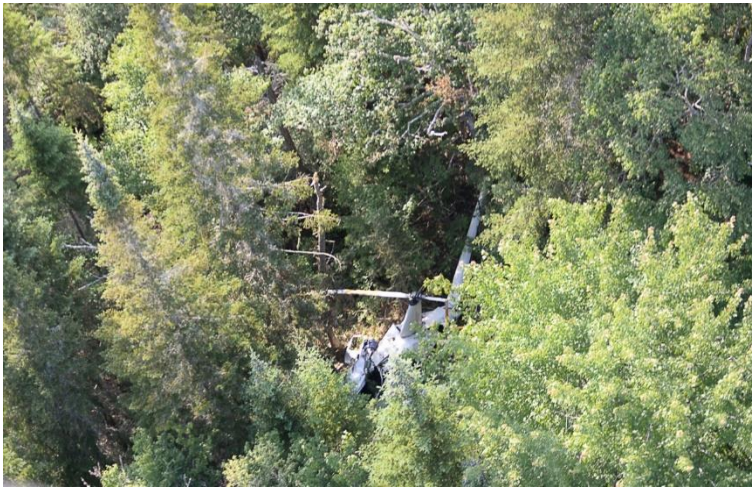
Figure 6. Aerial view of C-FJLH (Source: Sûreté du Québec)

The aircraft was found in a vertical position on a rocky outcrop in a densely wooded area (Figure 6). The landing gear, the cabin roof, and the floor at the front of the cabin had collapsed. The windshield had shattered; the rear doors and the door on the pilot side had ejected, leaving only the passenger door still attached to its frame. The seat backs had collapsed backward and the seat cushions had sunk down. The front passenger safety belt, which included a lap belt and a shoulder harness, was found undone. There was fuel in both tanks.

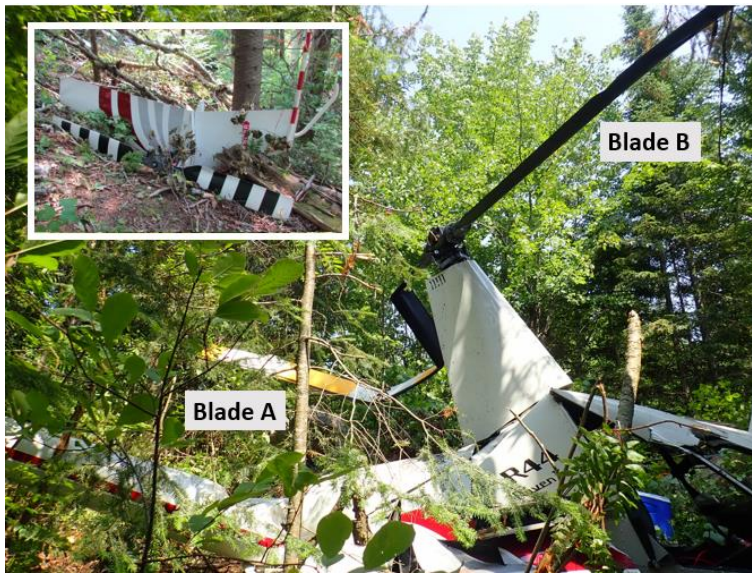
Figure 7. Main rotor and tail rotor assembly (Source: TSB)

The main rotor mast and rotor head were still attached to the main gearbox. The main rotor drive belts were in good working order and the belt tensioning mechanism was in the taut position. The main rotor blades did not show signs of the damage that is typically sustained on impact when the blades are rotating. One of the blades (blade A) was bent in several locations while the other blade (blade B) was straight but fractured at the tip (Figure 7).

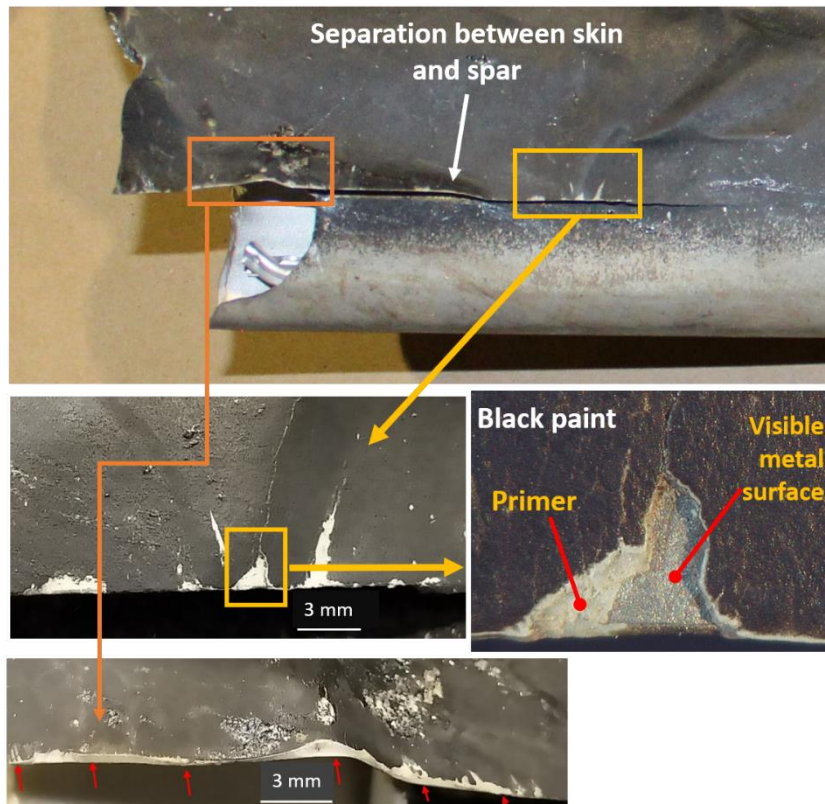
Figure 9. Enlargement of visible metal surfaces (Source: TSB)

Close visual observation revealed that the metal surface of the joint was visible in a few locations along the spar near station RS161. Signs of debonding and gaps in the skin at the spar bonding joint were also noted. Although the lower skin had debonded from the spar after fracturing, the enlargement of these areas shows that air had caused the paint and its underlying layer to erode over time, and that the erosion was not the result of paint suddenly chipping as the skin separated at the spar bonding joint (Figure 9). It is likely that the metal surfaces in these areas would have been visible and detectable before takeoff of the occurrence flight in optimal observation conditions allowing such details to be seen. The visual pre-flight inspection should be done in adequate lighting and at a suitable distance for signs of debonding to be identified, which may require equipment such as a stepladder and a flashlight.

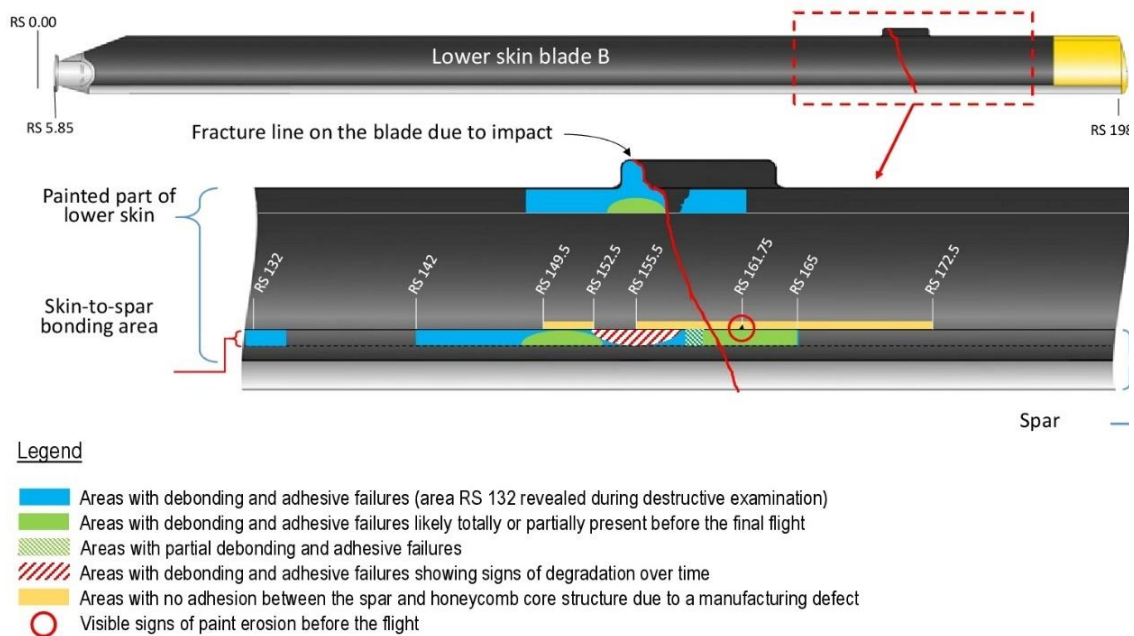
Figure 10. Various areas where debonding was present (Source: TSB)

A destructive inspection of the blade was performed to confirm the observed debonding of the skin. Separation of upper and lower skin samples confirmed the presence of several adhesive failures, of variable sizes, between stations RS132 and RS165 (Figure 10).

The examination revealed that, in some areas, debonding of the skin had allowed humidity to infiltrate below the skin and weaken the adhesion to the bonding joint over time.

In addition to the adhesive failures, there were several places where the adhesive on the surface between the honeycomb core structure and the trailing edge of the spar did not have the usual imprints found when there is contact between them. This was true over a cumulative length of 20 inches (yellow area), indicating that the condition had been present since the blade was assembled and was the result of a manufacturing defect.

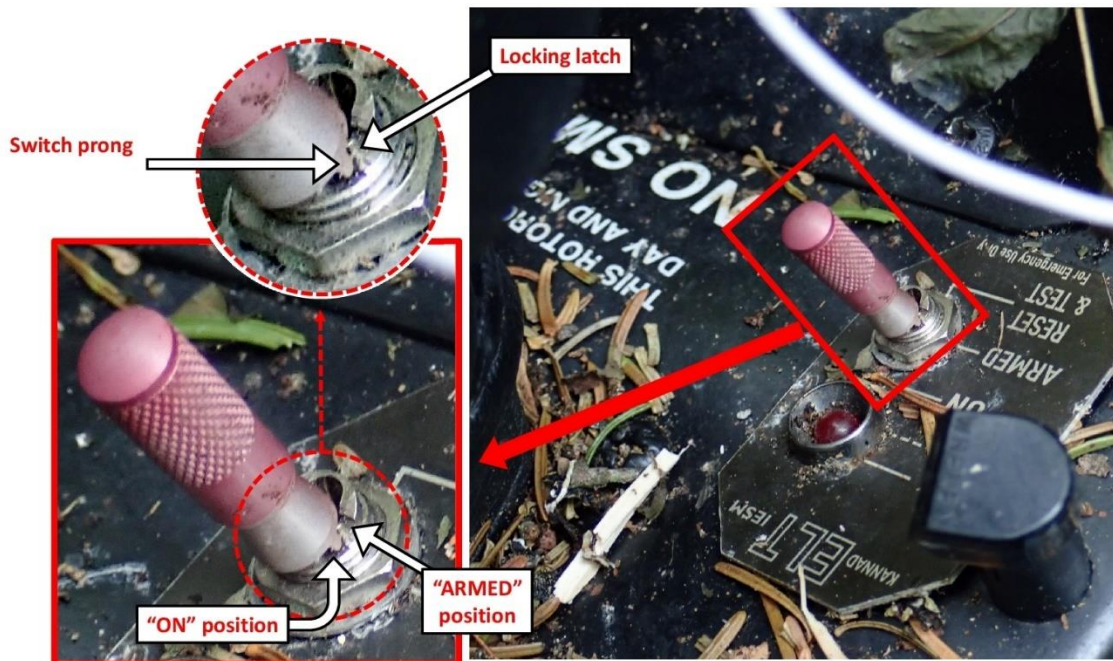
Figure 12. Remote control panel located between the two front seats (Source: TSB)

Upon initial examination of the wreckage at the accident site, the ELT did not appear to be damaged. Although it was no longer in its mounting bracket because the holding strap had broken, the ELT was still attached to the antenna by its wire. The antenna and wire showed no apparent signs of significant damage. The ELT switch was found in the OFF position and the switch on the remote control panel was found in the ON position (Figure 12).

The examination of the switch on the remote control panel indicated that it was working properly and the locking system did not show any signs of deficiency. It is therefore unlikely that this switch was moved to the ON position by an unsecured object inside the cabin at the time of impact.

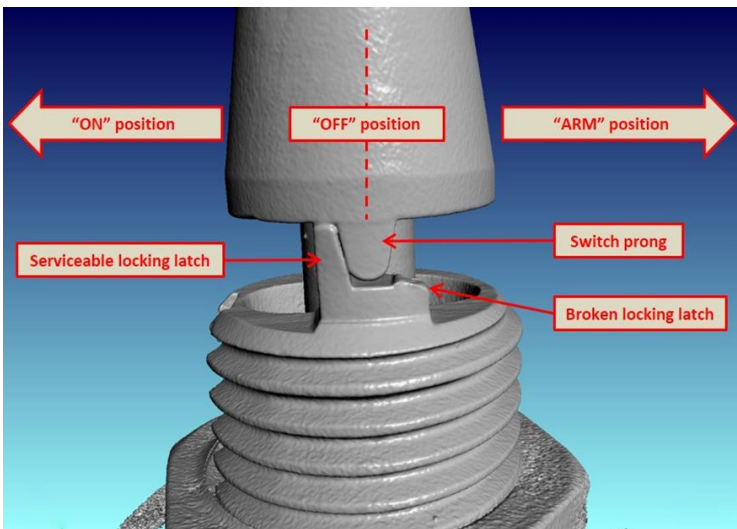
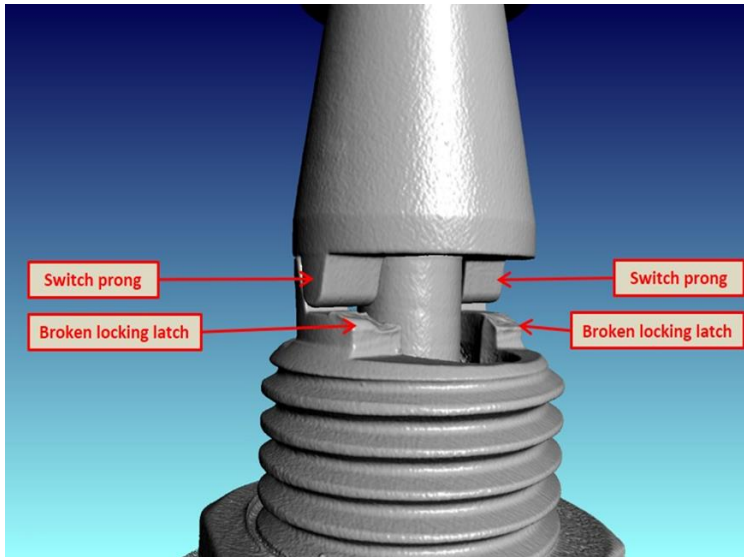
A more thorough examination of the occurrence ELT revealed that the locking latches between the OFF position and the ARM position were broken (figures 14 and 15). Furthermore, the examination showed that the fracture surface of these latches was smooth, indicating that the switch had moved several times between the OFF position and the ARM position over time.

Figure 14. CT scan of one of the 2 broken locking latches, side view (Source: TSB)

Figure 15. CT scan of the 2 broken locking latches, front view
(Source: TSB)
