AIR TRANSPORTATION SAFETY INVESTIGATION REPORT A19Q0128

LOSS OF CONTROL AND COLLISION WITH TERRAIN

Beechcraft Bonanza V35B, N3804X

29 July 2019

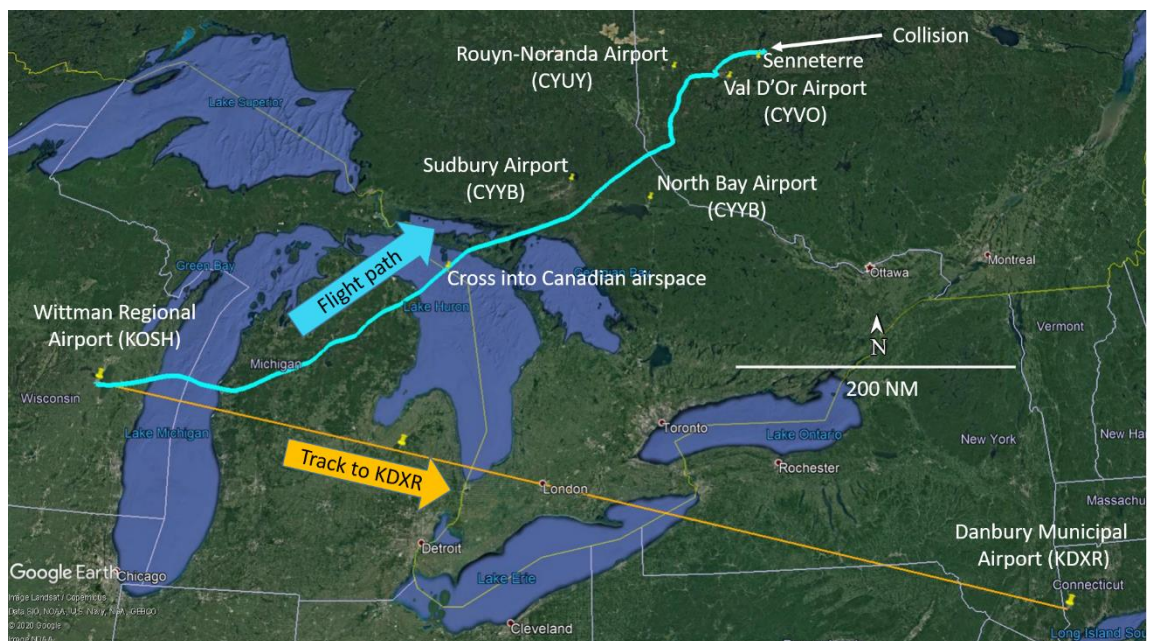
At 1555¹ on 29 July 2019, the Beechcraft Bonanza V35B aircraft (U.S. registration N3804X, serial number D-10358) departed Wittman Regional Airport (KOSH), Wisconsin, U.S., for a daytime visual flight rules (VFR) flight to Danbury Municipal Airport (KDXR), Connecticut, U.S., with only the pilot on board. Within minutes, the aircraft turned approximately 15° north of a direct flight path to KDXR.² At 1610, the aircraft climbed through 10 000 feet above sea level (ASL) and levelled off at approximately 11 500 feet ASL. As the flight progressed, the aircraft deviated toward the north and never regained a track or heading toward the original destination (Figure 1).

Figure 1. The occurrence aircraft's flight path (green line) and direct track from Wittman Regional Airport to Danbury Municipal Airport (orange line) (Source: Google Earth, with TSB annotations)

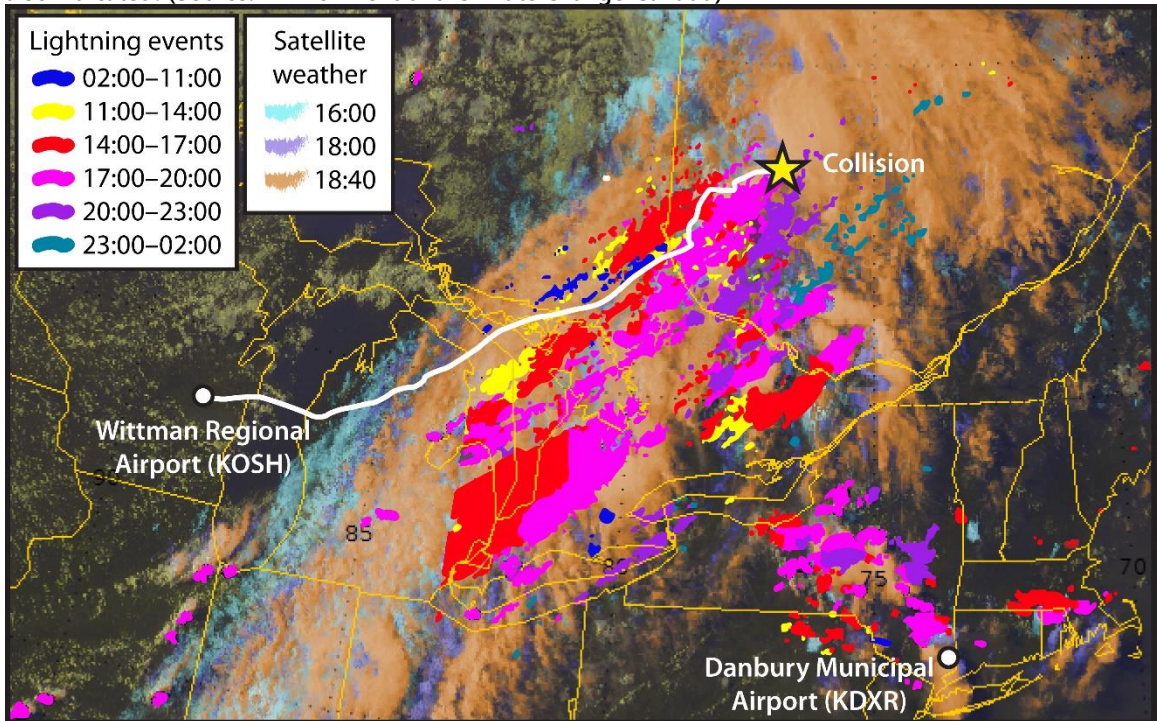
A weather analysis¹⁶ for the area and day of the accident determined that a broken line of showers and thunderstorms extended from Michigan into central Ontario and western Quebec, and was moving eastward at around 25 to 30 knots. The analysis concluded that near the thunderstorms and heavy showers, visibilities dropped to as low as 1½ statute miles (SM) and ceilings dropped to as low as 700 feet above ground level (AGL). The aircraft flew along the line of weather (Figure 3).

Figure 3. Flight path superimposed on multispectral visible satellite images around the time of the event, on 29 July 2019. Lightning strikes in the past 24 hours are indicated by a color code. The location of departure (KOSH), the intended destination (KDXR), and the location of the collision with the terrain are also indicated. (Source: Environment and Climate Change Canada)

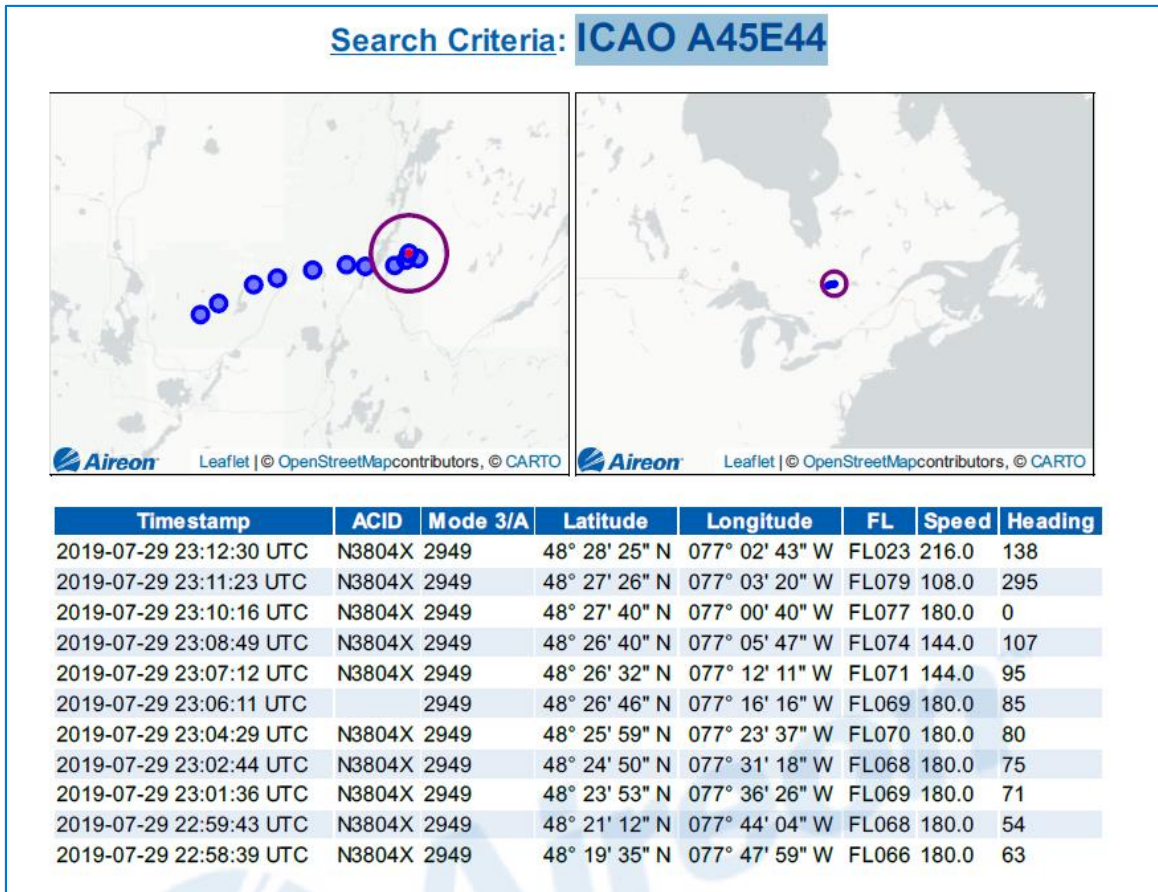
Figure 4. Aireon ALERT report for the aircraft (Source: NAV CANADA)

Since the occurrence, Aireon has improved the Aireon ALERT report. In addition to providing the last 15 minutes of detected flight at 1-minute intervals, the last minute of flight now includes updates at 5-second intervals.

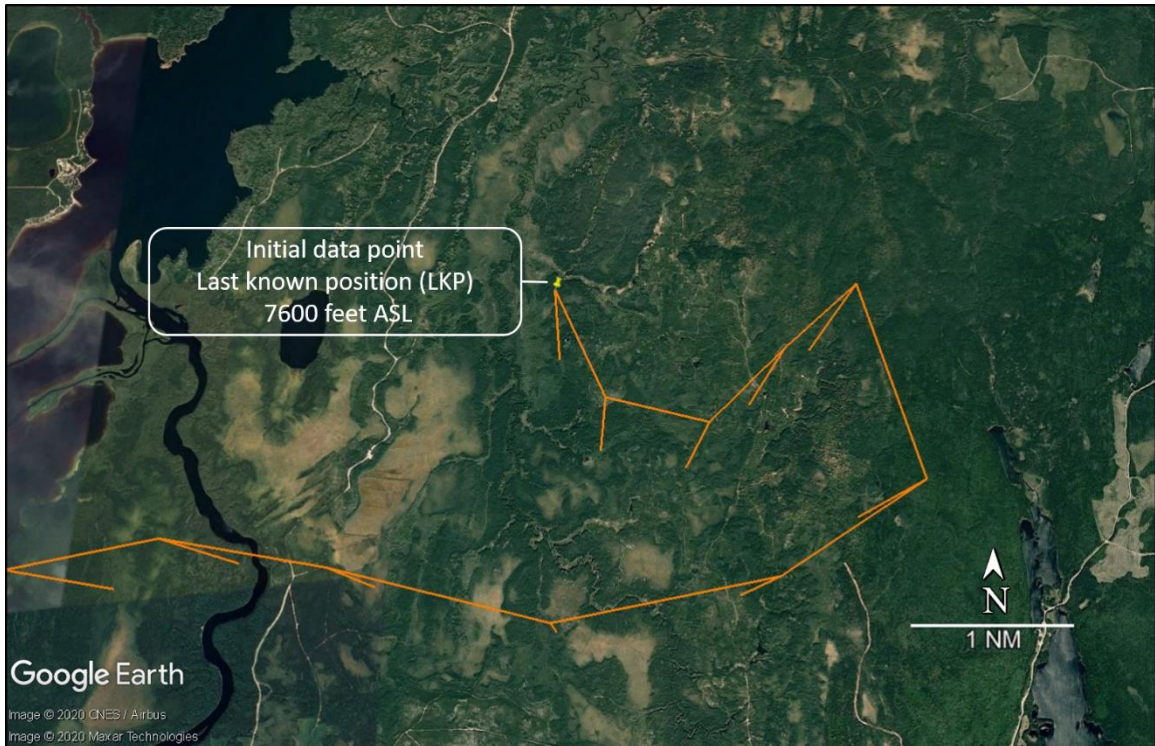
JRCC Trenton was notified that the aircraft was missing at 2331 on 29 July 2019, and initiated its SAR response. At 0049 on 30 July 2019, JRCC Trenton obtained some limited initial ground-based ADS-B data from the U.S. Air Force Rescue Coordination Center, which last recorded the aircraft's GPS position and altitude at 1911:42. JRCC Trenton used this data point to determine the search area. This initial data matched data that was available on the internet through several different networks of private ground-based ADS-B receivers. The data point was at 48°28'02"N, 077°03'50"W, at an altitude of 7600 feet ASL, and was 4638 feet (0.76 NM) from the actual crash site (Figure 5).

Figure 5. Automatic dependent surveillance – broadcast data provided to the Joint Rescue Coordination Centre Trenton (Source: NAV CANADA, Google Earth, with TSB annotations)

JRCC Trenton used this initial data point as a last known position (LKP).²⁶ However, given the absence of a flight plan, limited radar coverage below 8000 feet ASL in the area, no ADS-B data available below 7600 feet ASL, no ELT signal, and no indication that the aircraft had crashed, JRCC Trenton was focused on locating a lost or missing aircraft. Based on the aircraft's endurance, the overall search area was defined as an area with a radius of 250 NM. Dense tree canopy coverage made aerial visual search methods difficult and at times ineffective.

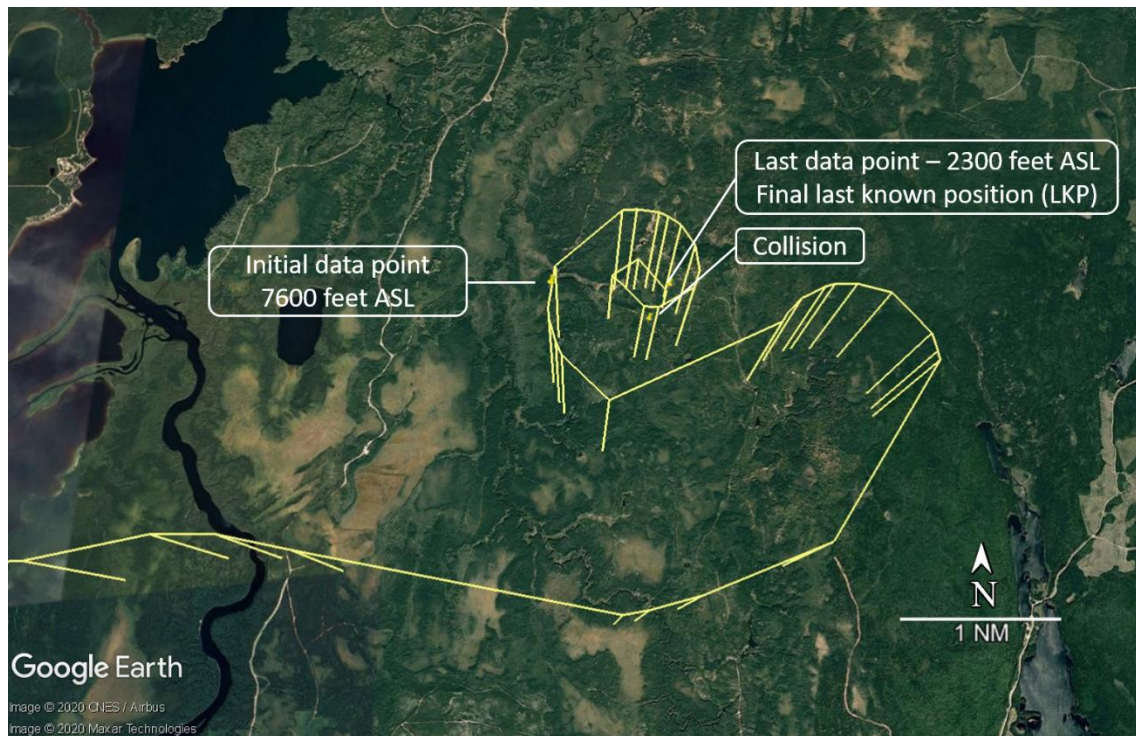
Figure 6. Space-based automatic dependent surveillance – broadcast data available after the occurrence (Source: NAV CANADA, Google Earth, with TSB annotations)
