# AIR TRANSPORTATION SAFETY INVESTIGATION REPORT A21Q0087

## **RUNWAY OVERRUN**

Airmédic Inc.  
Pilatus PC-12/47E, C-GIOX  
Sept-Îles Airport, Quebec  
12 September 2021

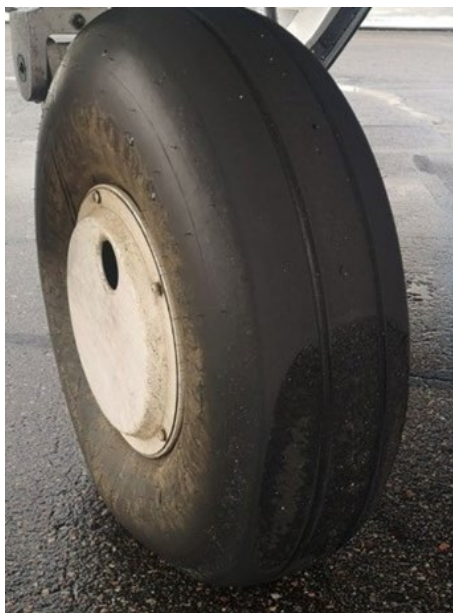
The aircraft was not damaged; however, the tires on the main landing gear showed signs of rubber reversion (figures 2 and 3).

Figure 2. Photo of the left tire (rear view) (Source: Airmédic Inc.)

Runway conditions were not available at the time of the approach. However, the crew observed that the runway was wet. The tire inspection conducted after the flight found marks which confirmed that reverted-rubber hydroplaning had occurred while the aircraft was braking on the runway. Given that braking distance increases with hydroplaning, it is reasonable to conclude that the increase in braking distance on the wet runway exceeded the theoretical margin of 157 feet available for a landing on a dry runway with maximum reverse thrust.

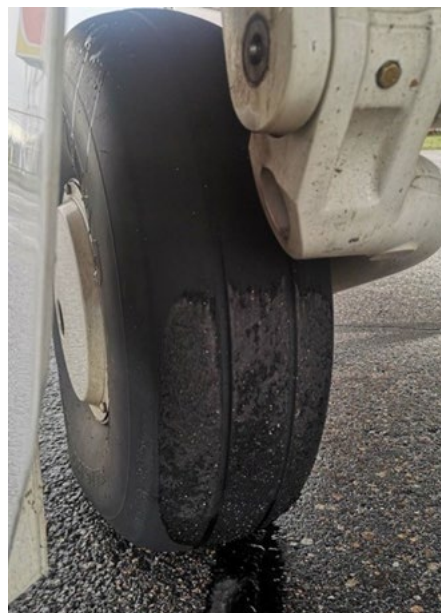
Figure 3. Photo of the right tire (front view) (Source: Airmédic Inc.)

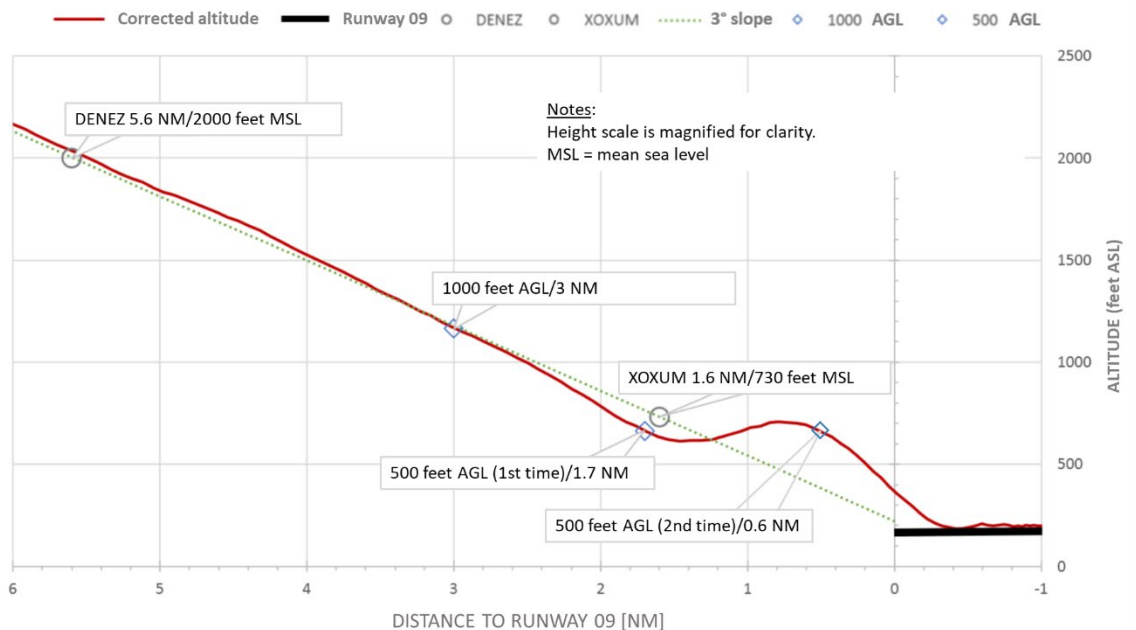
Figure 5. Graph illustrating the aircraft’s vertical path (solid line) in relation to the nominal 3° approach slope (dotted line) (Source: TSB)

The aircraft crossed the runway threshold at 200 feet AGL, at 180 KIAS (ground speed of 191 knots), with a rate of descent of 2000 fpm, the landing gear was in transit, and the flaps were in the fully retracted position. In such a situation, even if the pilot manages the flight path for a landing within the first  $\frac{1}{3}$  of the runway, the aircraft has excessive vertical and horizontal speeds. To recognize that a change of plan is needed and to react in time, a pilot must perceive the condition or stimulus as important enough to warrant immediate action. Plan continuation bias becomes even stronger when a goal is on the verge of being achieved.

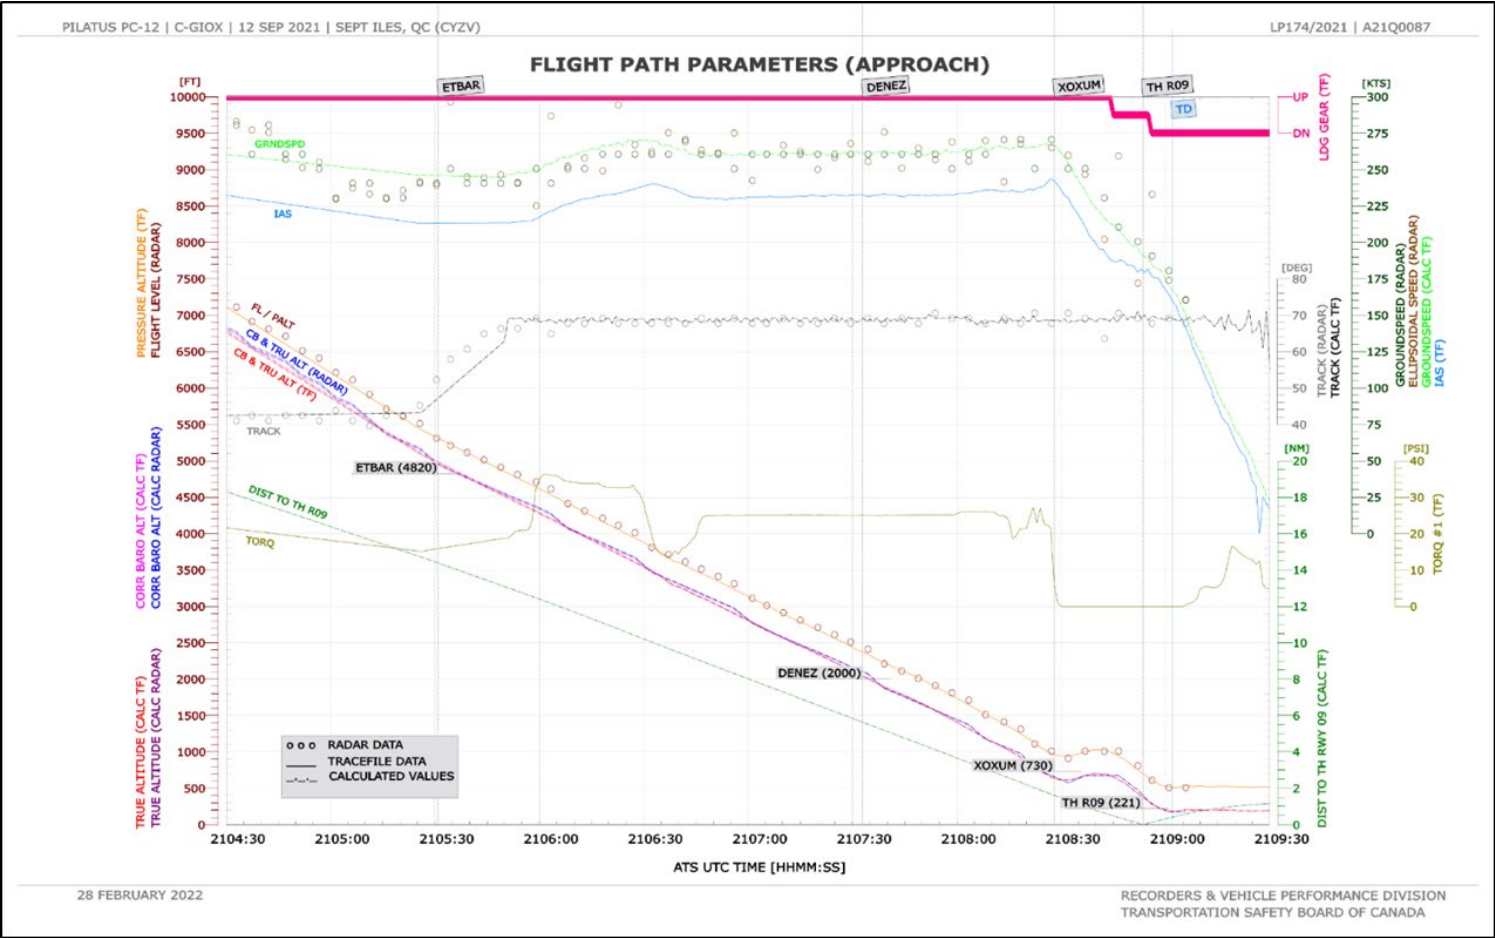
Figure D1. Flight path data plots during the approach

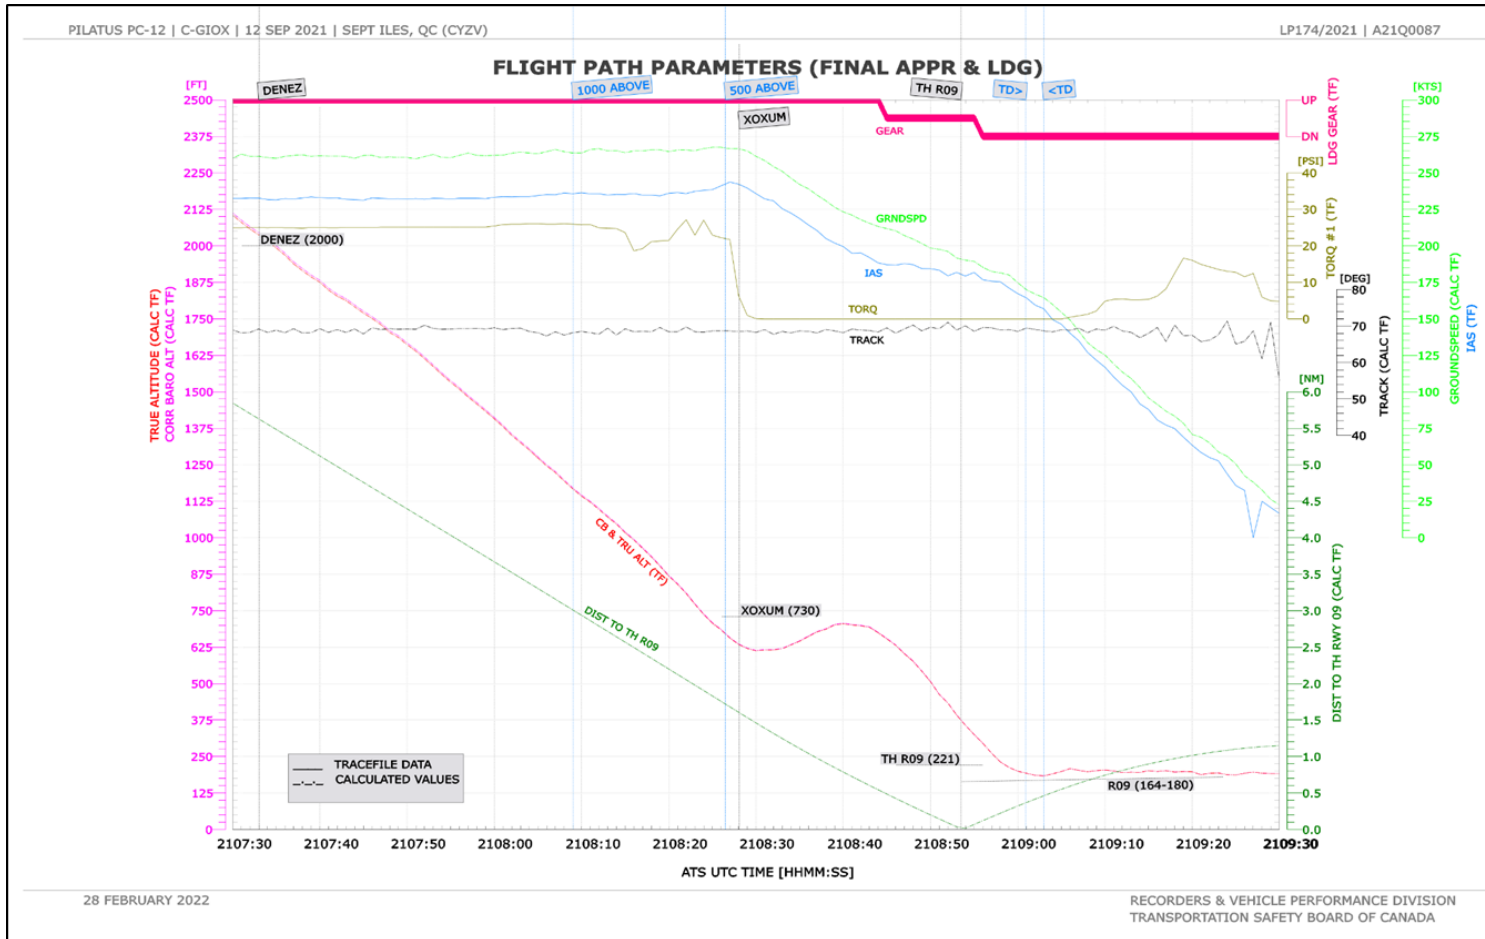
Figure D2. Flight path data plots during the final approach and landing

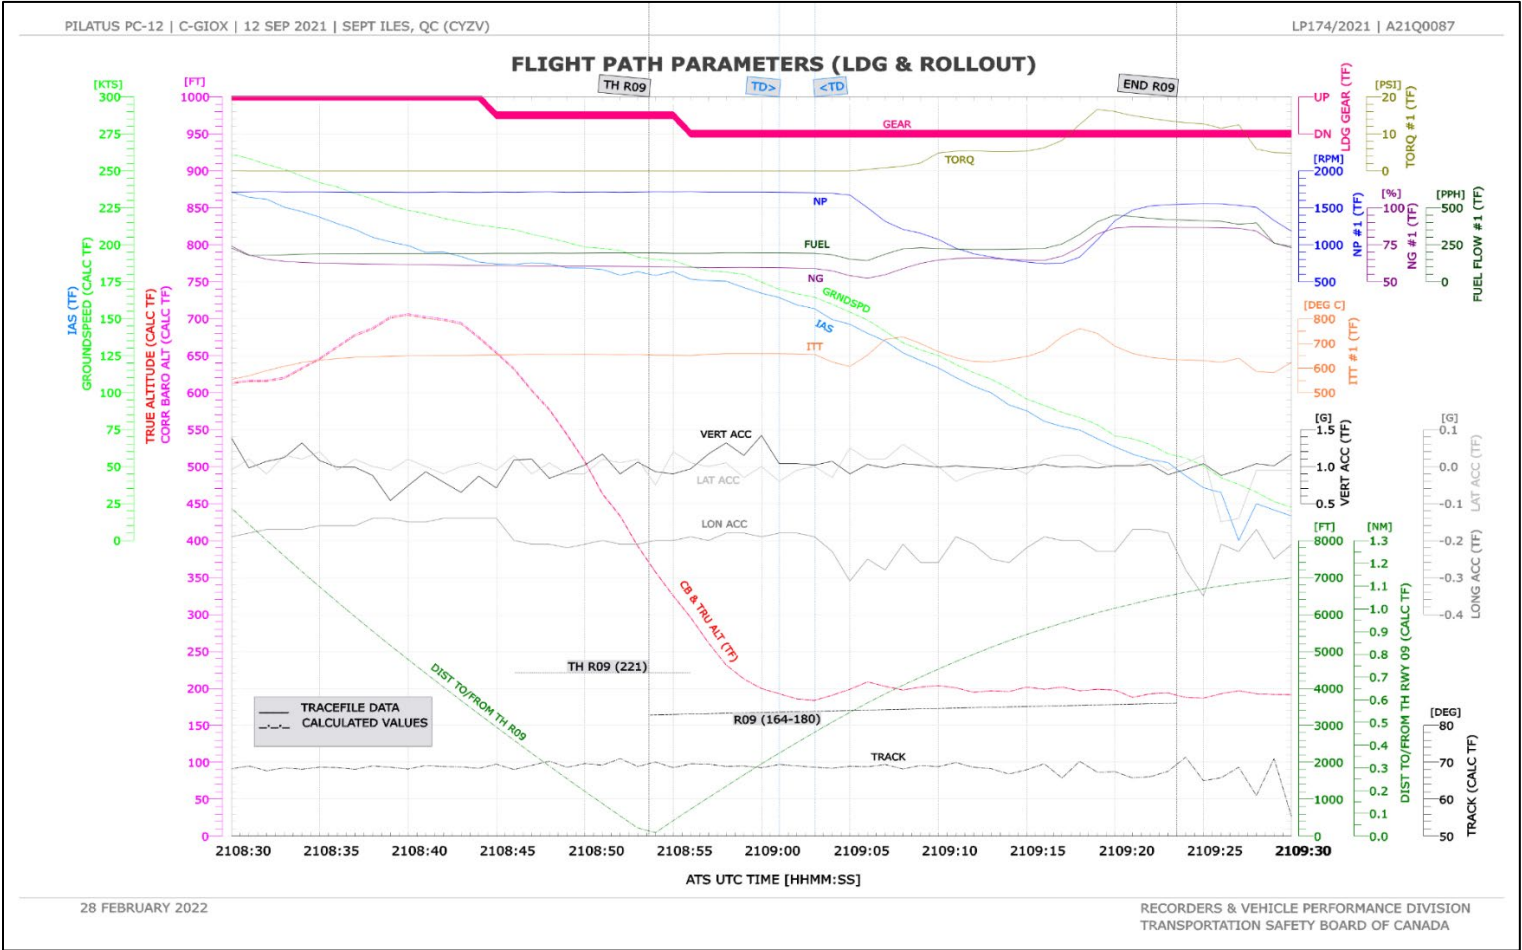
Figure D3. Flight path data plots during the landing and landing roll
