AIR TRANSPORTATION SAFETY INVESTIGATION REPORT A21W0071

COLLISION WITH TERRAIN

Privately registered
Mooney M20C, C-GTIJ
Slave Lake Airport, Alberta, 12 NM NE
31 August 2021

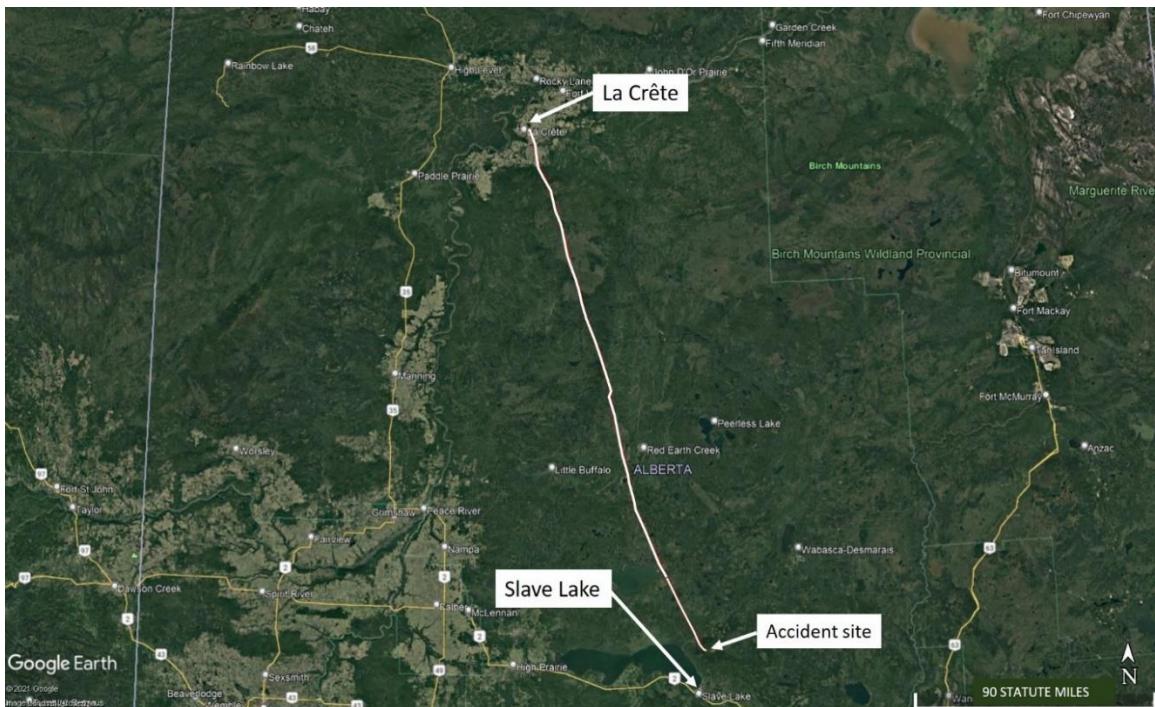
Figure 1. Map showing the occurrence flight track (Source: Google Earth, with TSB annotations)

The aircraft departed at 0900 in visual meteorological conditions and initially climbed to 3500 feet ASL on a southerly heading (figures 1 and 2). Along the route to CYZH, the aircraft reached an altitude of 4000 feet ASL before descending, likely due to cloud ceilings. When the aircraft was 14 nautical miles (NM) north of CYZH, the pilot changed the destination in the GPS (global positioning system) from CYZH to CYLL. The aircraft's track then turned to the east toward CYLL and toward rising terrain. At this time the aircraft was at 3000 feet ASL or 500 feet above terrain.

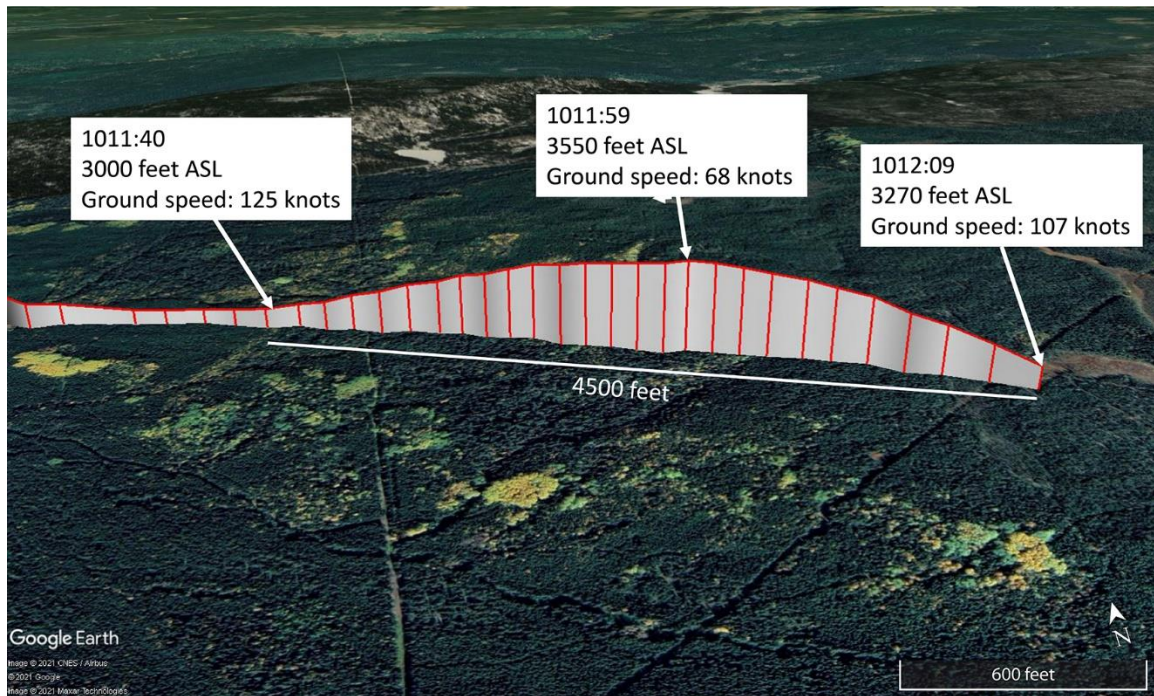
Figure 3. Aerial photo showing the flight path before the collision with terrain (Source: Google Earth, with TSB annotations)

At 1011:40, the aircraft climbed to 3550 feet ASL and its ground speed decreased from 125 knots to 68 knots. The aircraft then started a descent at 1011:59 and descended until shortly after 1012:09, when it impacted terrain in a wooded area at approximately 3200 feet ASL (Figure 3). GPS data from

the digital engine monitor² showed that the aircraft's descent angle before it hit trees was about 15°. The average descent rate was 1680 fpm until a few seconds before impact, when it increased to over 2000 fpm. The pilot was fatally injured. The aircraft was destroyed. The emergency locator transmitter activated.

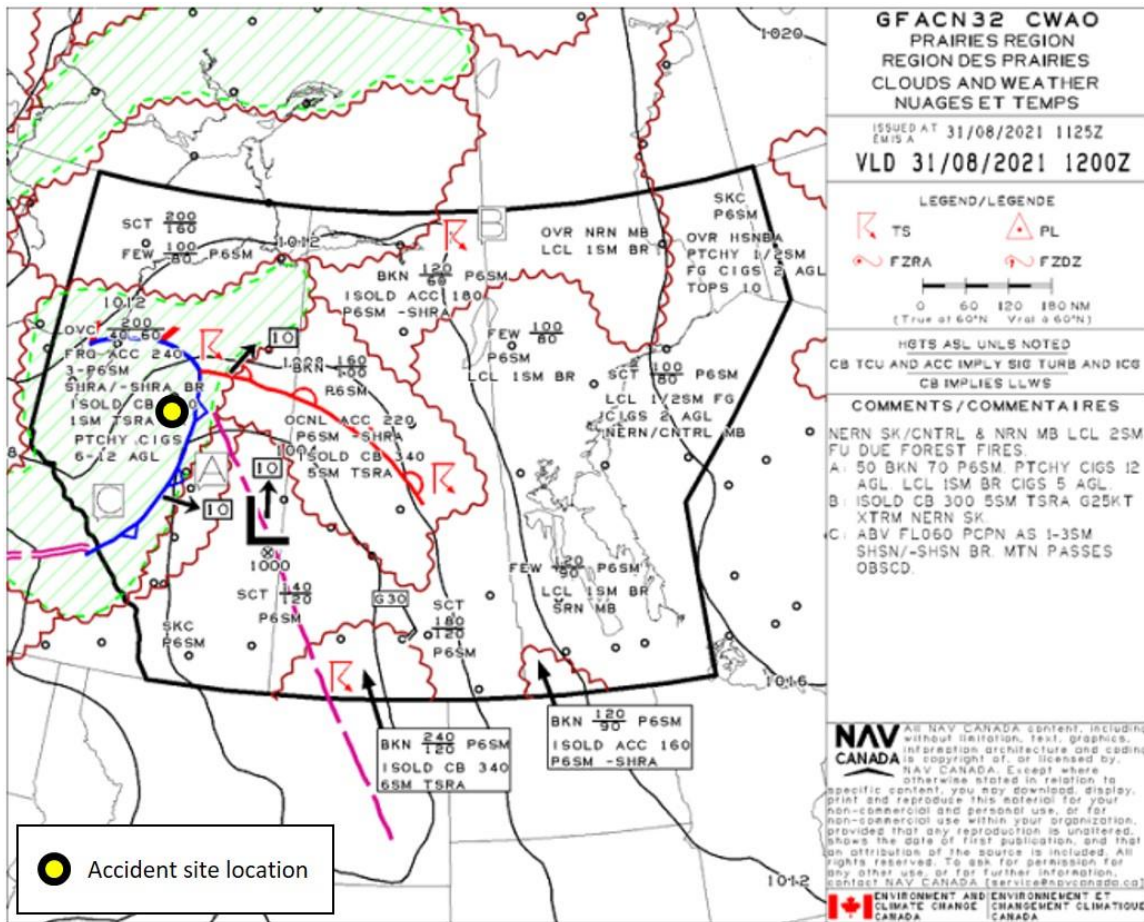
Figure 4. Graphic area forecast valid at 0600 Mountain Daylight Time on 31 August 2021. Yellow circle denotes accident site location. (Source: NAV CANADA, with TSB annotations)

The forecast for the route indicated on the graphic area forecast (GFA) (Figure 4) was:

- overcast cloud ceilings between 4000 and 6000 feet ASL with tops at 20 000 feet ASL
- frequent altocumulus castellanus clouds with tops at 24 000 feet ASL
- visibility 3 SM to more than 6 SM in rain showers or light rain showers with mist

The GFA also indicated isolated cumulonimbus clouds with tops at 34 000 feet ASL giving visibilities of 1 SM in thunderstorms, rain, and mist. During those periods patchy cloud ceilings were expected between 600 and 1200 feet AGL.
