AIR TRANSPORTATION SAFETY INVESTIGATION REPORT A22C0016

COLLISION WITH TERRAIN

Bamaji Air Inc.
Cessna 208 Caravan, C-GIPR
Sioux Lookout, Ontario, 17 NM NNW
08 March 2022

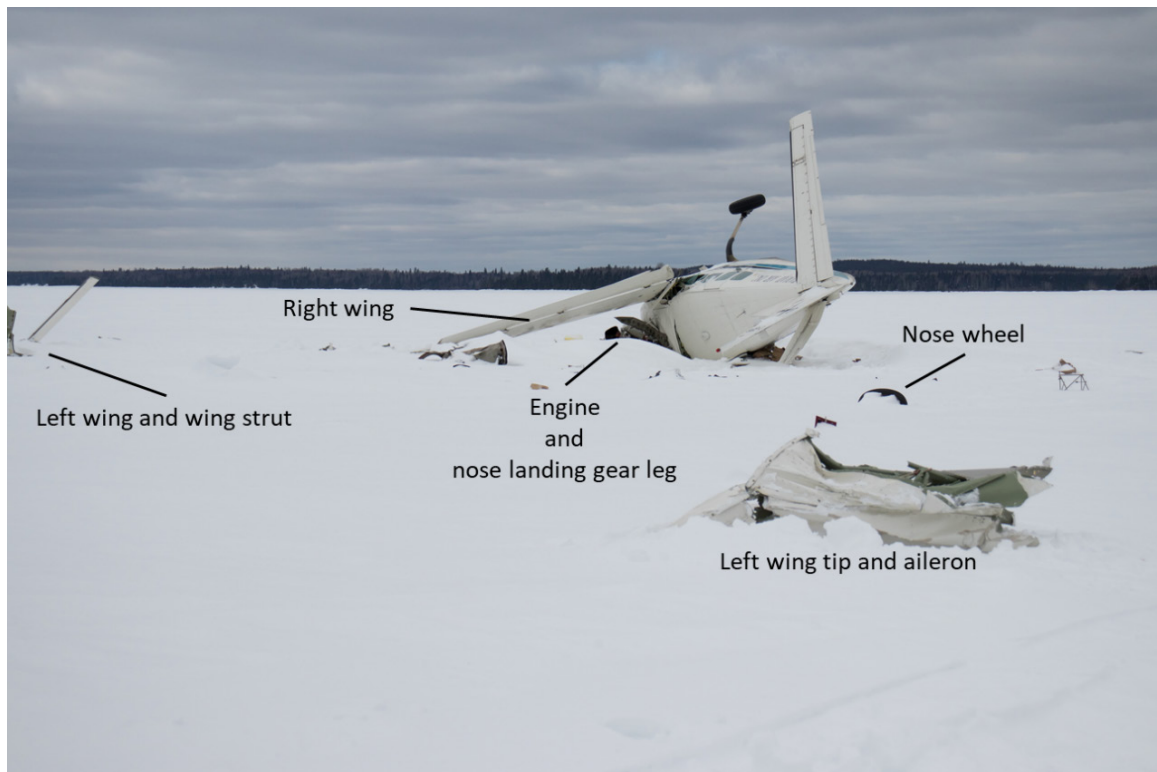
The pilot turned his head to inspect the left wing and saw that ice appeared to be accumulating on the leading edge. He turned his attention back to the flight instruments and saw that the altimeter was descending rapidly. He then pulled back on the control column to stop the descent; however, within a few seconds, the aircraft struck the frozen surface of Lac Seul, approximately 17 NM north-northwest of CYXL (Figure 1).

Figure 1. View along the wreckage trail (Source: TSB)

The on-site inspection of several sections of the wing leading edges that had been protected by snow cover and sheltered from the sun revealed a few patches of very thin frost or ice. However, there were no indications of significant ice accumulation on the aircraft's exposed critical surfaces either in photos taken within a few hours of the crash or during the TSB on-site examination of the wreckage.

The aircraft collided with the snow-covered frozen surface of Lac Seul at an elevation of approximately 1100 feet ASL, in a nose-down, left-wing-low attitude. The 2 to 3 feet of snow cover on the ice surface reduced the forces generated by the collision. The aircraft cockpit and cabin remained largely intact and provided a survivable space. The wreckage trail was approximately 550 feet long and oriented about 310°T, which is roughly 40° to the left of the direct bearing (350°T) from CYXL to the ice runway at Springpole Lake.

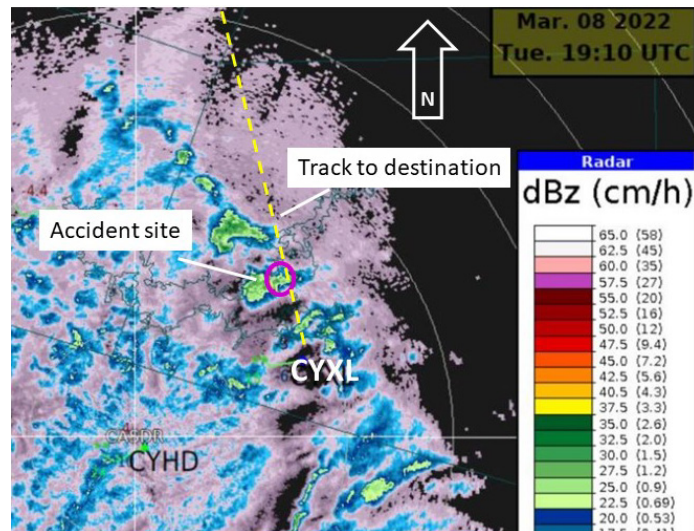
At 1310, a few minutes after the crash, relatively intense radar echoes indicate that snow was falling at a rate of about 2 cm/h at the accident site (Figure 2).

The assessment concluded that low visibility in snow squalls was likely at the time of the occurrence. In addition, the aircraft likely encountered moderate, possibly severe, mixed icing as well as moderate, possibly severe, turbulence at the time of the occurrence.

Figure 2. Snow radar imagery at 1310 on 08 March 2022. The legend shows reflectivity in dBz (unit of radar reflectivity used in meteorology) or snowfall in cm/h. (Source: Environment and Climate Change Canada, Meteorological Assessment: March 8th, 2022 - Sioux Lookout, Ontario, with TSB annotations)
