AIR TRANSPORTATION SAFETY INVESTIGATION REPORT A2200140

COLLISION WITH TERRAIN

Privately registered
Quad City Ultralight Aircraft Corporation
Challenger II (advanced ultralight), C-IYDD
Westport/Rideau Lakes Aerodrome, Ontario, 11 NM WSW
24 September 2022

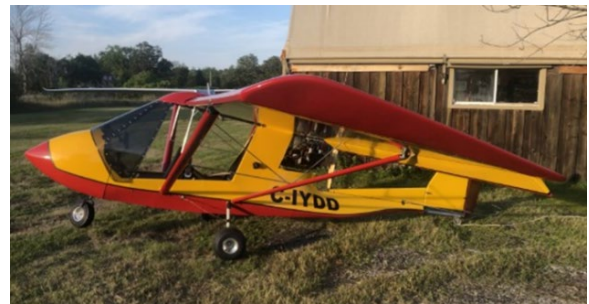
Figure 2. The occurrence aircraft (Source: Niall Leslie, with permission)
