AIR TRANSPORTATION SAFETY INVESTIGATION REPORT A23Q0088

LOSS OF CONTROL AND COLLISION WITH GROUND

Orizon Aviation Québec Inc.
Cessna 152, C-FNBP
Québec/Jean Lesage International Airport, Quebec
01 August 2023

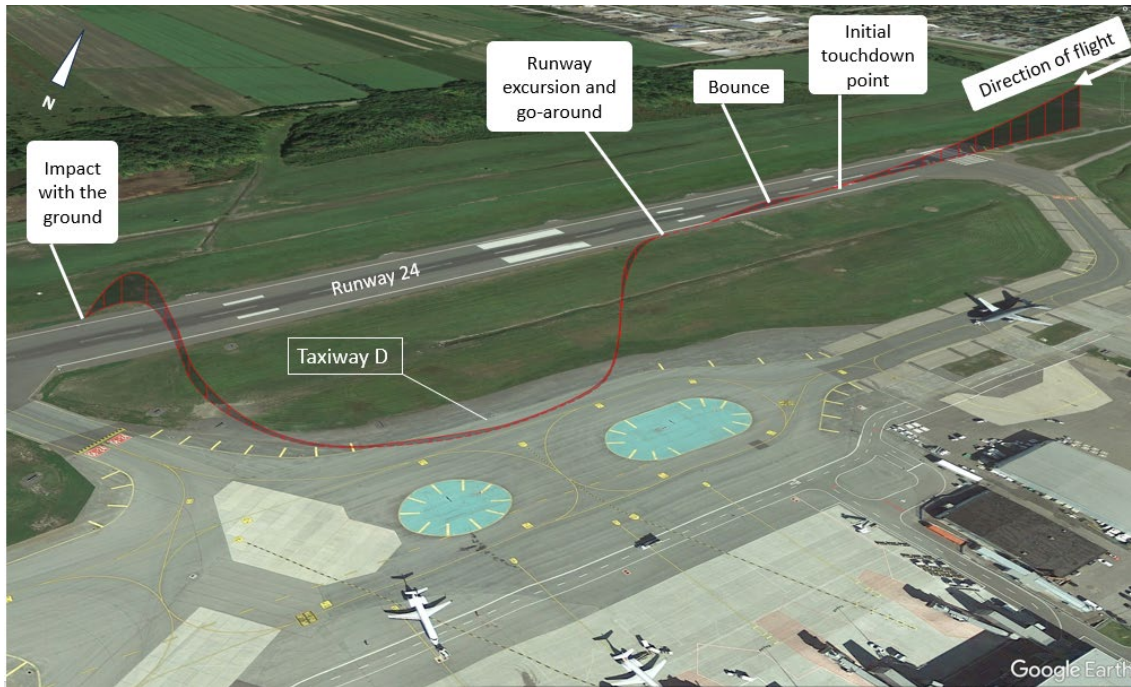
When the aircraft was on the downwind leg, the tower instructed the student pilot to “extend the downwind,” which the student pilot did. Fifty-four seconds later, the tower authorized him to turn to join the base leg. The aircraft crossed the threshold of Runway 24 at 0920 at a height of approximately 60 feet above ground level (AGL) and landed on the runway approximately 550 feet beyond the runway threshold. An analysis of video footage recorded by the airport’s surveillance cameras suggests that, on initial touchdown, the aircraft’s nose wheel hit the ground first, causing the aircraft to bounce³ before touching down again approximately 350 feet away.

An uncontrolled lateral deviation followed, and the aircraft veered off the left side of the runway. The student pilot then initiated a go-around. The aircraft took off again, and the student pilot attempted to regain altitude over the grassy area between the runway and Taxiway D, while gradually turning toward the airport terminal building. At that time, the aircraft was in slow flight⁴ and still near the ground.

The aircraft reached Taxiway D, which the student pilot flew over at a few feet above the ground, attempting to regain altitude. Seeing that he was heading toward the control tower and terminal building, the student pilot turned to the right, away from them and back toward Runway 24. When the aircraft reached Runway 24, it was able to climb to approximately 45 feet AGL by making a left turn. The left wing then stalled, and the aircraft rolled to the left and entered a spin before crashing on the edge of the runway (Figure 1). The aircraft collided with the ground in an almost-vertical, nose-down attitude, and then rolled onto its back.

Figure 1. Map showing the sequence of the accident at Québec/Jean Lesage International Airport, Quebec. All annotations related to aircraft operations are approximate. (Source: Google Earth, with TSB annotations)

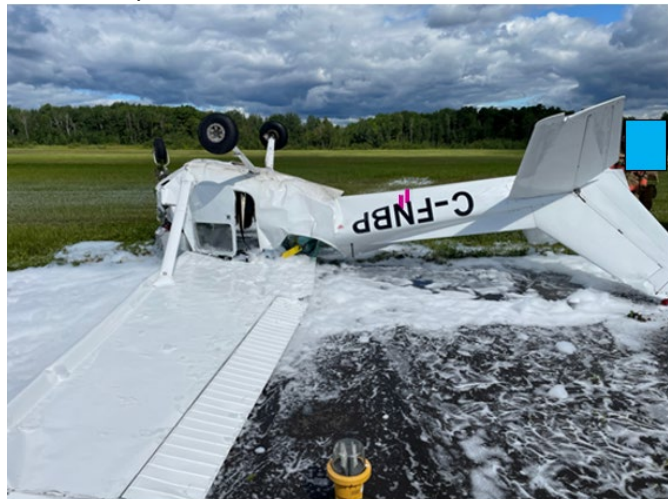
The aircraft collided with the ground in an almost-vertical attitude, on a grassy surface.

The propeller damage was consistent with an engine that was producing power at the time of impact, but the amount of power it was producing could not be determined. Flight control cable continuity was confirmed from the elevators to the seats, from the rudder to the rudder pedals, and from the ailerons to the fuselage. The position of the flap actuator indicated that the flaps were at approximately 13° at the time of impact.

Figure 2. Occurrence wreckage (Source: Québec/Jean Lesage International Airport's Airport Security Service, with TSB annotations)

The aircraft systems were examined to the extent possible, and no signs of failure were observed.
