AVIATION OCCURRENCE REPORT

LOSS OF CONTROL

**BEECH B58P BARON C-FKSB
TORONTO ISLAND AIRPORT, ONTARIO 1.8 nm W
09 OCTOBER 1993**

REPORT NUMBER A93O0343

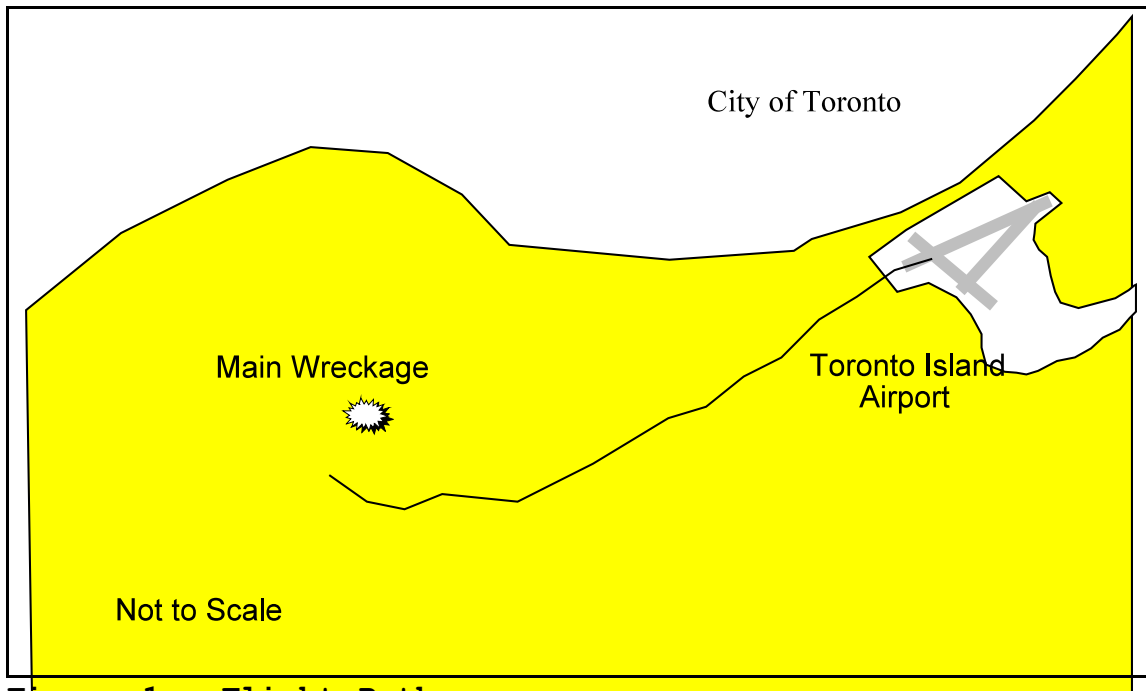
Figure 1 - Flight Path

Once airborne, the pilot contacted the Toronto Area Control Centre (ACC) departure controller and was given a departure instruction, which he did not acknowledge. When the departure controller repeated the departure instruction, the pilot responded that he had an engine failure and requested an immediate return to the airport. There were no further radio transmissions from the aircraft and it was observed in a steep nose-down descent when it struck the water at 0738 during daylight hours.

Metro Toronto Police divers found the aircraft about 1.8 nautical miles (nm)³ west of the airport in 50 feet of water at latitude 43°37'37"N, longitude 079°26'41"W. There were no survivors.

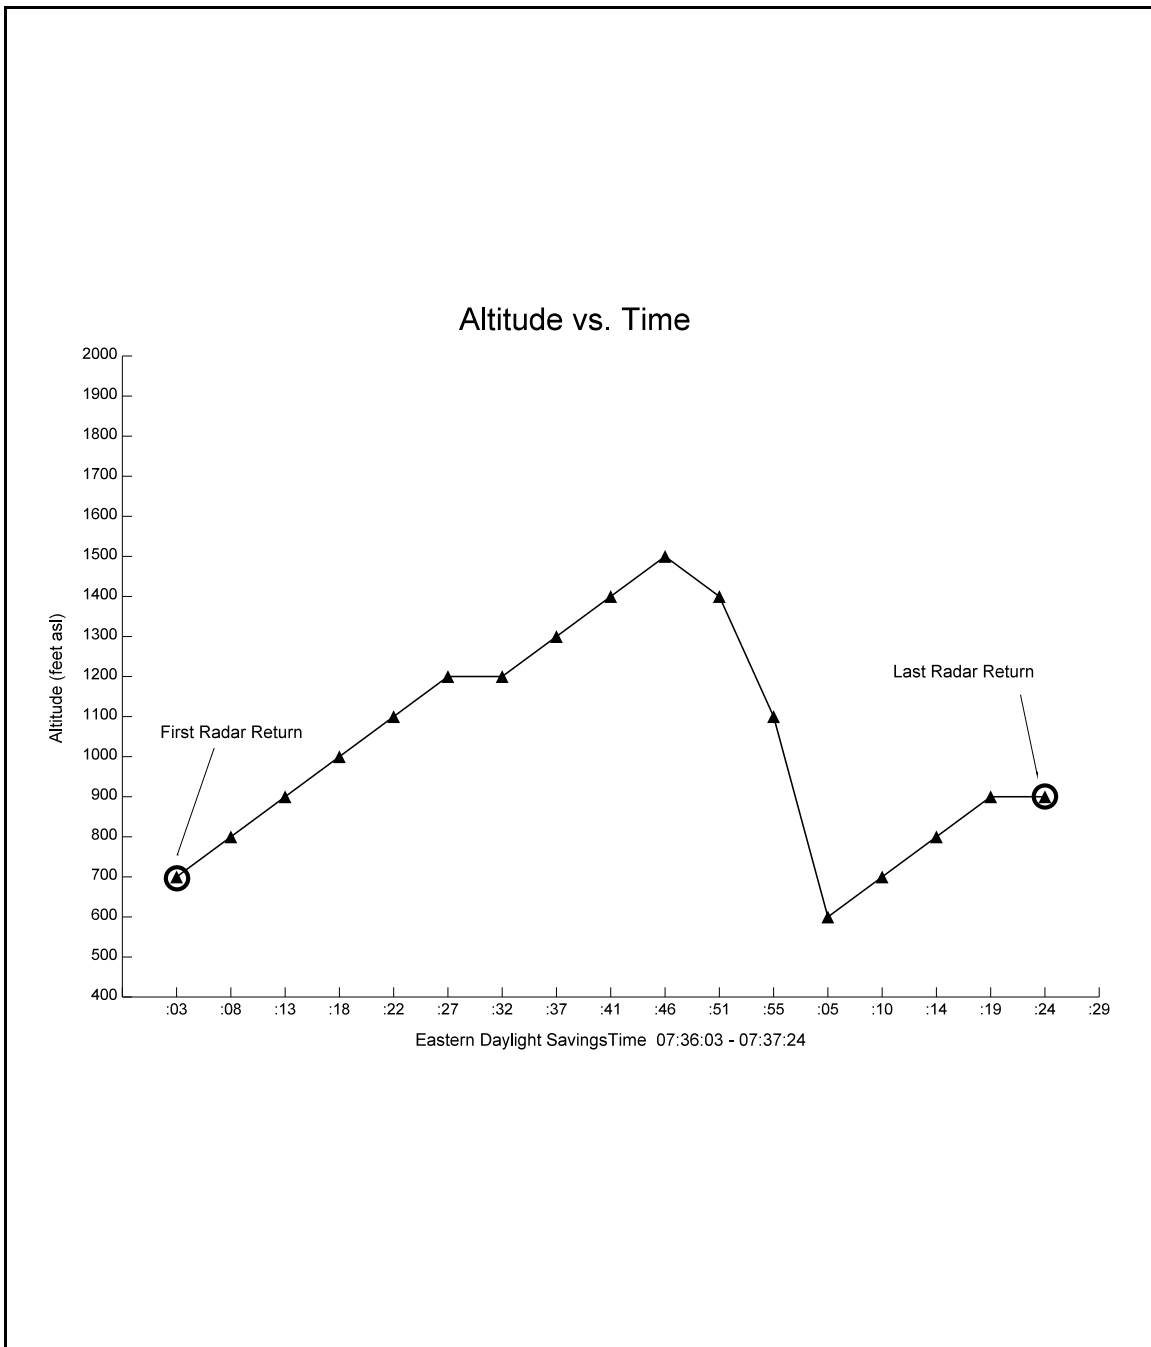
Appendix A - Radar Flight Path Data

The first radar contact indicated that the aircraft was at 700 feet asl on the initial climb. The aircraft climbed about 1,000 fpm to 1,050 feet asl, with the groundspeed increasing from 96 knots at 700 feet asl to a maximum of 123 knots at 1,050 feet asl. The radar indicated that the aircraft was drifting south of the extended runway centre line, although no significant turn or change in aircraft heading was observed.

At 1,050 feet asl, the groundspeed began to decrease from 123 knots to 84 knots over a 15-second period. The 1,000 fpm climb was arrested as the aircraft temporarily levelled off at 1,200 feet asl. During the next 11 seconds, the groundspeed remained below 90 knots, and the 1,000 fpm climb was re-established as the aircraft climbed to its maximum altitude of 1,500 feet asl while maintaining a fairly constant departure track. During this portion of the climb, at approximately 1,300 feet asl, the pilot contacted the departure controller. The pilot received his initial departure instructions but did not read them back.

As the aircraft altitude reached 1,500 feet asl, the 1,000 fpm climb was arrested; the aircraft began to descend and momentarily reached a maximum descent rate of 4,000 fpm. In this nine-second flight segment, the aircraft track indicated a significant turn to the northwest while the aircraft groundspeed remained below 100 knots. The aircraft descended to 600 feet asl before the rate of descent was arrested, and a 1,000 fpm climb was briefly re-established as the aircraft climbed to an altitude of 900 feet asl and the ground speed decreased to 83 knots. Passing through 800 feet asl, the pilot informed the departure controller that he had an engine failure and wanted to return immediately to the airport. This was

the last communication from the aircraft. The last radar target showed the aircraft at 900 feet asl in a right turn, with the ground speed below 100 knots.
