**RISKS OF COLLISION
BETWEEN
FAIRCHILD SA-227AC METRO III C-GYHD
AND
FOKKER F-28 MK. 1000 C-GTUU**

**WINNIPEG INTL AIRPORT, MANITOBA
02 NOVEMBER 1994**

REPORT NUMBER A94C0232

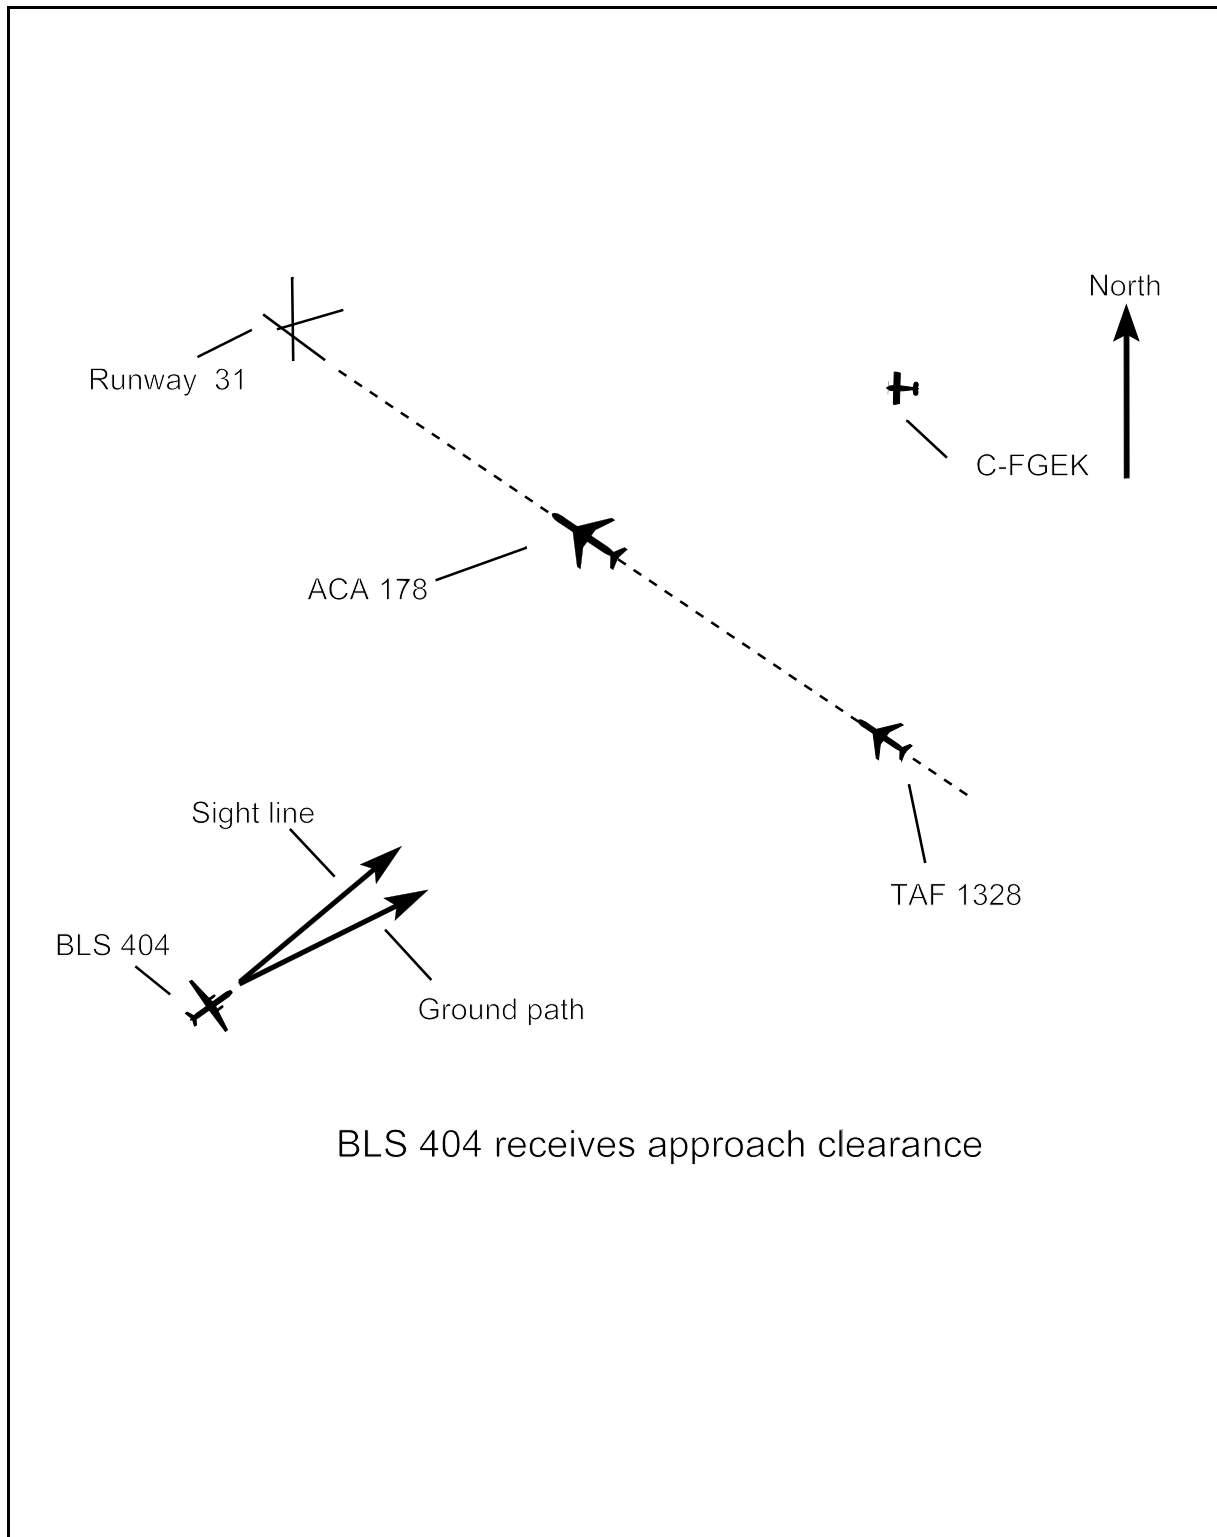
Appendix A - Aircraft Relative Position at 1623:25

At 1617:31 CST, the Fairchild Metro III crew first called the arrival controller 37 nautical miles (nm) southwest of Winnipeg, at 15,200 feet above sea level (asl)². At 1623:25 CST, at an altitude of 7,000 feet asl, the crew³ reported that the airfield was in sight, and the arrival controller advised them to follow the F-28 traffic turning final just through their twelve o'clock position and about 8 nm, down low. The F-28 referred to was TAF 1328, whose altitude at the time was 3,800 feet asl. The Fairchild Metro III crew observed one aircraft on approach, at their 11:30 position⁴, that fit the description of the F-28. They advised the arrival controller that they had the traffic in sight, and were cleared for the left hand visual approach to runway 31 to follow the F-28. The crew carried out the aircraft landing checks after receiving approach clearance, and were reportedly aware that traffic information was based on their ground track. The arrival controller did not provide the Fairchild Metro III crew with a sequence number, nor was he required by regulation to do so. The crew did not request one.

At 1624:41 CST, to draw the crew's attention to the fact that their aircraft was rapidly closing with the F-28, the arrival controller advised them that their groundspeed was 290 knots and that the F-28's ground speed was 160 knots. The aircraft that the crew was observing was on short final approach at a position left of 12 o'clock, and they believed they had ample spacing behind the traffic. The crew acknowledged the call and took no further action. The arrival controller was reportedly reluctant to interfere in the conduct of visual approaches because crews are responsible for maintaining their own separation with the aircraft they are following.

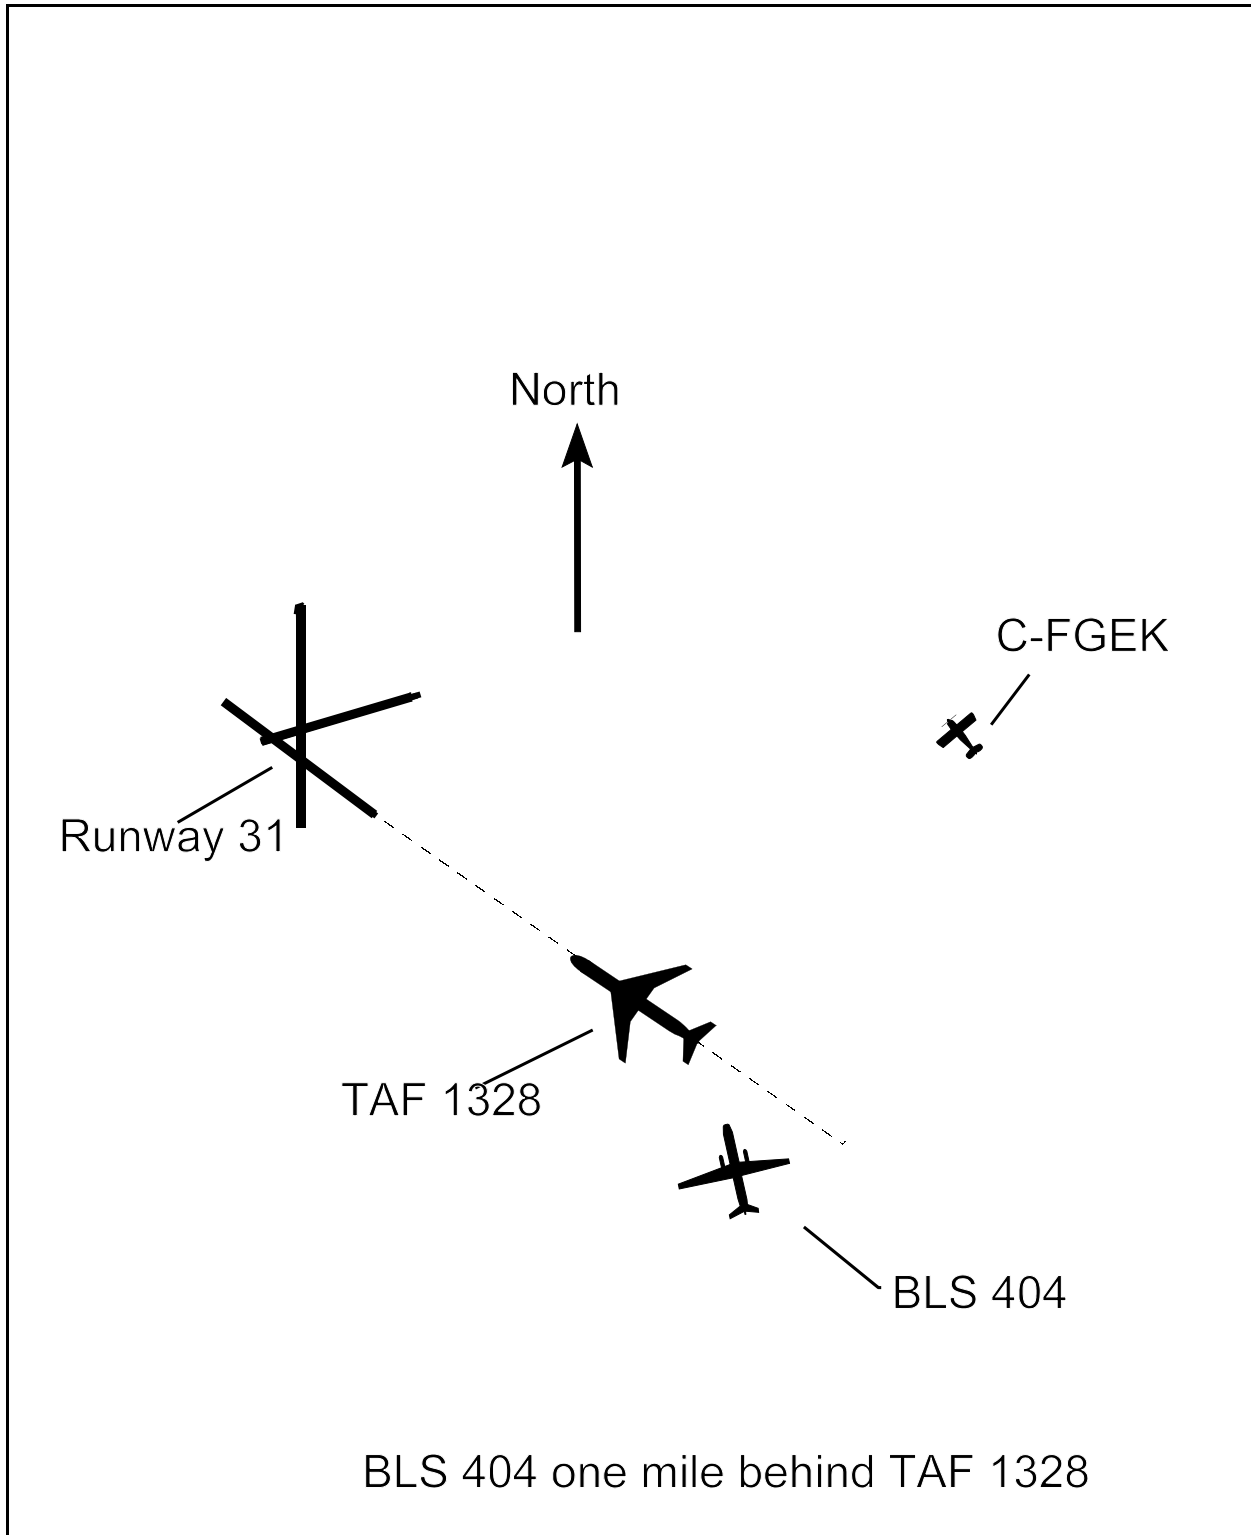
Appendix B - Aircraft Relative Position at 1625:49

At 1625:49 CST, the arrival controller asked the Fairchild Metro III crew whether the F-28 was still in sight, and the crew responded that it was. The arrival controller then informed the Fairchild Metro III crew that their groundspeed was 70 knots greater than that of the F-28 which was at their 12 o'clock and at a distance of one mile⁵. The Fairchild Metro III crew acknowledged this, re-directed their attention to this last position and immediately saw the F-28. The Fairchild Metro III crew started a right turn to increase separation between the two aircraft, and passed through the runway 31 approach path .7 nm behind the F-28, with 700 feet of vertical separation.

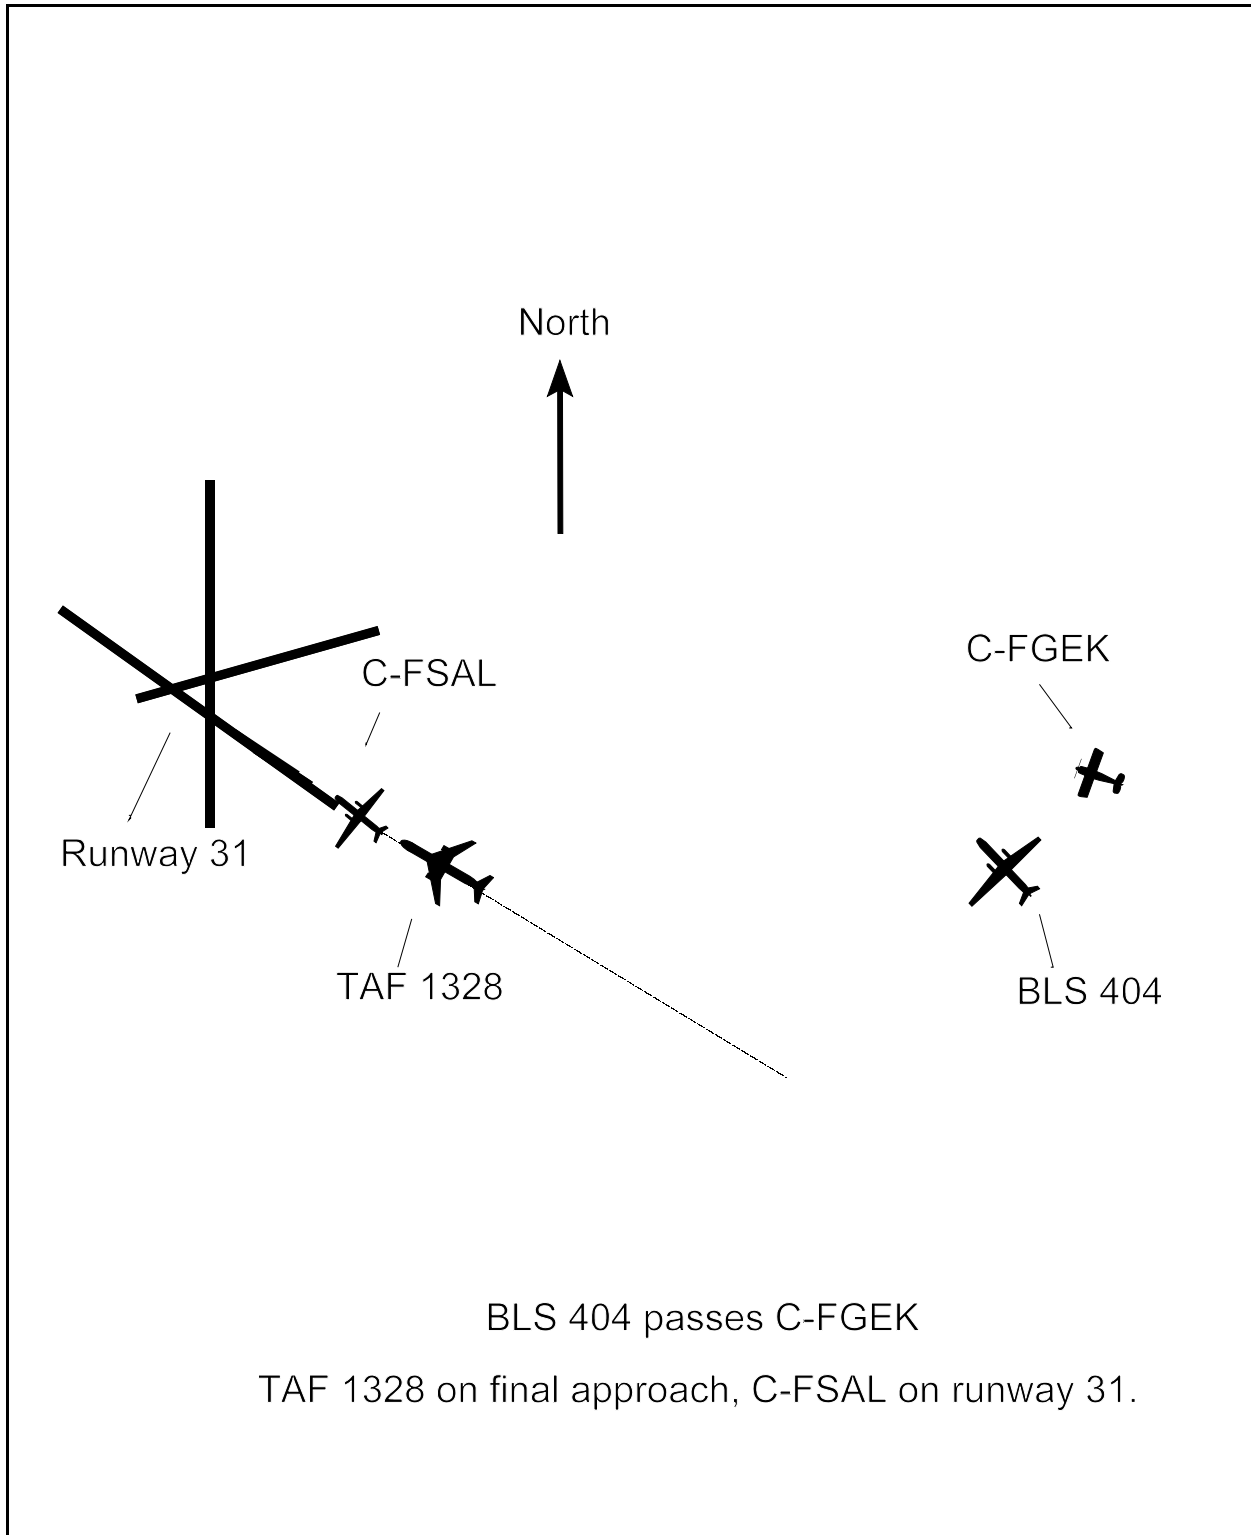
Appendix C - Aircraft Relative Position at 1626:48

As the Fairchild Metro III was passing behind the F-28 and through the approach path for runway 31, Arrival instructed the Fairchild Metro III crew to call Winnipeg Tower on their frequency. The crew called the airport controller at 1626:05 CST, and asked whether he wanted the flight to use runway 25. The airport controller discussed this request with the arrival controller and, at 1626:26 CST, advised the Fairchild Metro III crew of the Cessna 152 traffic watch aircraft, and instructed the crew to start a left hand 360-degree turn to rejoin the approach to runway 31. The Fairchild Metro III crew confirmed that the traffic was in sight and started the turn. Radar data shows the Cessna 152 northwest bound, turning left, at the time of the closest proximity between the Fairchild Metro III and the Cessna 152, while the Fairchild Metro III was northbound, and also turning left⁶. During the turn, the Fairchild Metro III passed the Cessna 152 with .4 nm horizontal and no vertical separation.

At 1626:50 CST, the airport controller broadcast an instruction to the Cessna 152 to turn north; however, no reply was received. The Cessna 152 pilot's next call to Tower was at 1628:54 CST, when he advised that he was again monitoring the frequency.

After the DC-9 landed, the pilot of C-FSAL, a Cessna 414, advised Tower that he was ready for take-off, and received clearance at 1625:48 CST to move to position and hold on runway 31. The Tower voice recording shows that the airport controller was then in almost continuous communication with the arrival controller and the crews involved in the second ROC, until the F-28 approached the runway⁷. At 1627:00 CST, the F-28 crew asked whether there was an aircraft on the runway, but this transmission was almost unintelligible because it coincided with a transmission between Tower and Arrival concerning the second ROC. The F-28 crew then received clearance to land on runway 31. Shortly thereafter, at 1627:10 CST, the F-28 crew advised Tower that they were carrying out a missed approach. The crew reported that they initiated the missed approach at about one-half mile from the runway from an altitude of about 300 feet above ground level (agl), when they visually confirmed that the Cessna 414 was on runway 31.
