## **AVIATION OCCURRENCE REPORT**

### **LOSS OF CONTROL DURING CLIMB**

**LES AILES DE CHARLEVOIX INC.  
CESSNA 421C GOLDEN EAGLE C-GVPB  
CHARLEVOIX, QUEBEC 2 km SE  
03 AUGUST 1994**

**REPORT NUMBER A94Q0140**

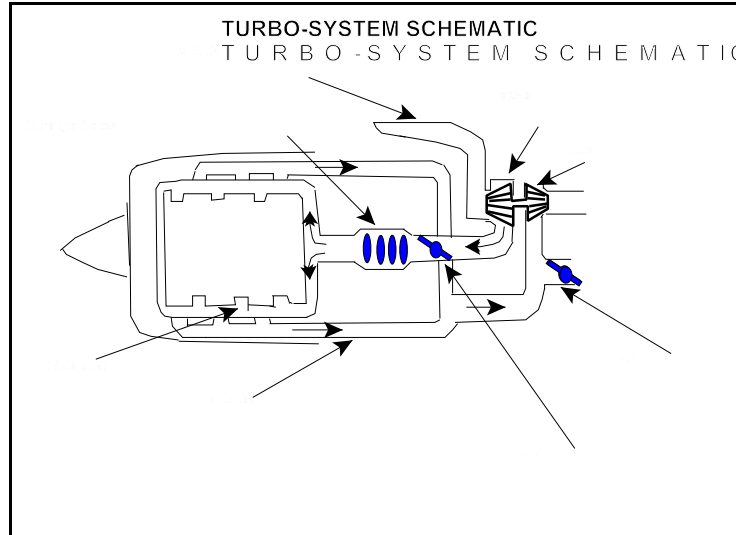
Each engine is supercharged by a supercharger driven by exhaust gases. A waste gate controls the amount of exhaust gases directed to the supercharger, and this regulates boost. Waste gate movement is controlled by oil pressure, which acts against a spring to close the waste gate and increase supercharger rpm, depending on throttle position and engine parameters. The supercharger increases engine power by 27 per cent.

Rubberized hoses conduct oil to the waste gate and lubricate the supercharger. The hoses are located close to the exhaust system, and they were replaced in July 1993. Although they were encased in a fireproof jacket, the hoses on the left engine were destroyed in the fire.

Impact forces completely broke up the left supercharger and tore off the waste gate; the right supercharger, which remained attached to the wing, was relatively intact. The left waste gate was stuck in the open position and the supercharger showed no signs of rotation. The right waste gate was stuck in the closed position, and the supercharger exhibited obvious signs of rotation.
