AVIATION OCCURRENCE REPORT

COLLISION WITH FROZEN LAKE

**EAGLE AIR SERVICES
PIPER PA-31-325 NAVAJO C-GOLM
WOLLASTON LAKE, SASKATCHEWAN 1 nm NE
25 NOVEMBER 1995**

REPORT NUMBER A95C0250

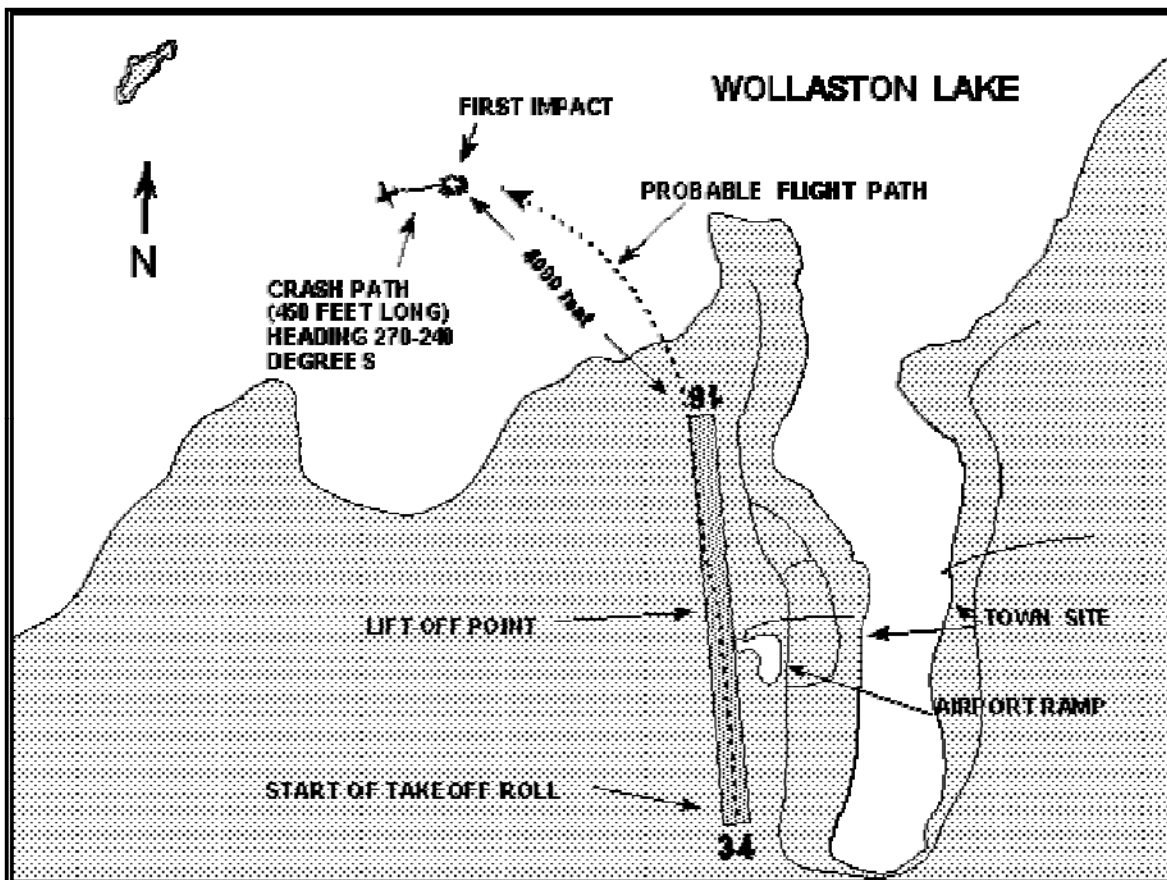
Appendix A - Flight Path

The aircraft was observed to climb at an unusually shallow angle after take-off, and, when efforts by company personnel to reach the pilot by radio were unsuccessful, a ground search was commenced. The aircraft was found about five minutes after the accident, located on the ice- and snow-covered surface of Wollaston Lake, about 0.75 nautical miles (nm) from the departure end of the runway, and about 1.3 nm from the point of commencement of the take-off roll³.

The wreckage trail was about 450 feet long. The impact marks indicate that the aircraft struck the lake surface on a heading of about 270°, in a left bank, and slightly nose down. The aircraft came to rest in an inverted position.

Calculations show that the length of the aircraft's flight path was about 6,000 feet, and at an average speed of 115 knots, the flight would have taken about 30 seconds. If the aircraft began turning as it passed over the departure end of the runway, then the average angle of bank required for the aircraft to reach the crash site would have been about 19°.
