LOSS OF CONTROL

**GOVERNMENT OF CANADA
DEPARTMENT OF TRANSPORT
AIRCRAFT SERVICES DIRECTORATE
BEEHCRAFT KING AIR A90 C-FCGE
NORTH BAY, ONTARIO
18 MARCH 1997**

REPORT NUMBER A97O0043

Summary

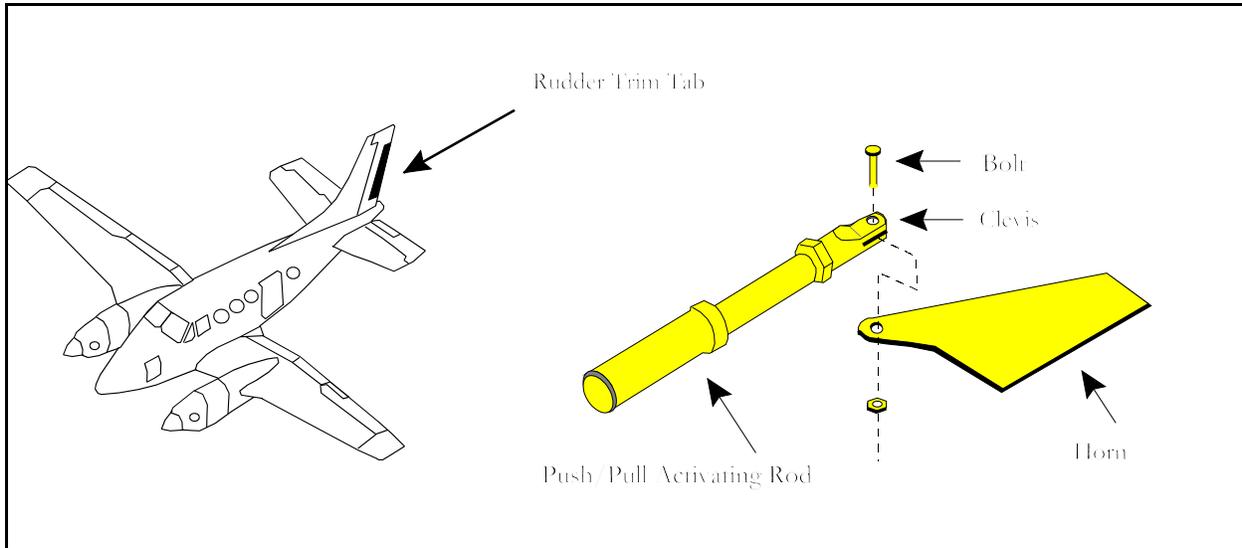
Figure 1 Rudder Trim Tab Location and Parts

The rudder trim is set by turning a wheel in the cockpit. This movement is converted into a fore and aft motion of the push/pull rod. The rod, attached by a clevis and bolt to a horn on the starboard side of the rudder trim tab, displaces the tab either to the left or right. This causes the rudder to be moved in the opposite direction thereby trimming out the control forces necessary to maintain co-ordinated flight. (See Figure 1)

The bolt and associated hardware securing the push/pull actuating arm to the rudder trim tab horn was missing after the occurrence. There are several possibilities as to why the bolt failed to remain secure. Possibilities are - it was not there on take-off, it fell out at some point, or it broke during flight. The first hypothesis is not likely, as the crew would have noticed this during pre-flight inspections or in flight prior to the occurrence.

The third hypothesis, that the bolt broke in flight, is the most likely scenario. The fracture would not have been due to overload stresses because there was no evidence of deformation on the clevis or trim tab horn. However if there were cyclic loads of sufficient magnitude present, the bolt could have failed in fatigue without damaging the surrounding components.

TSB liaise with Transport Canada to have Beechcraft review and revise the IPCs of the Beechcraft 90, A90 and B90 aircraft to reflect the correct AN hardware for the rudder trim tab to rudder trim actuator attachment.

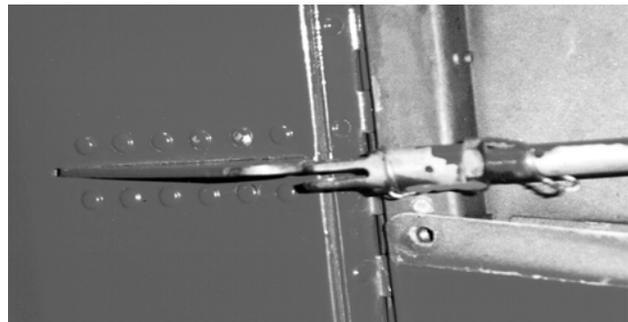
Figure 2 Clevis against the horn

When the crew finally regained control of the aircraft they noted that 2/3 rudder was required to maintain coordinated flight. If the push/pull actuating rod moves slightly up or down and inward toward the aircraft body, the arms of the clevis can end-butt against the horn (see Figure 2) and force the tab to the left. If this occurred, the rudder would be displaced to the right requiring left rudder input to maintain coordinated flight. Tests on another King Air showed that when the rod is in this position the trim tab would be displaced approximately half its maximum deflection if the trim tab control started in the neutral position. The air stream would be sufficient to hold the tab horn firmly against the clevis unless another buzz was introduced. These tests also showed that this was a fairly stable position for the clevis that would not shift with control inputs or minor vibration.
