AVIATION INVESTIGATION REPORT

A98Q0114

SPIN—LOSS OF DIRECTIONAL CONTROL

CESSNA 152 C-GZLZ

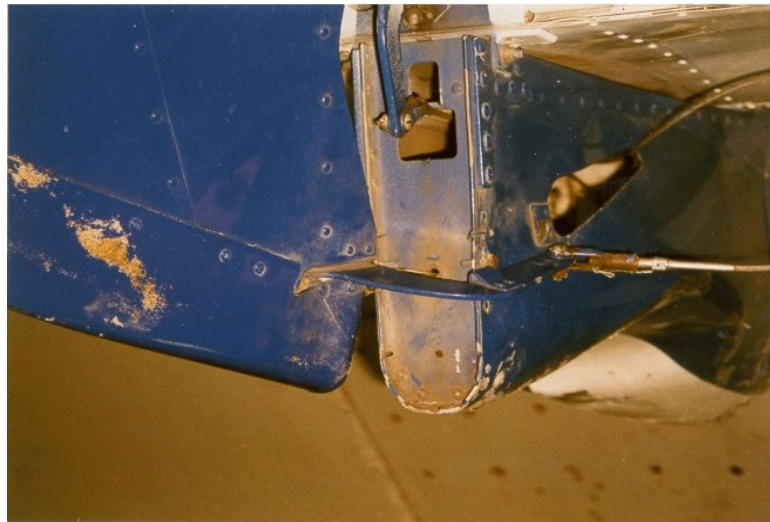
The rudder components and the front end of the aircraft were sent to the TSB Engineering Laboratory in Ottawa, Ontario. It was observed that the rudder stop plate on the right-hand half of the rudder horn was firmly jammed behind its stop bolt on the fuselage. The rudder was deflected 34 degrees measured perpendicular to the hinge line, whereas the maximum allowable deflection for setting the stops is 23 degrees. When the rudder was released from its jam, the deflection was 23 degrees. It

required 36 pounds of steady pull on the trailing edge of the rudder to break the rudder out of its jammed position. This steady pull of 36 pounds equated to 180 pounds if the force was applied to the rudder pedal. However, given that the direction of cable pull tended to increase the jamming by closing the horn, it would not have been possible to break the rudder jam with the application of right rudder.

It can therefore be concluded that the aircraft entered a left spin with the rudder locked at a 34-degree deflection. With the rudder jammed the way it was, no amount of right rudder pedal force would have released the jammed rudder, as the direction of cable pull tends to increase the jamming by closing the horn.

On 14 March 2000, Cessna notified the TSB that it had designed a rudder horn stop bolt with a larger head diameter to prevent over-travel of the rudder following a hard rudder input. Cessna has notified the Federal Aviation Administration (FAA) Aircraft Certification Office about this matter and expects to issue a Service Bulletin offering the new configuration rudder stop bolt for all Cessna 150s and 152s built after 1966. A time frame for these actions was not specified.

The Department of Transport issue an Airworthiness Directive to all Canadian owners and operators of Cessna 150 and 152 aircraft addressing a mandatory retrofit design change of the rudder horn stop bolt system to preclude over-travel and jamming of the rudder following a full rudder input.
