AVIATION INVESTIGATION REPORT

A99P0075

POWER LOSS—FUEL STARVATION

BELL 214B HELICOPTER C-GEWT

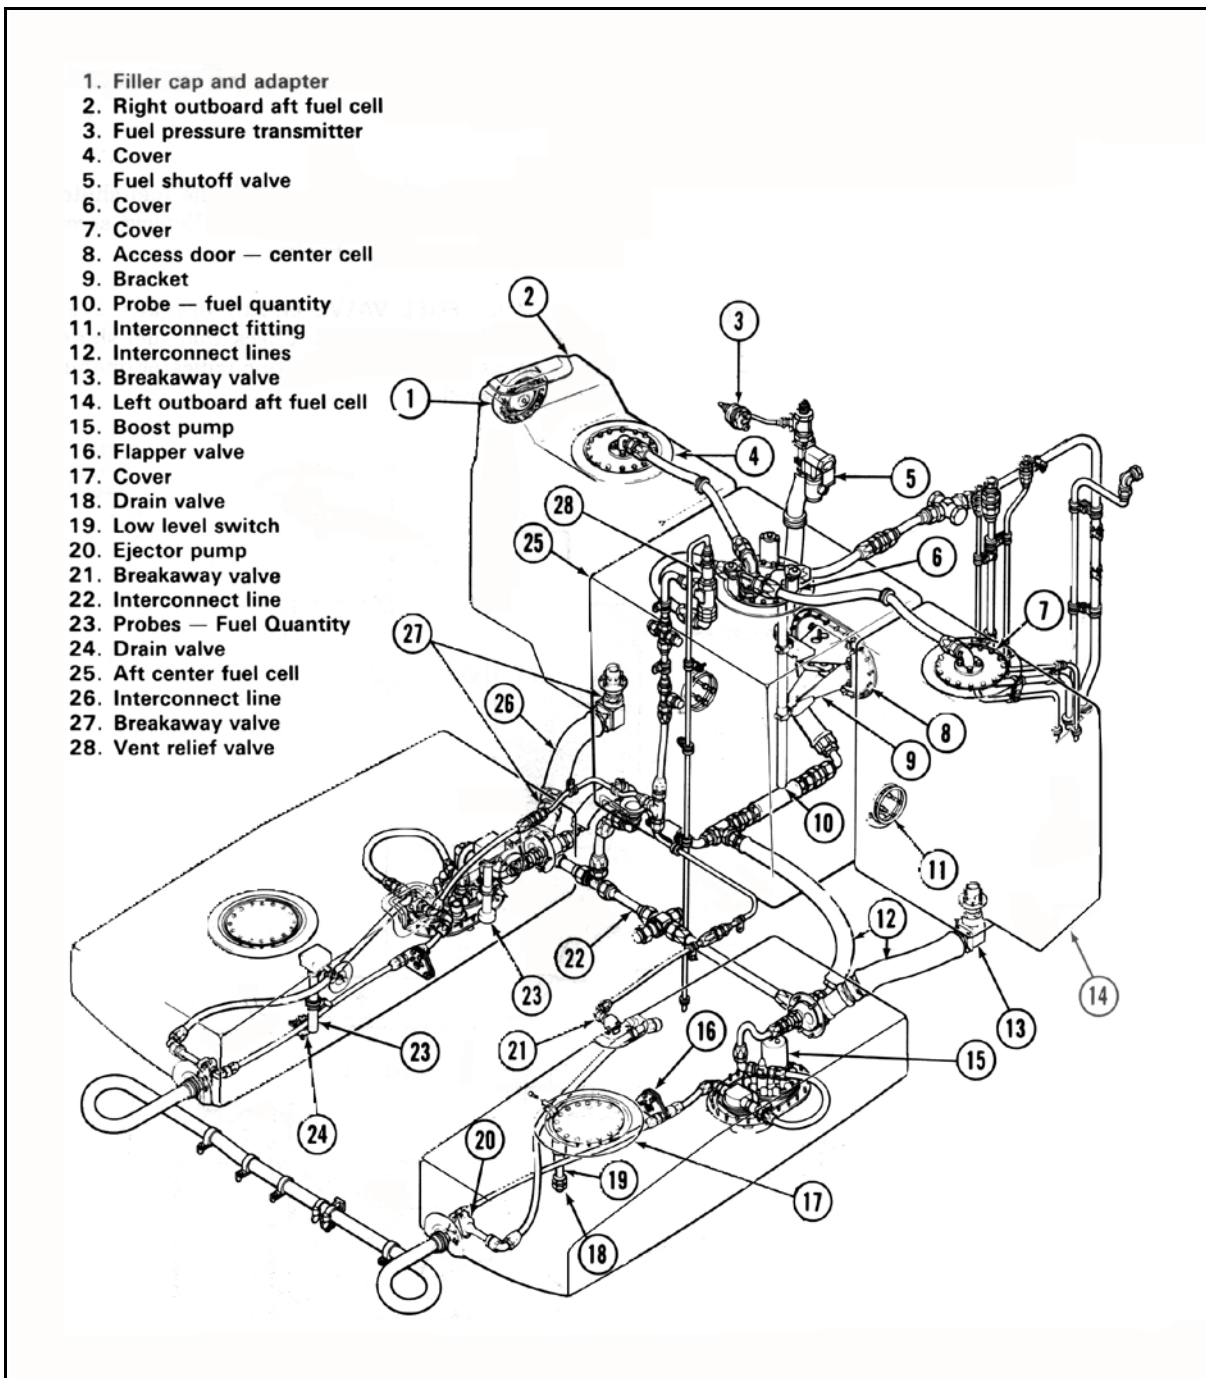
The Bell 214B helicopter is equipped with five fuel cells interconnected to feed into the two forward fuel cells, which are the lowest cells in the system (see Figure 1). Each of the forward cells has a partition with a small one-way flapper valve, which divides the cell into a forward and an aft section. The aft section of each forward cell contains an electrically driven boost pump, part number 164A213, which supplies fuel to the engine. Each boost pump also operates a jet pump, located in the forward section of each cell, to supply fuel from the forward section of the cell to the aft section. A fuel cell interconnect line runs between the left and right forward fuel cells, normally ensuring that the fuel level in the two forward cells remains equal. The fuel quantity gauge is operated by probes located in the centre cell and the right forward fuel cell. If the centre fuel cell does not contain any fuel, the fuel quantity gauge is operated solely by the probes in the right forward cell. The fuel quantity gauge does not directly register fuel in the left forward cell. The left forward fuel cell contains a float-switch used to activate the low-fuel warning light. The Bell 205 has similar fuel storage, fuel transfer, and fuel indicating systems.

The light bulb analysis showed that the low-fuel light and the right boost pump annunciator light might have been illuminated at the time of the crash. The fuel level sensor is in the left forward cell; therefore, the low-fuel light would indicate that the left forward cell was virtually empty. Assuming the right boost pump became inoperative, the fuel from the left forward cell was consumed at a faster rate than the fuel could transfer from the right forward cell to the left forward cell. The fuel in the left forward cell eventually reached an unusable level, and the engine stopped. The fuel gauge indicator retains its last position when power is cut off. The gauge indication after the crash was 500 pounds. Assuming that power was lost at impact, the gauge was indicating 500 pounds of fuel just before the crash. Relying on the principle that the fuel in the forward cells will remain equal because of the cell interconnect line, the system measures the amount of fuel in the right forward cell, and doubles that amount for the fuel quantity indicator. Therefore, at the moment of the crash, there was approximately 250 pounds of fuel in the right cell and virtually none in the left cell. The boost pump light would indicate that the right boost pump was not operating or that there was no useable fuel in the right fuel cell. In light of the following, it is likely that the pump was not operating (failed): the engine stopped in flight; nothing mechanically wrong was found with the engine; there was useable fuel in the right cell; and the boost pump light might have been on.

The average length of time that the fuel boost pumps on the Bell 214B were found to operate before requiring repair or overhaul is much lower than the design life goal set by the pump manufacturer. Depending on the attitude of the helicopter, failure of a boost pump in one cell could result in a significant amount of fuel remaining in that cell, while the fuel in the cell with the operable boost pump is consumed to exhaustion. This is because the forward fuel cell interconnect is unable to flow fuel from the cell with the inoperable boost pump to the cell with the operable pump as rapidly as the engine can consume fuel from the cell with the operable boost pump. Exhaustion of the fuel in the cell with the operable boost pump will cause the engine to flame out.

Because the fuel quantity indicating system does not directly measure the amount of fuel in the left forward cell, unless the fuel level in both forward cells is equal, the gauge will indicate an incorrect amount of fuel remaining. For the same reason, the fuel low-level warning system, which does not directly measure the fuel in the right forward cell, can read incorrectly. Either of these indications could lead the pilot to believe that there is more fuel than is actually available and to continue flight operations until fuel exhaustion.
