MARINE INVESTIGATION REPORT

M00L0043

FALL OVERBOARD

FROM THE PASSENGER VESSEL *MISS GATINEAU*

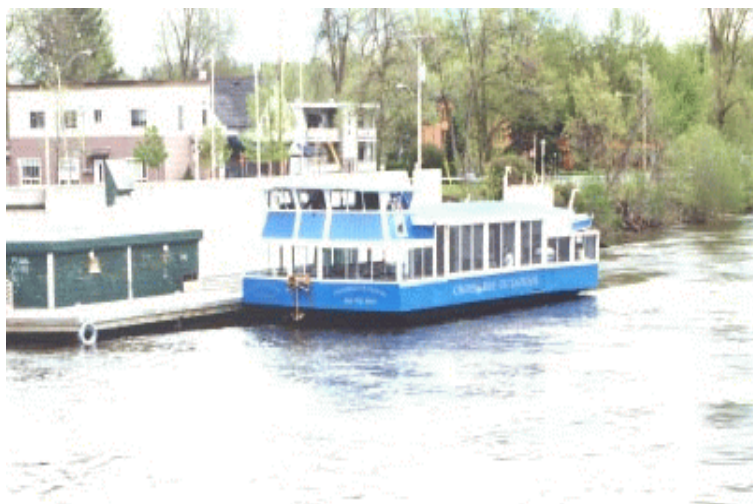
The *Miss Gatineau* is a converted vehicle ferry with a flat-bottom steel barge hull (see Figure 1). The navigation bridge is located at the bow above the passenger area, and the engine room is on the centre line, aft. An aluminium superstructure covers the former vehicle deck, which has been converted into a passenger area. The passenger area is arranged with a disk jockey booth aft, a bar to port, and washrooms to starboard. Forward of the disk jockey booth is an open area which was arranged as a dance floor surrounded by passenger

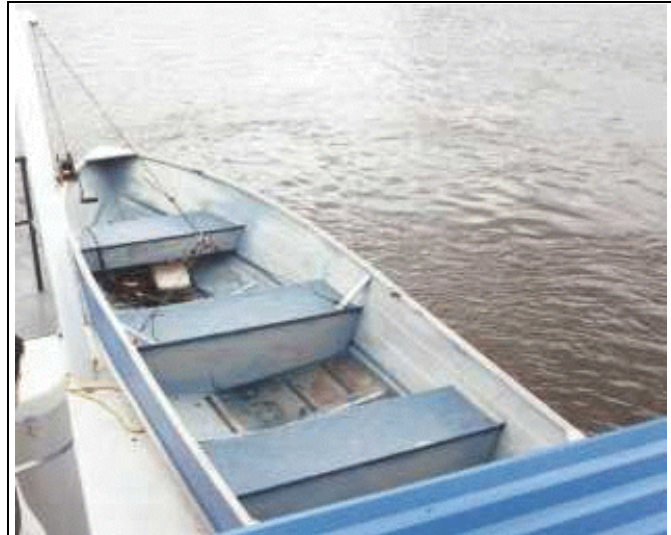
In 1992 Transport Canada Marine Safety (TCMS) advised the original owner that the lifeboat on board was required to be equipped with a motor (see Figure 2). In response, the vessel's owner requested and was granted an exemption from the Transport Canada Board of Steamship Inspection (BSI) from the requirement to carry a motorized rescue boat capable of towing liferafts, citing the oar-equipped skiff on board as an alternative. At the time of the occurrence, the new owner (son of the original owner) was under the impression that TCMS would not allow him to equip the lifeboat with an outboard motor.

In 1993 the then owner of the *Miss Gatineau* had applied to the BSI for an exemption from the requirement to carry a motorized boat on board. The requirement for a motorized boat was primarily intended to facilitate the marshalling of liferafts, and the rescuing of persons in distress.⁸ Since the *Miss Gatineau* was operating in sheltered waters a short distance from shore, the BSI granted the exemption. The BSI considered an aluminium skiff, propelled with oars, (as carried on board as a lifeboat at the time of the occurrence) to be a suitable alternative. Consequently, the *Miss Gatineau* was not equipped with a motorized boat which would have allowed the crew to rapidly proceed downstream in the strong current to conduct a systematic search for the victim.
