MARINE INVESTIGATION REPORT

M01C0029

SWAMPING AND CAPSIZING

FISHING VESSELS *SHANNON DAWN* AND *RACHEL M*

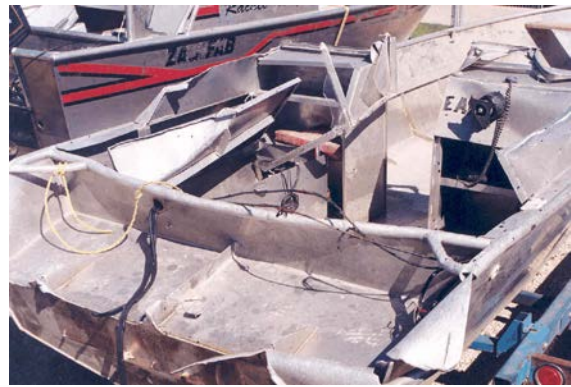
Swamping/Capsizing Scenario

The *Shannon Dawn* was found with the tip of the bow projecting above the surface of the water, which tends to support a “capsizing settling by the stern” scenario. When the vessel was recovered, it was missing its motor. It is suspected that the motor was ripped off the transom when the *Shannon Dawn* passed over the first set of shoals at the southwestern tip of Berens Island. The vessel then drifted approximately one mile further. Any ingress of large volumes of water would create a dangerous “free-surface effect” and significantly reduce the *Shannon Dawn’s* stability. The bilge pump was missing and had been reported as being non-operational. Consequently, shipped water could not be discharged from the vessel. In the heavy rolling sea with cresting waves, the free-surface effect of the entrapped water on board would have contributed to the capsizing action.
