MARINE INVESTIGATION REPORT

M02L0039

GENERAL CARGO VESSEL *VAASABORG*

22 MAY 2002

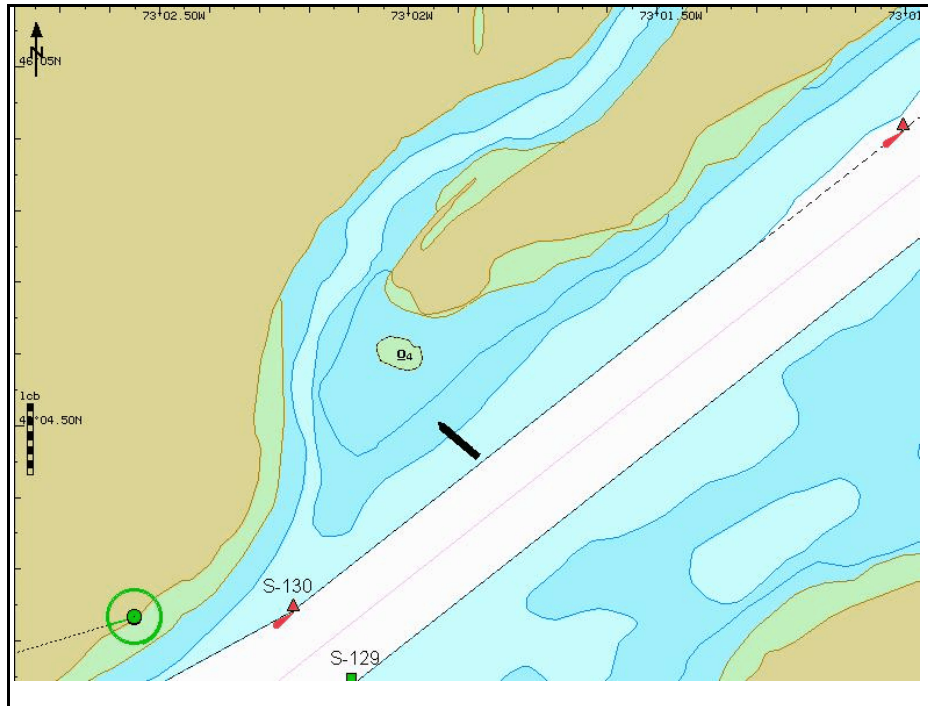
The pilot put the engine-telegraph astern. The master was in the ship's office and felt the vessel list to port. He immediately ran to the bridge. Upon his arrival, he saw the rudder angle indicator showing that the rudder was moving from hard-a-starboard to port; he put the engine-telegraph to zero (stop) and then astern. The master ordered the OOW to go to anchor stations. Notwithstanding these actions, at approximately 1005, at a speed over the ground of 11.6 knots, the vessel ran aground outside the north side of the channel, off Île de Grâce. The vessel came to rest in position 46°04'30" N, 073°01'54" W, on a heading of 310.5° Gyro (see Figure 1 and Appendix A).

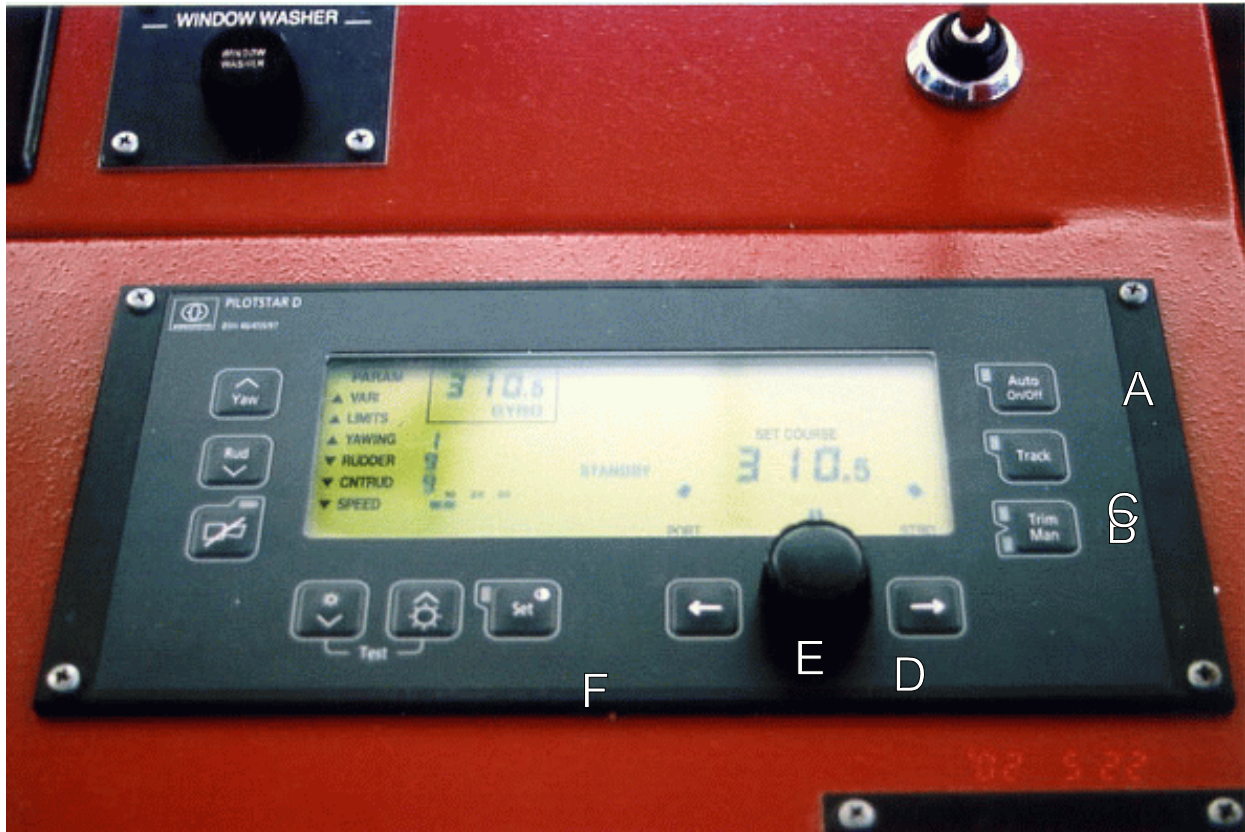
The steering gear of the *Vaasaborg* can be controlled automatically by an Anschutz, Pilotstar D, Type AP01-S01, autopilot.³ The main control panel is found on the central console near the starboard captain's chair. It is fitted with a liquid crystal display (LCD) screen, a membrane keyboard, and a rotary knob (see Photo 2). The LCD screen is divided into two logic fields of application (that is, a monitoring field on the left and an operating field on the right). In the monitoring field, a gyro-heading reading and several operational adjustment parameters are displayed. The operating field has a mimic indicator for off track and off course, a set course reading and a helm indicator with membrane keys (A, B, C, D and F) to select active mode, as well as a rotary knob (E) for set course preselection.

On the Pilotstar D autopilot control panel, the “Auto On/Off,” “Track” and “Trim Man” function membrane keys are identical in size and touch as the arrow (course alteration) keys. The proximity of the “Trim Man” function key to the starboard arrow key and the vessel’s behaviour in the events leading up to the grounding suggest that the pilot inadvertently pushed the “Trim Man” key instead of the starboard arrow key, just prior to the vessel turning abruptly to starboard.

By pushing this function key, the autopilot was deactivated, the system changed to manual control and to NFU mode. In manual and NFU mode, the set course reading is deactivated and the reading does not change. All further attempts to correct course to steer, using the arrow keys, were now actual rudder commands. The sequence of events indicates that the actions of the pilot to regain control of the rudder and steer 230° were in fact now causing the rudder to move increasingly to starboard. This is consistent with the vessel’s rapid swing to starboard and would account for the 80° deviation of the course.

Upon receiving MSI 08/02, the LPA communicated with the Port of Montréal (District No. 1.1) pilots and the two pilot corporations, i.e. Montréal–Québec (District No.1) and Québec–Les Escoumins (District No.2), recommending that the pilots not steer the vessel themselves using an autopilot, but instead request the services of a qualified helmsman. The LPA insists that a qualified deck watch officer and helmsman from the ship's complement be in the wheelhouse in compulsory pilotage waters to steer the vessel.
