MARINE INVESTIGATION REPORT

M02W0089

CAPSIZING — TWO FATALITIES

LOG SALVAGE VESSEL *BRUCE BROWN*

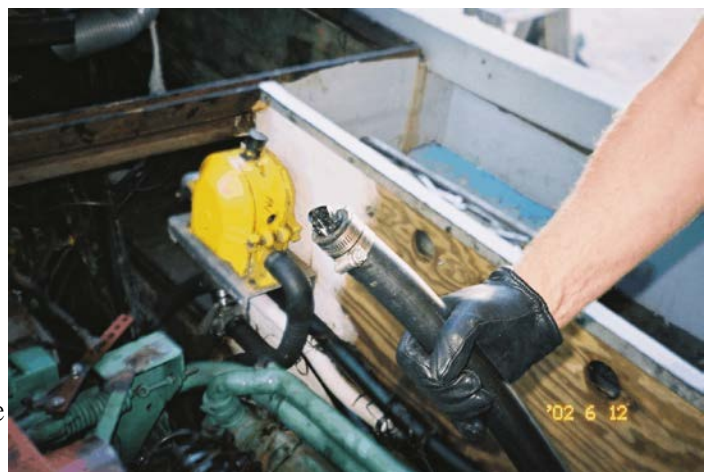
After the vessel was recovered, it was discovered that one of the two 28.5 mm, wire-reinforced rubber hoses on the discharge side of the raw water cooling system had parted. This failure was located in the section between the heat riser and the through-hull fitting at the side of the vessel, within the engine compartment. The hose parted where two lengths of hose of the same diameter had been joined with a metal connector. Examination of this connector revealed that, in place of a straight connector, a reducer had been used. One end of this reducer matched the 28.5 mm inside diameter of the rubber hose, while the other end was 25.4 mm in diameter. This smaller diameter had been built up to match the 28.5 mm inside diameter of the hose by the application of plastic electrician's tape. Two hose clamps had then been secured over each hose end at the reducer.

The raw cooling water, its temperature raised by heat drawn from the engine, warmed the electrician's tape and softened its adhesive. The wire reinforcing within the rubber hose limited the ability of the hose clamps to compress the hose against the reducer. The pressure of the cooling water, as supplied by the circulating pump, was sufficient to elongate the warmed adhesive of the electrician's tape until the connection failed and the hose parted (see Photo 3).

The engine's raw water circulation pump continued to supply cooling water to the system. Where the hose had parted, that water now flowed into the vessel's bilges instead of overboard. Because this hose failure occurred during darkness, it is unlikely that the operator would have been able to observe that the cooling water discharge was now reduced to a single stream. The accumulation of water in the bilges would have served to trim the vessel by the stern. A vessel's change of trim can often be detected when referenced to the horizon. This, however, would be more difficult to detect during darkness. The noise generated by the engine would most probably have obscured the sound of the accumulating water moving within the vessel – an additional warning that a dangerous situation had developed.
